## Bridge 20476 Inspection Report

**Asset #20476**(Routine, NSTM)

**Independence/CR 11 over TENMILE CREEK**

## **NSTM Inspection Report and Procedure** **Bridge No. 20476 2.09 MI W US 167**

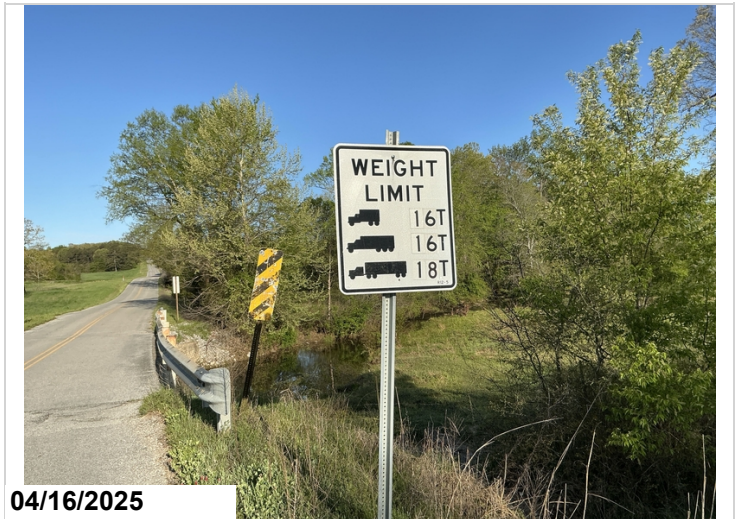
Abutment 1: Load Posting Sign.

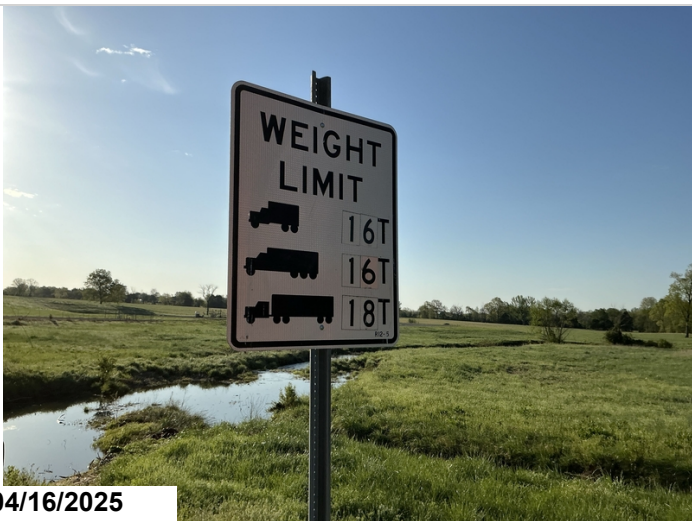
Abutment 2: Load Posting Sign.

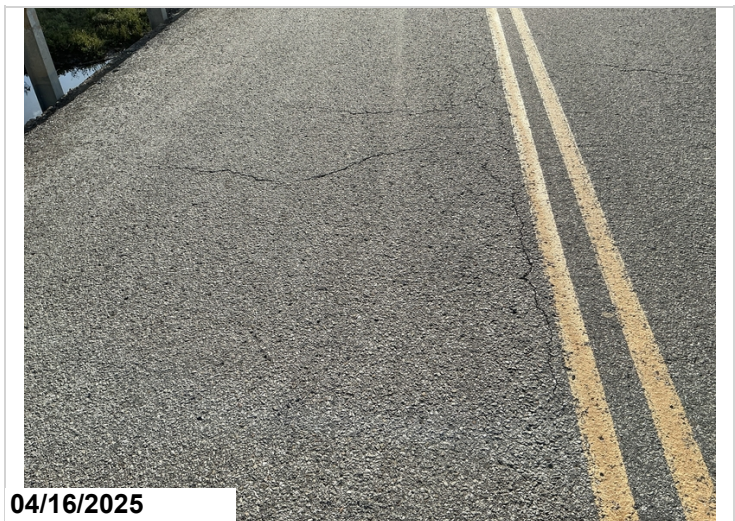
Overall, the Deck is in Good condition with cracking to the asphalt overlay.

Deck: cracking to asphalt overlay.

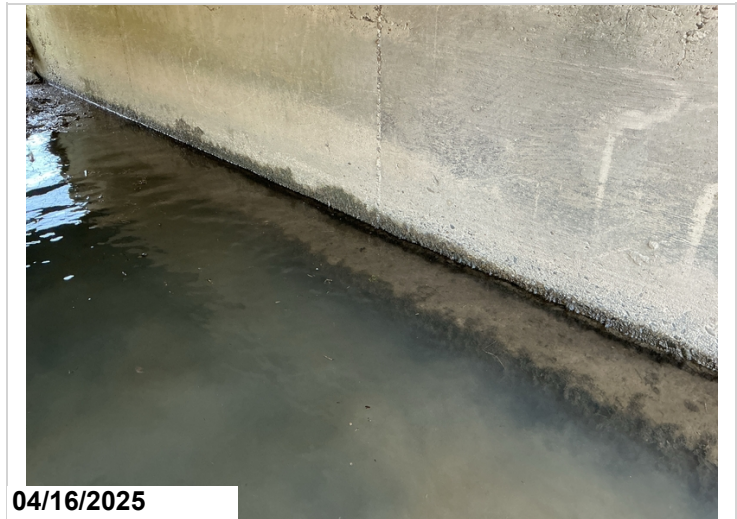
Abutment 1: footing exposed.(Footing is on solid rock)

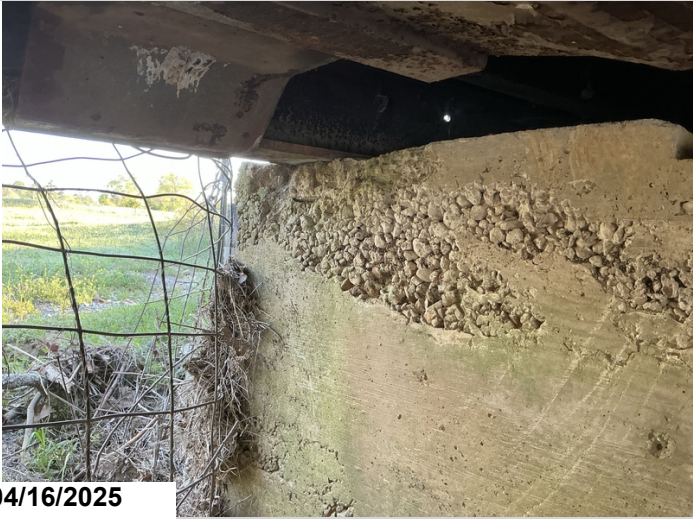
Abutment 1, Right Railcar, Girder 8: spalling with exposed reinforcing steel. No Section Loss.

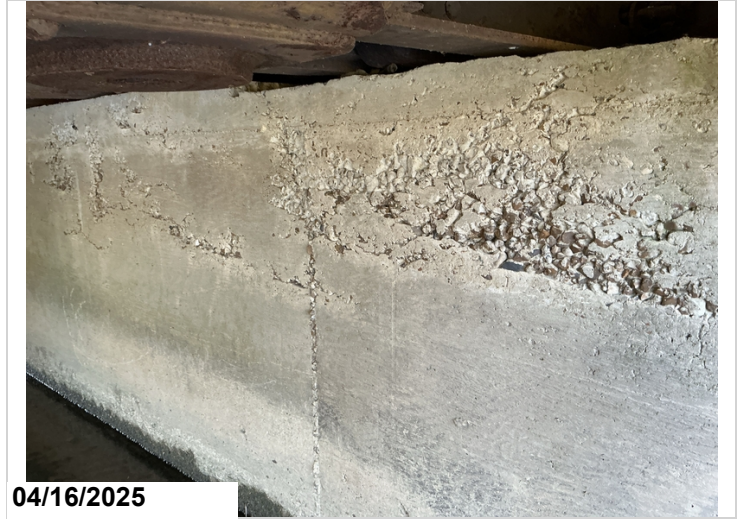
Honeycomb area to abutment 1.

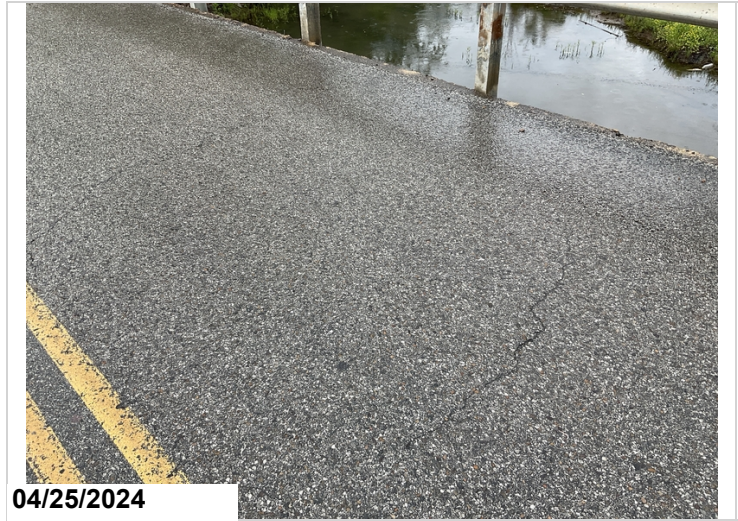
Deck: transverse cracking to asphalt overlay.

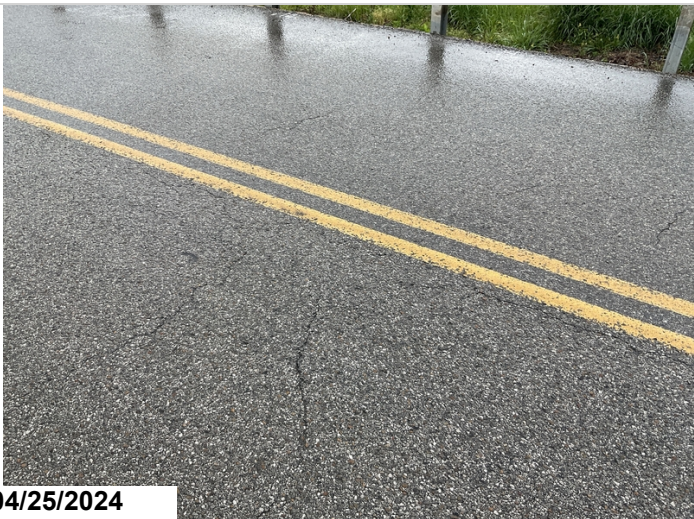
Deck: cracking to asphalt overlay.

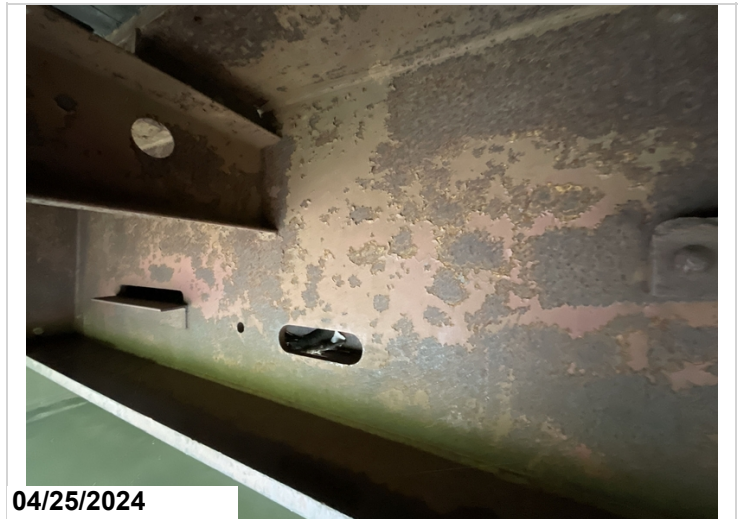
Typical flaking paint & surface corrosion.

**A-60 - Full Girder Painting Needed (Yes)**

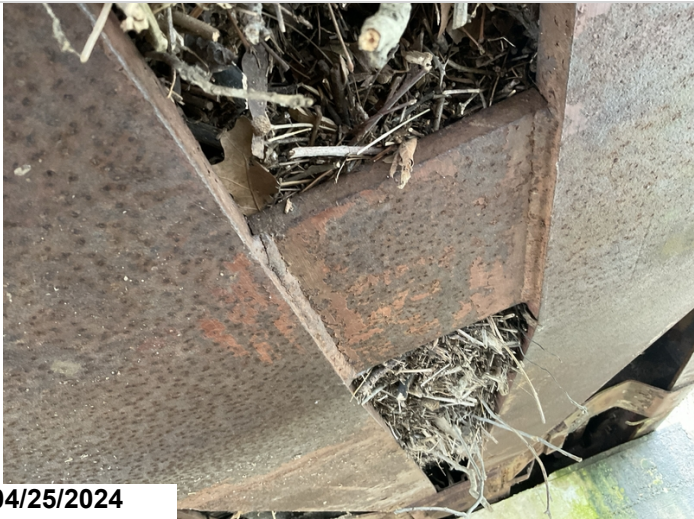
Right Railcar, Brace Plate between Girders 6 & 7: cracked weld near 3/4 point.

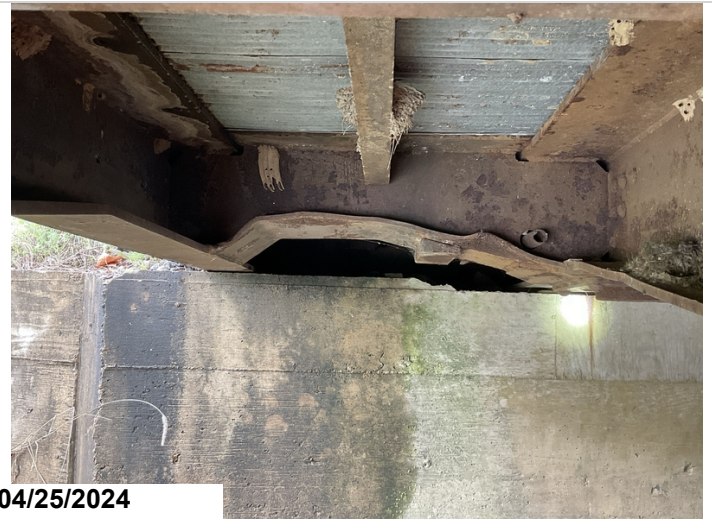
Left Railcar, between Girders 1 & 2, Bolster near Abutment 2: out-of-plane bending to cross member.

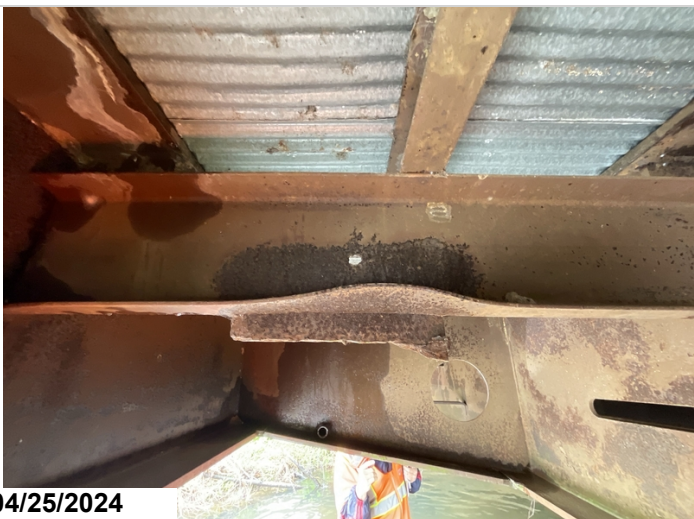
Left Railcar, Crosstie 2, between Girders 1 & 2, between Floor Beams 2 & 3: out-of-plane bending.

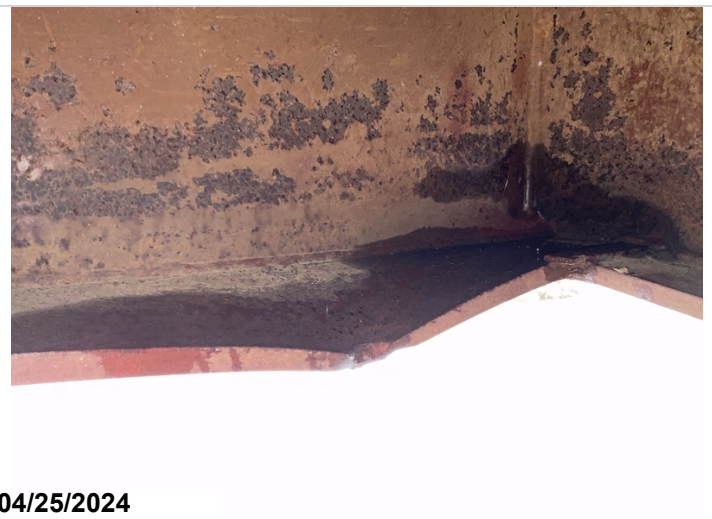
Left Railcar, Girder 1, 1' back of Floor Beam 2: out-of-plane bending.

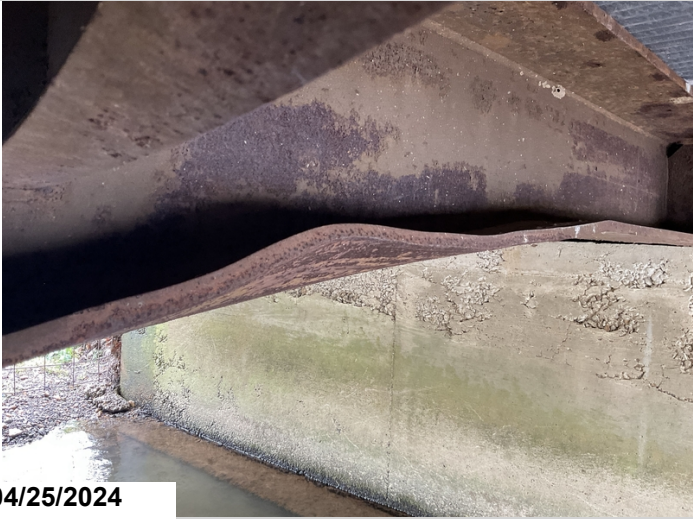
Left Railcar, Girder 4, Bottom Flange, 5' ahead of Abutment 1: twisted for 7'.

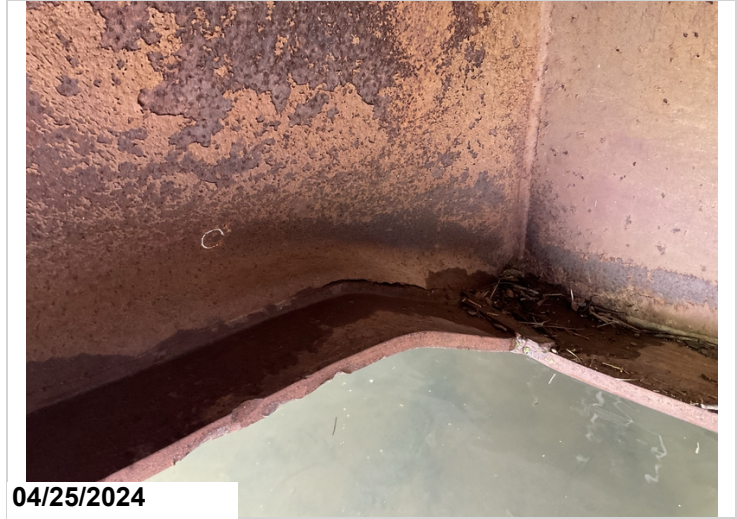
Left Railcar, Floor beam 1, Left side of Girder 2: 8" crack along the web & bottom flange connection along Floor beam.

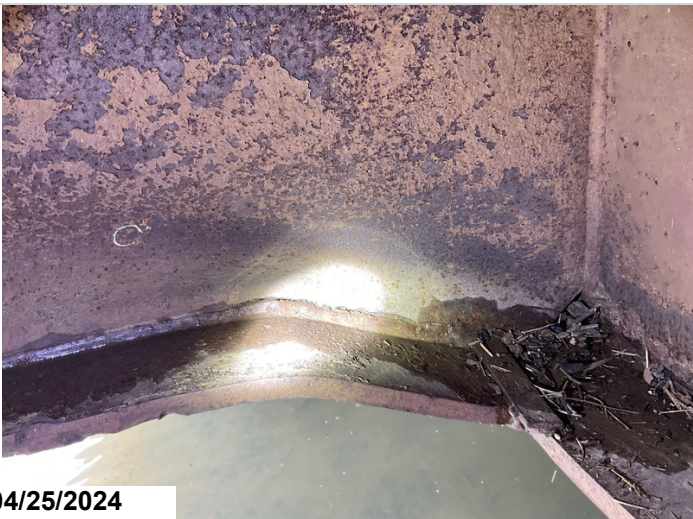
Left Railcar, Floor beam 1, Left side of Girder 2: crack along the web & bottom flange connection along Floor beam.

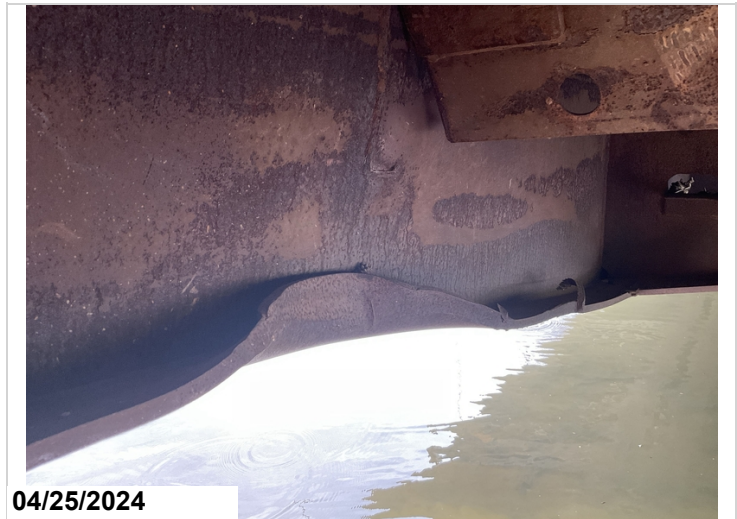
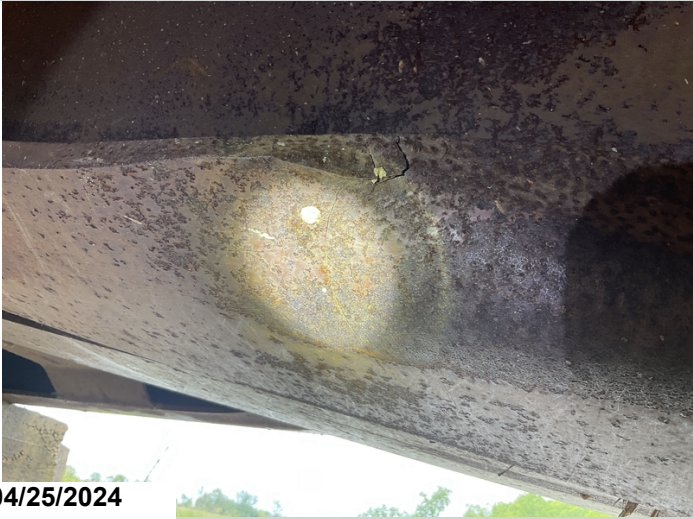
Left Railcar, Abutment 1, girder 3: 5" crack to bottom flange in large bent area 4.5' ahead of Bolster near Abutment 1.

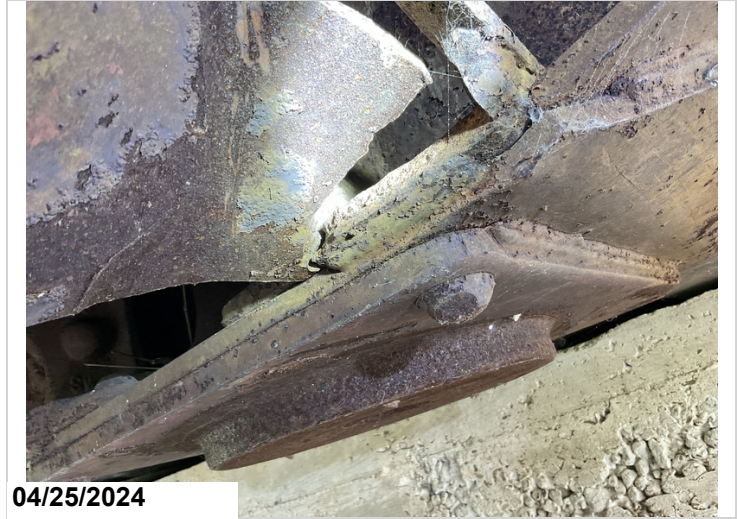
Left Railcar, Abutment 1, girder 2: 6" crack to bottom flange, and 1" vertical crack to web at Bolster

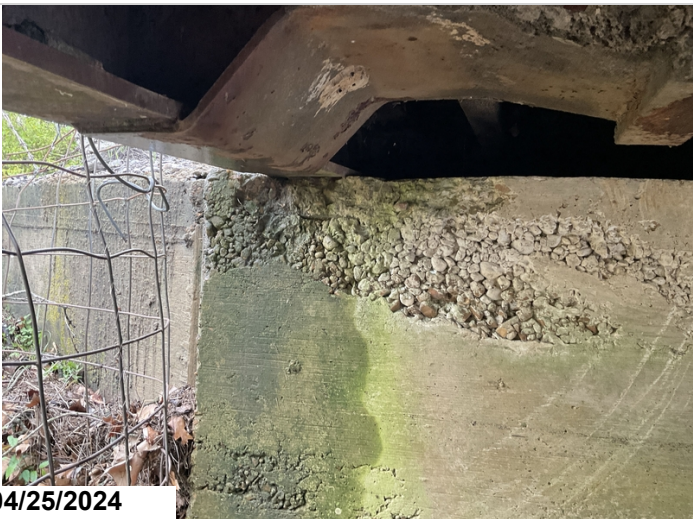
Abutment 1, Right Railcar, Girder 8: spalling with exposed reinforcing steel. No Section Loss.

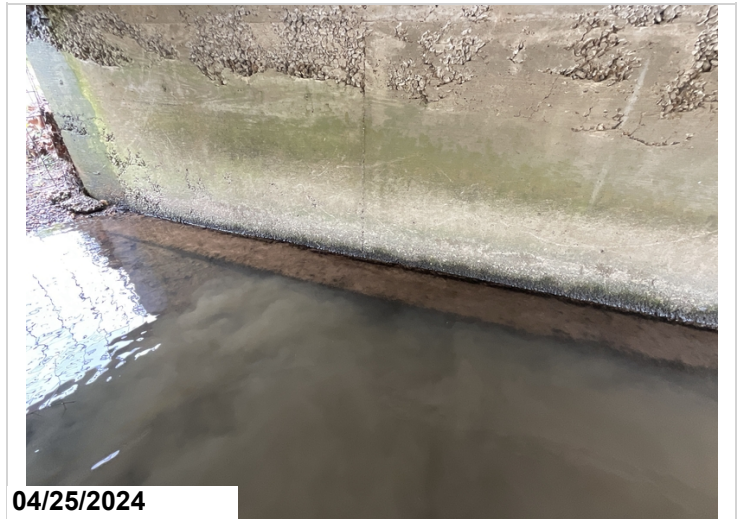
Abutment 1: footing exposed.

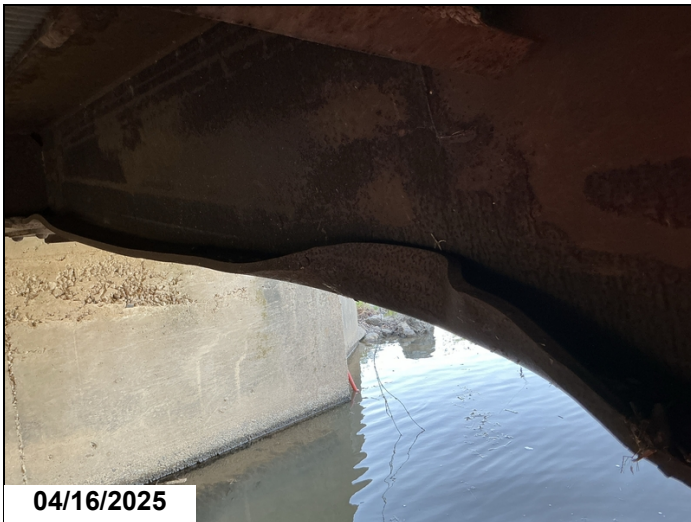
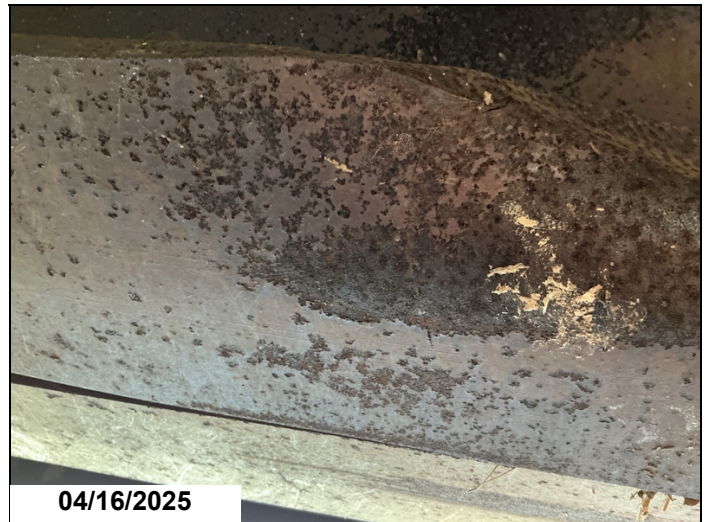
Left Railcar, Abutment 1, girder 3: 5" crack to bottom flange and large bent area 4.5' ahead of Bolster near Abutment 1.

**Type of Work:** Superstructure Repair

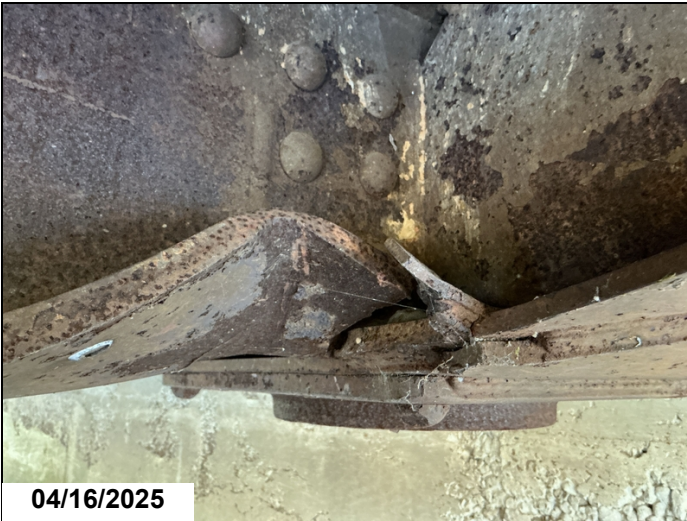
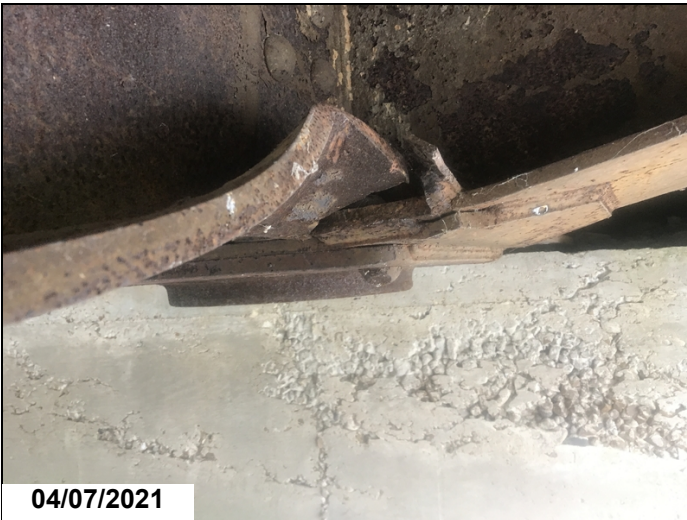
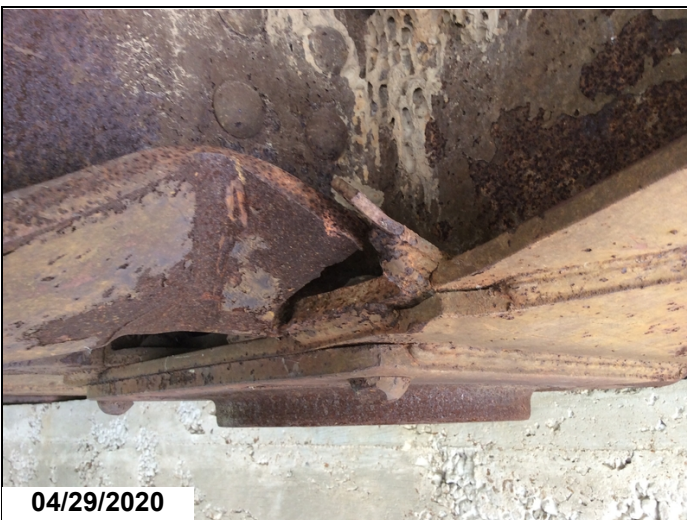
Left Railcar, Abutment 1, girder 2: 6" crack to bottom flange, and 1" vertical crack to web at Bolster.

Longitudinal Girder 2 has 6" crack to bottom flange, and 1" vertical crack to web at Bolster near Abutment 1.

Longitudinal Girder 2 has 6" crack to bottom flange and 1" vertical crack to web at Bolster near Abutment 1.

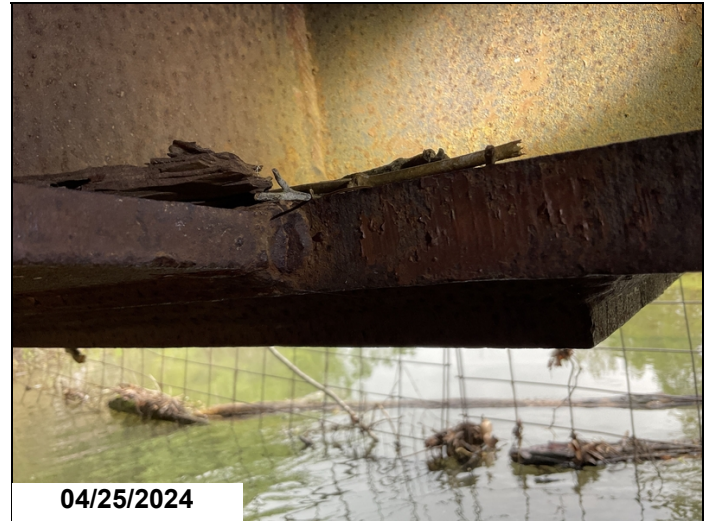
Right Railcar, Floor Beam 3, Left side of Girder 6: cracked weld at the Bottom Flange connection to the Floor Beam and Girder.

Right Railcar, Floor Beam 3, Left side of Girder 6: cracked weld.

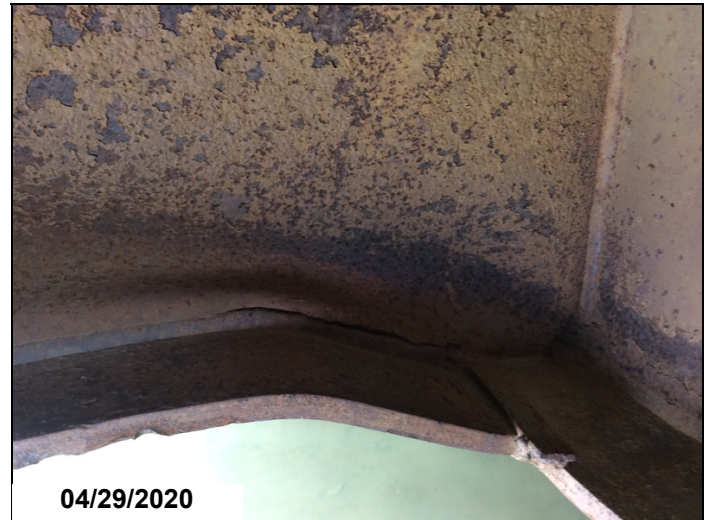
Left Railcar, Floor Beam 1, Left side of Girder 2: 8" crack along the web & bottom flange connection along Floor Beam.

Left Railcar, left Floor Beam - 8" horizontal crack at bottom flange.

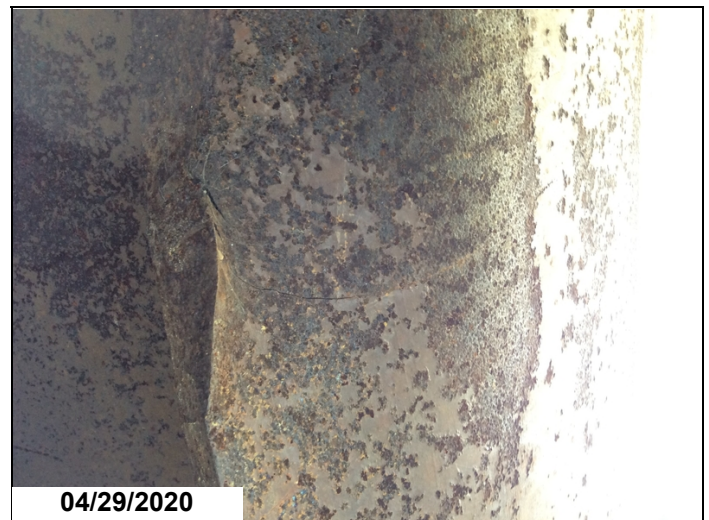
Longitudinal Girder 3 has crack in bottom flange where bent.

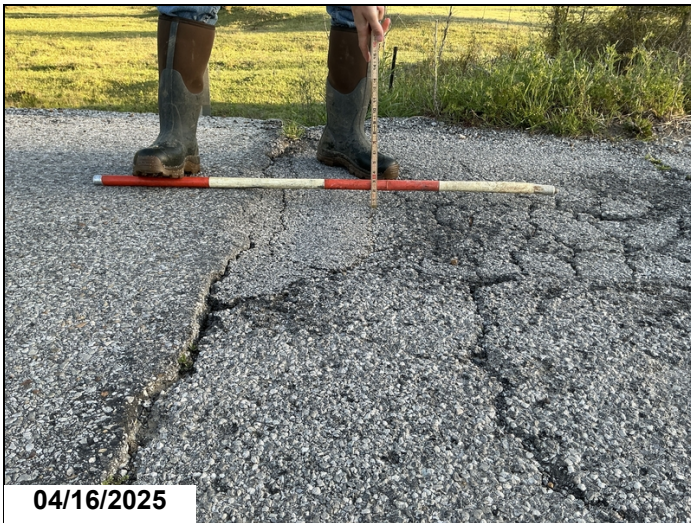
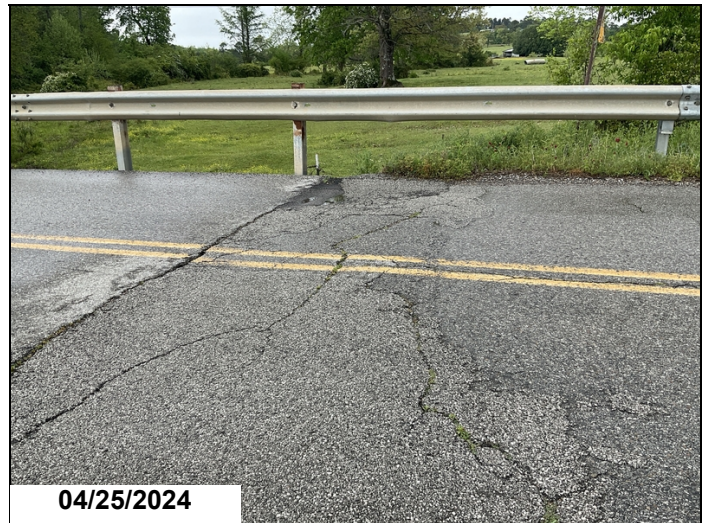
Abutment 1, Right, Approach Roadway: settlement causing a 4' X 3' pothole.

**Type of Work:** Approach Leveling/Maintenance

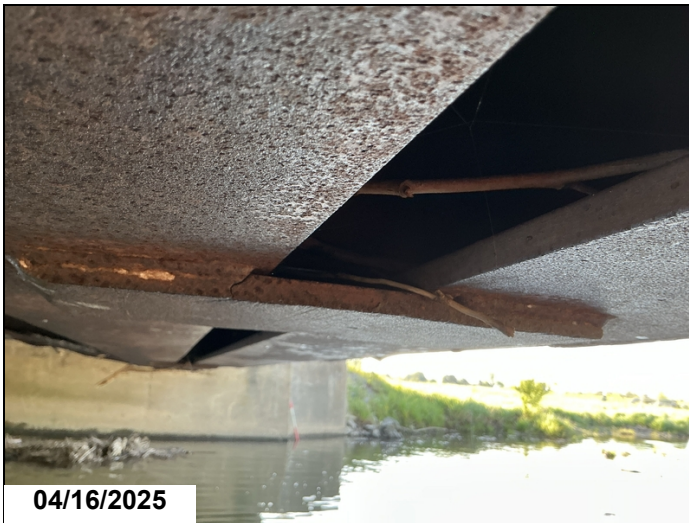
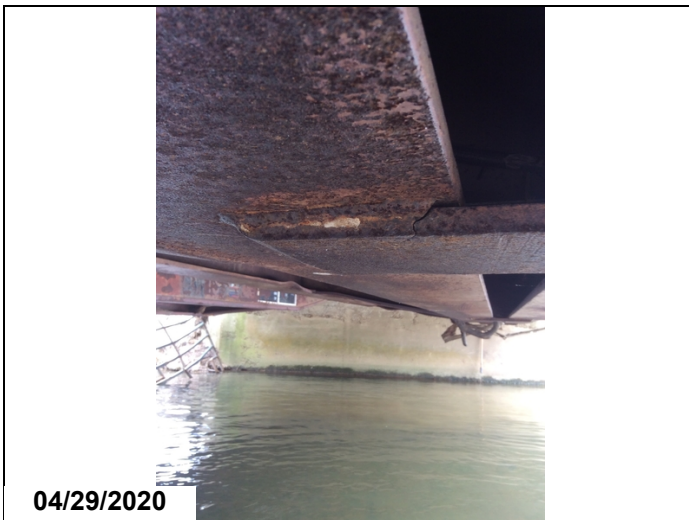
Typical broken welds and cracks to brace plate between Girders 2 & 3 on Left car.

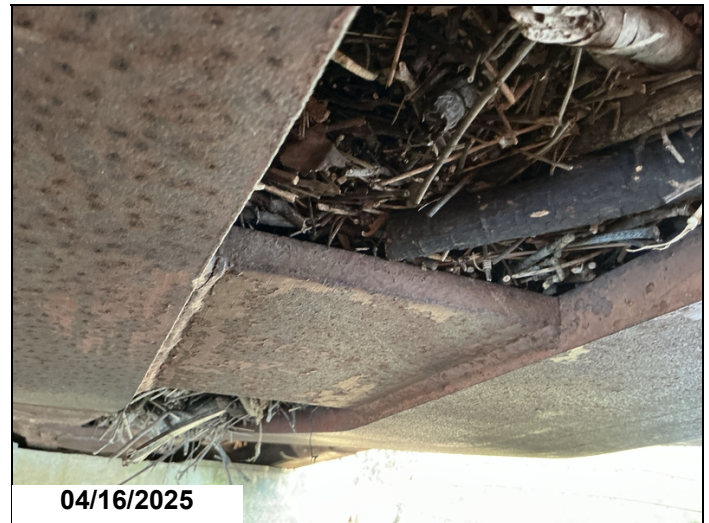
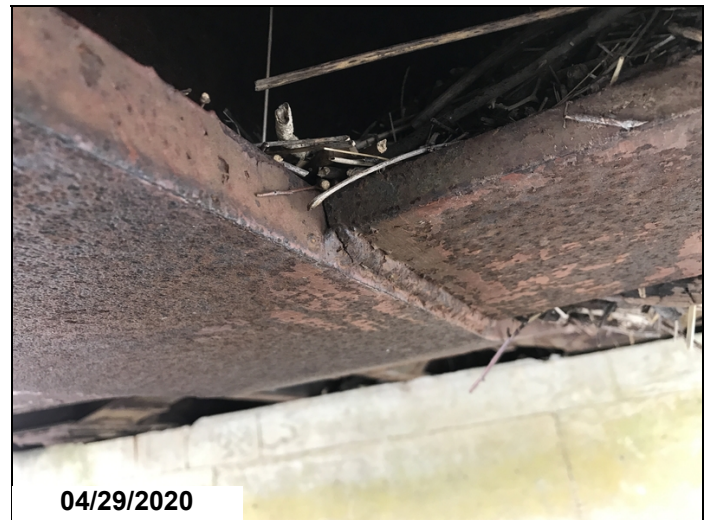
Right Railcar has Broken weld to brace plate welded between Girders and 6 & 7 @ 3/4 point.

Type of Work: Repair (General)

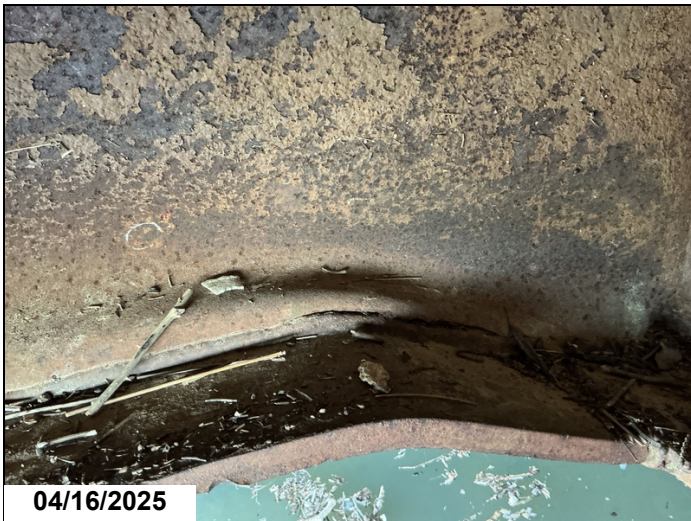
Left Railcar, Floor Beam 1, Left side of Girder 2: crack along the web & bottom flange connection along Floor Beam.

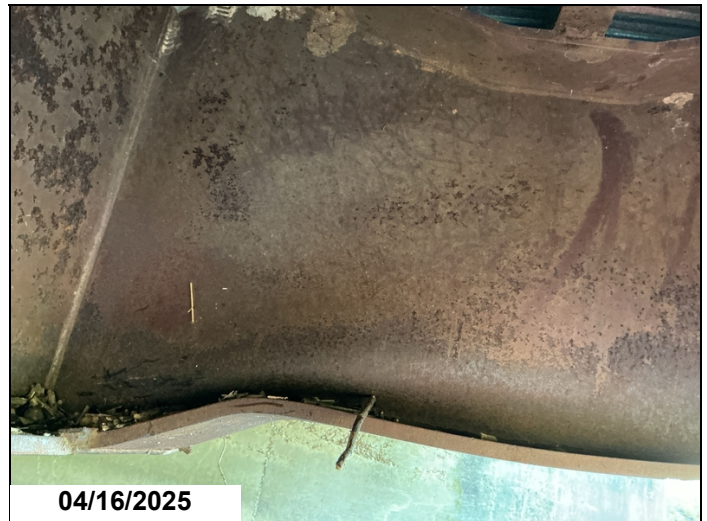
Left Railcar, Floor Beams 1 & 2, between Girders 3 & 4: out-of-plane bending to the bottom flange.

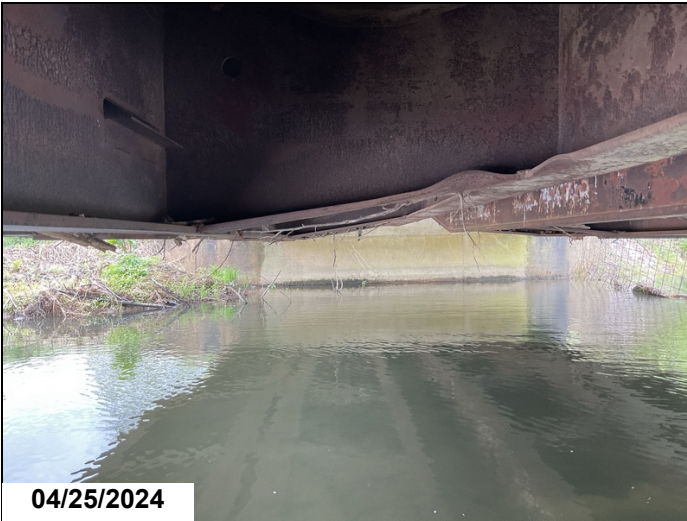
Floor Beam 2, Back, between Girders 3 & 4: out-of-plane bending.

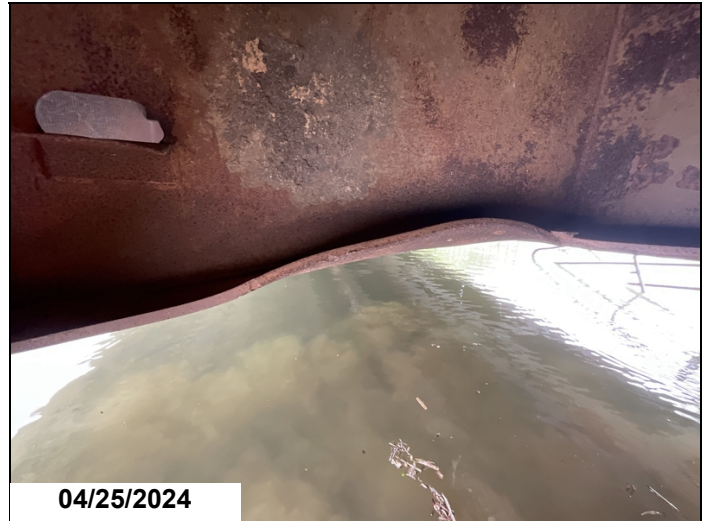
Floor Beam 1, Back, between Girders 3 & 4: out-of-plane bending.

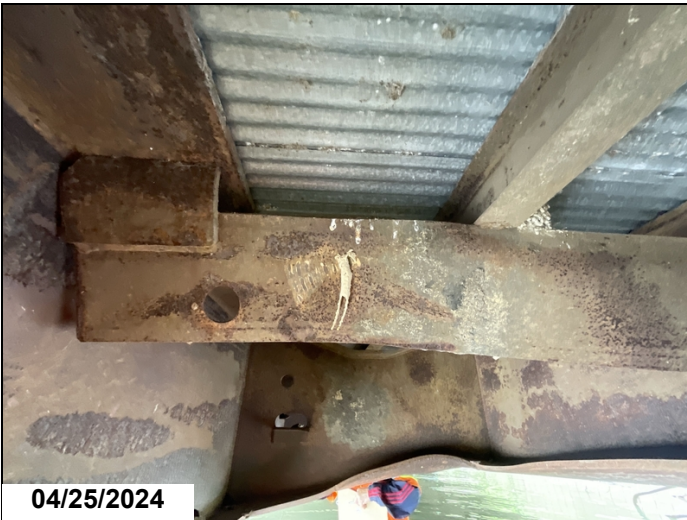
Cross brace, Back side of Floor Beam 1, between Girders 3 & 4: twisted.

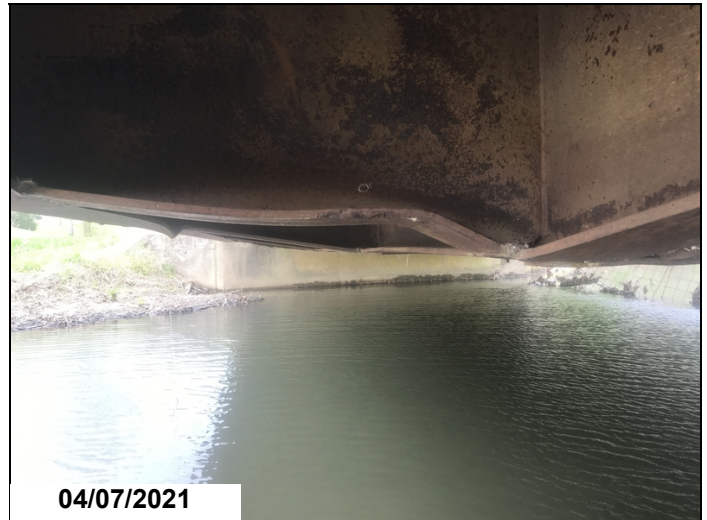
Floorbeams 1 & 2 between Girders 3 & 4 has bent bottom flange.

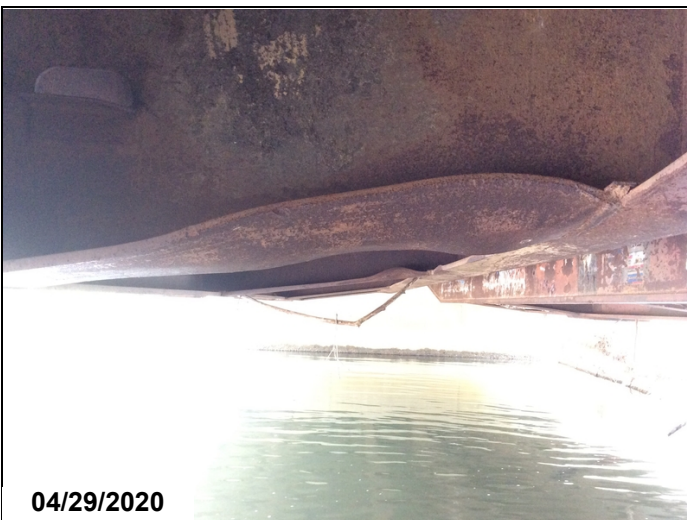
Floor beams 1 & 2 between Girders 3 & 4 of Lt. Railcar.

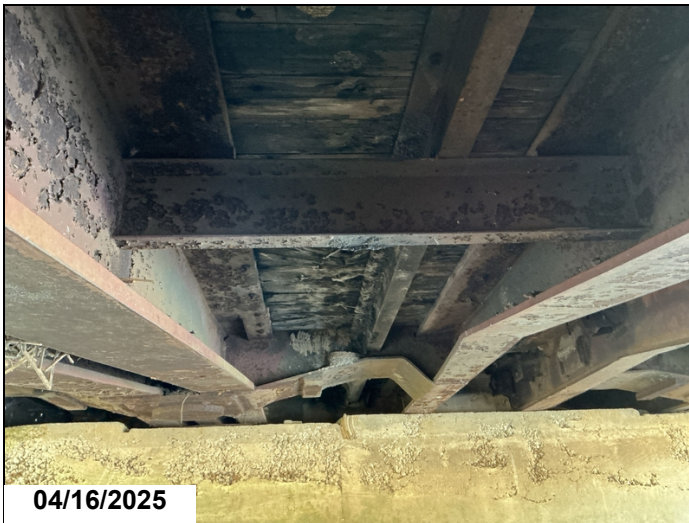
Timber Stay in place form is deteriorating between girders 5 and 6 on right rail car.

**Type of Work:** Deck Repair
