Asset #21665(Routine, Underwater type 2)

MiddleWarrenRd-CR over Creek

Location: 2.1 MI N SH 54-Pinebergen

Team Lead: Sharon Hooks, Inspection Date: 11/09/2021

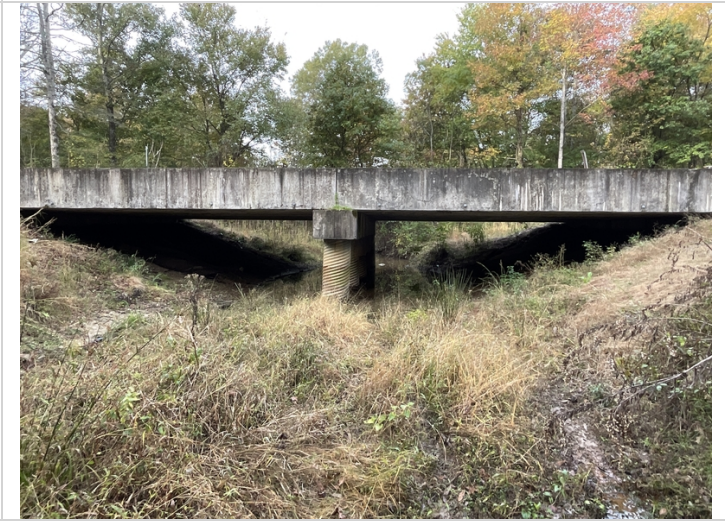
Elevation.

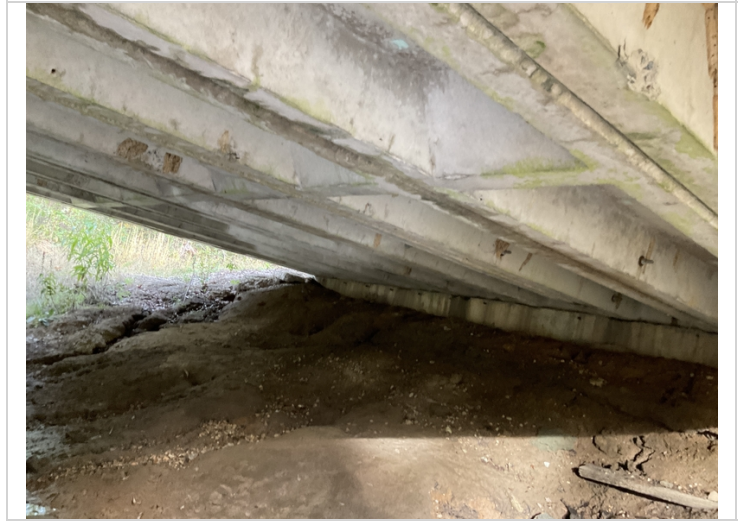
Under view.

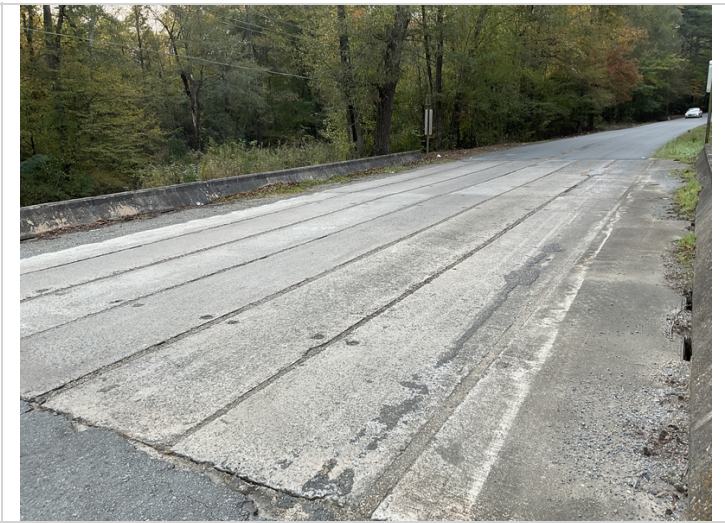
Deck over view.

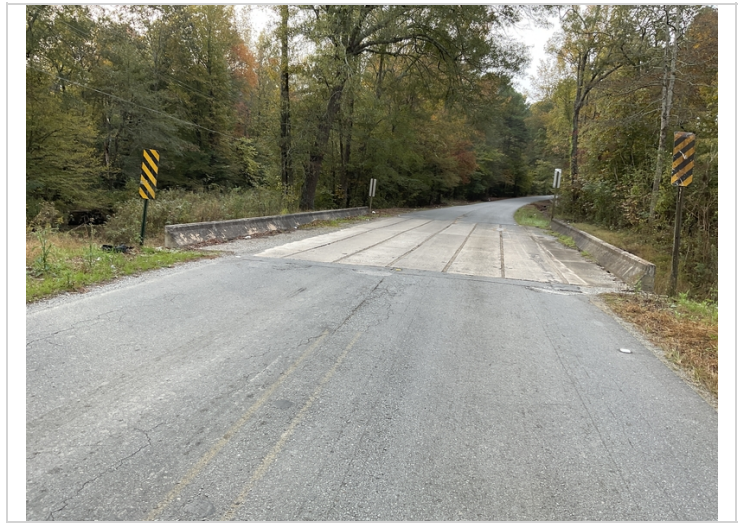
Approach.

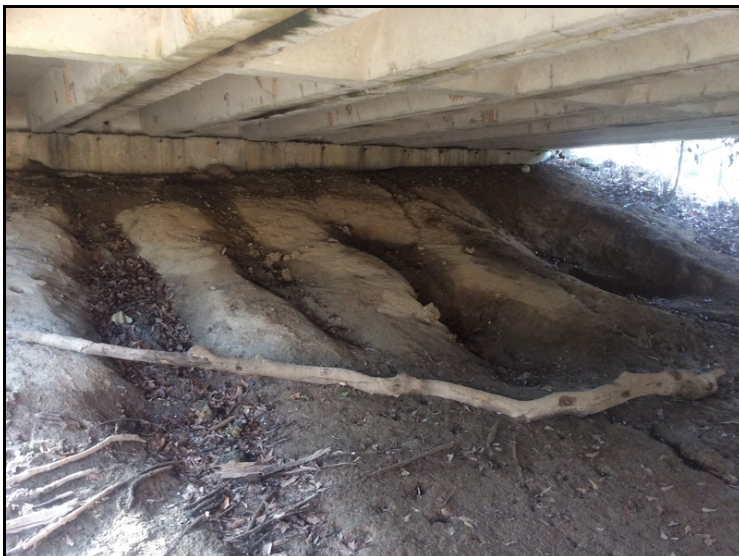
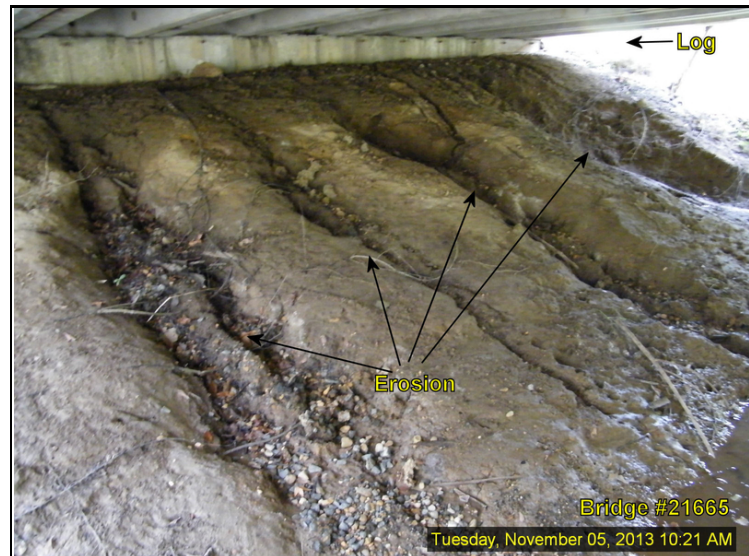
End slopes – Bents 1 & 3: Some erosion of slope material due to leaking of stormwater through joints between units, heaviest at Bent 1 left and Bent 3 full width.

Endslope - Bent 3: Erosion

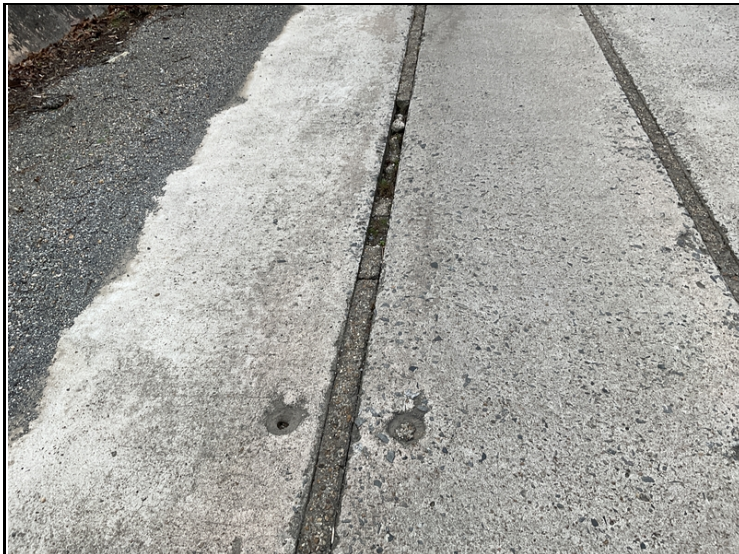
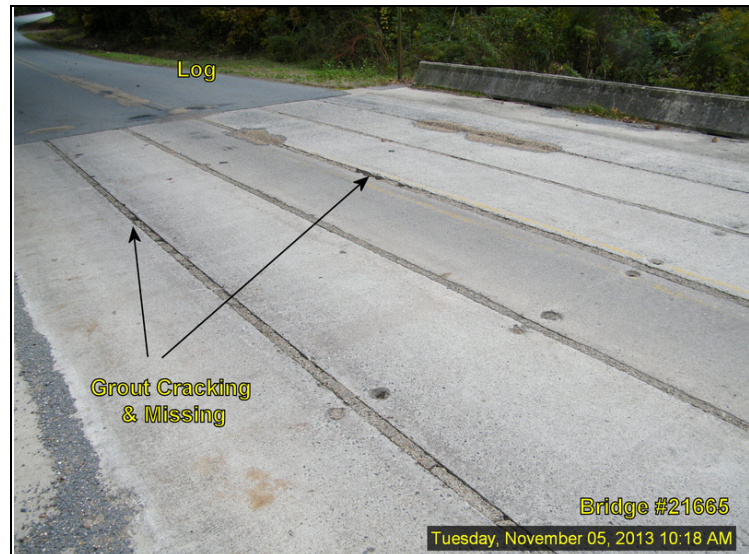
Deck – various locations: Grout between units is cracked, broken up, and missing in several places, especially Span 1 Units 2-5 and Span 2 Units 2-7.

NOTE: A couple areas have been patched with an asphalt/pea-gravel mix.
This repair does prevent any leakage of stormwater through cracks; however, it does not provide for the transferring of loads between units that proper grout does.

Deck grout missing in keyways at various locations.

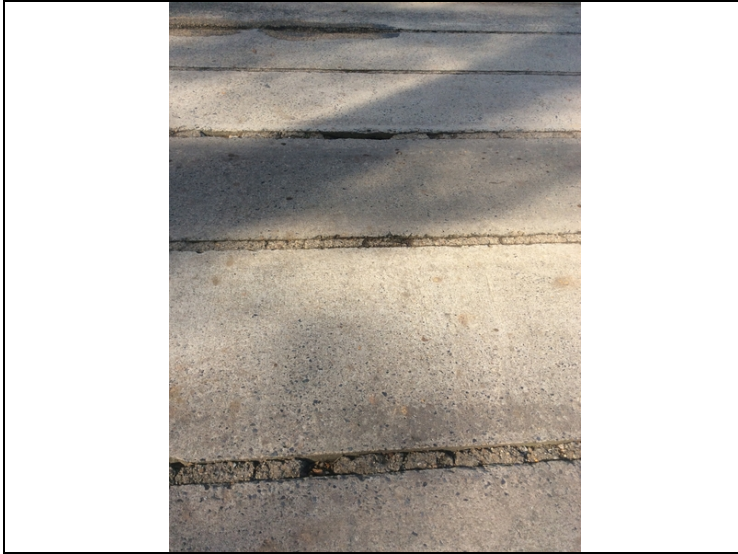
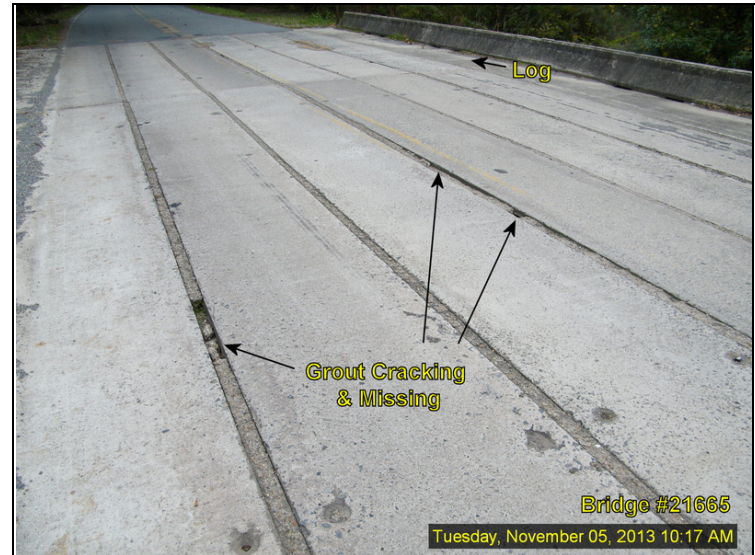
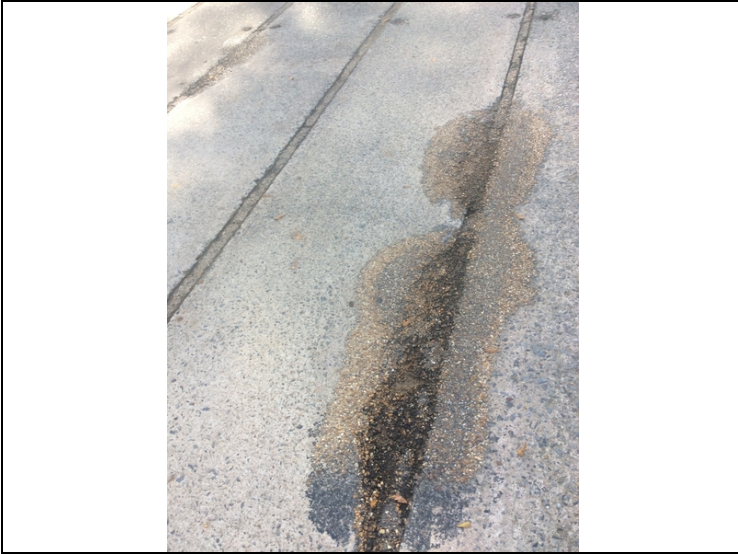
Deck - Span 2 Units 2-7: Grout deterioration
