Asset #21927 (Routine, Underwater type 2)

MiddleWarrenRd-CR over Creek

Location: 0.8 Mi N SH 54-Pinebergen

Team Lead: Sharon Hooks, Inspection Date: 11/09/2021

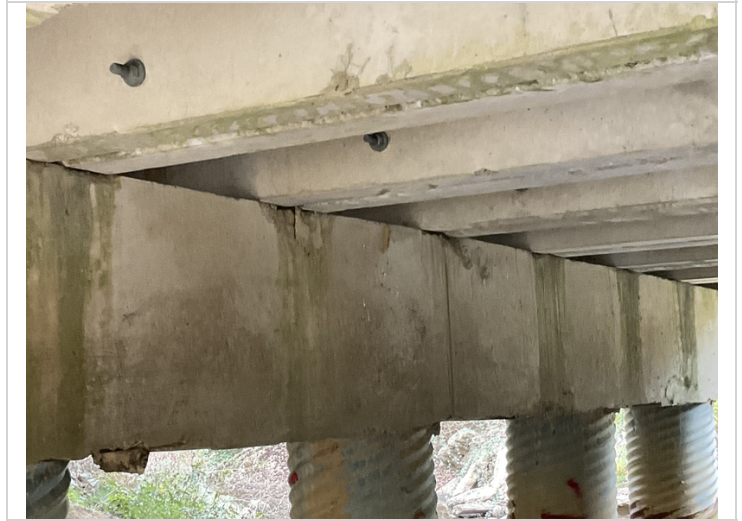
(234) Caps: 32' each / Bent 2. Bent 2 cap has contact spalls on both sides.

Bent 2 cap under girder 3 has delam and spall.

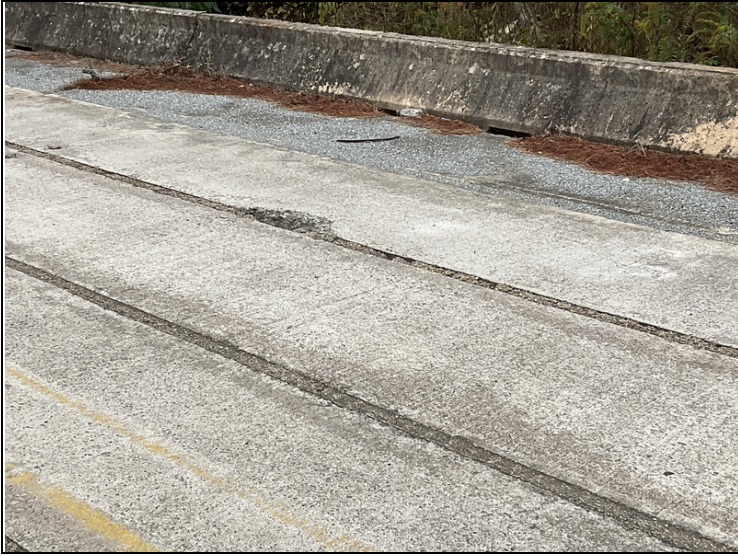
Span 1 girder 7 has spall at keyways.

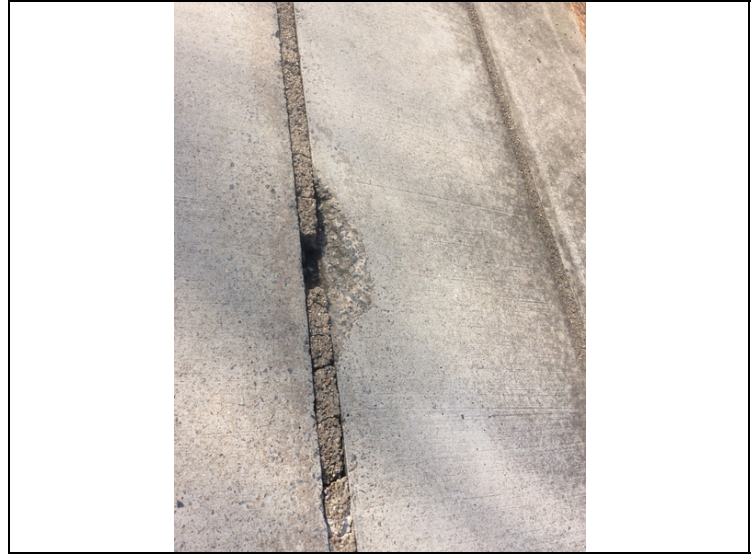
Deck – Span 1 Unit 7: Spall (8" x 16" x 4" deep) on left edge of unit near midspan. Adjacent grout is broken and 4" section is missing.

Deck - Span 1 Unit 7: Spall

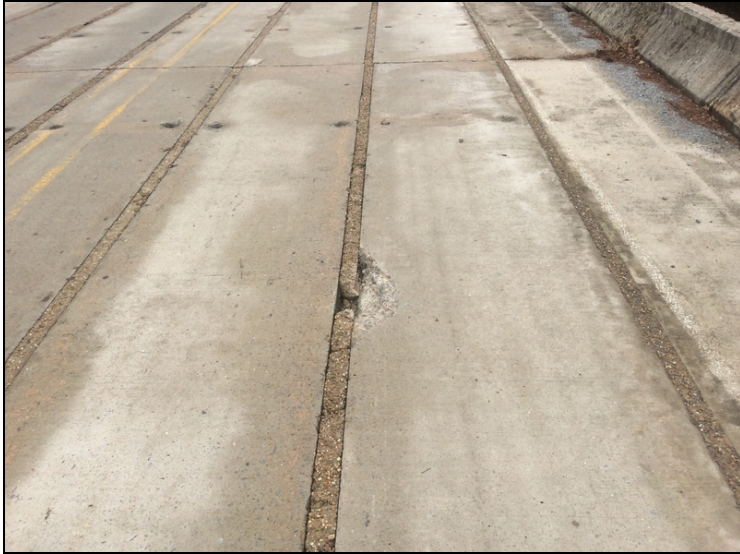
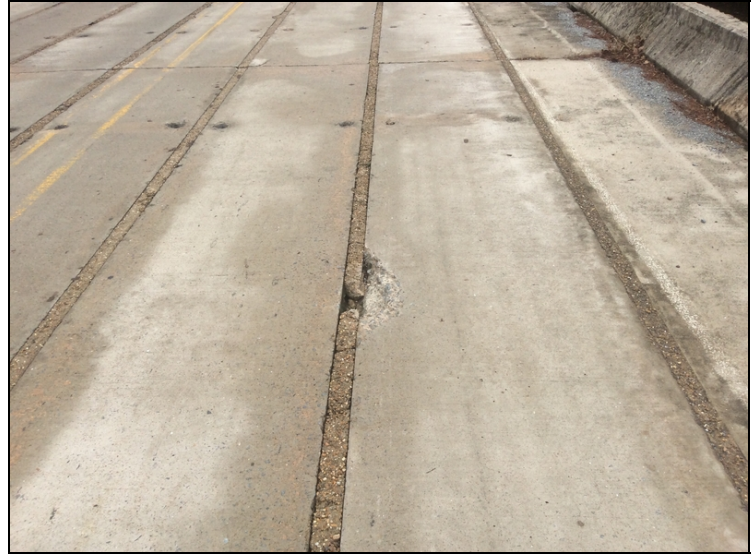
Span 1 unit 7 spall

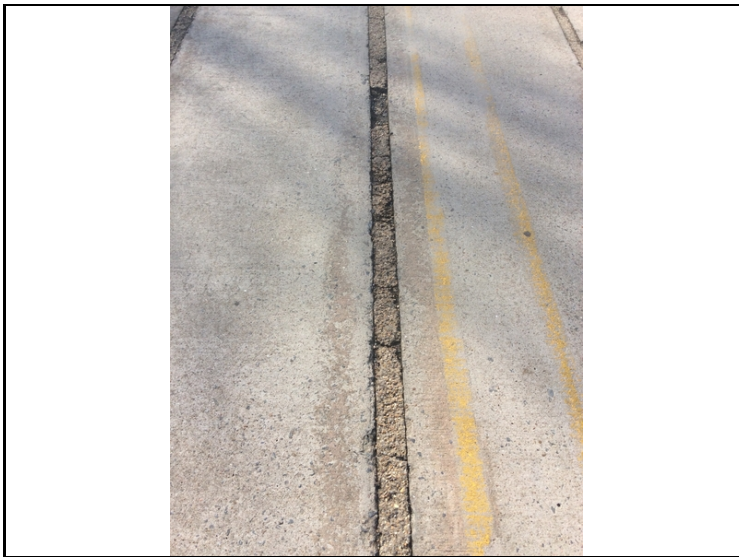
Deck - Spans 1-2: Grout between the units is beginning to deteriorate and break up.

Deck - Span 1 Units 3 & 4: Grout deteriorating

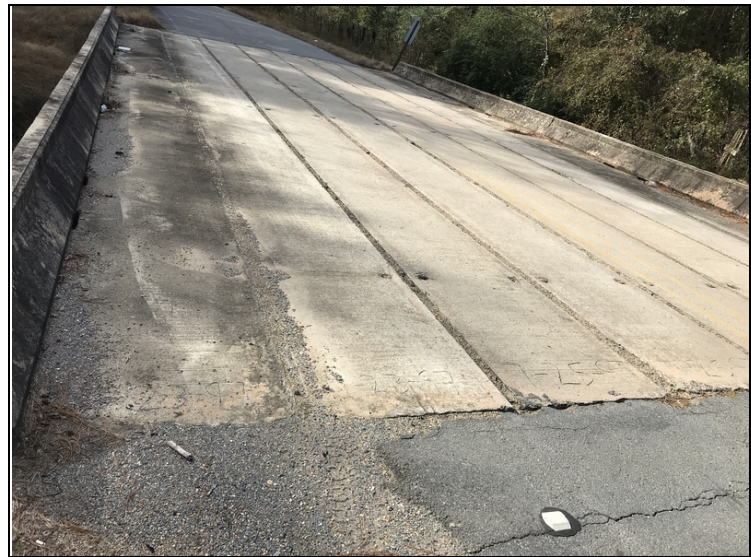
Deck - Spans 1-2 :Typical
