Asset #21987(Routine)

MiddleWarrenRd-CR over Creek

Location: 3.5 Mi S CR 25-PineBluff

Team Lead: Sharon Hooks, Inspection Date: 11/10/2021

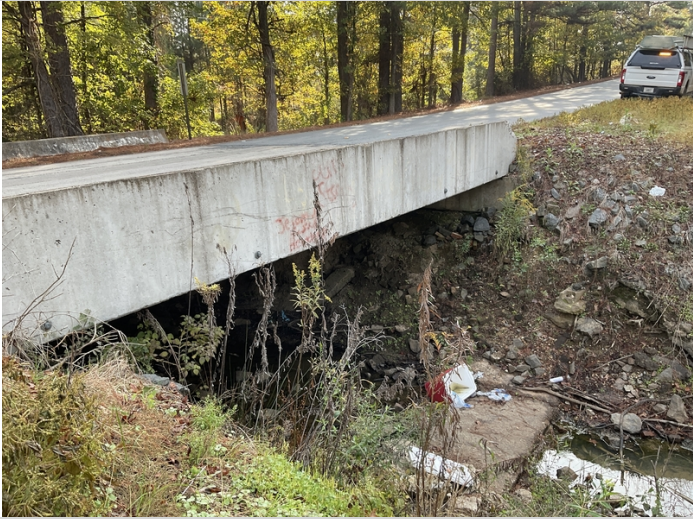
Elevation.

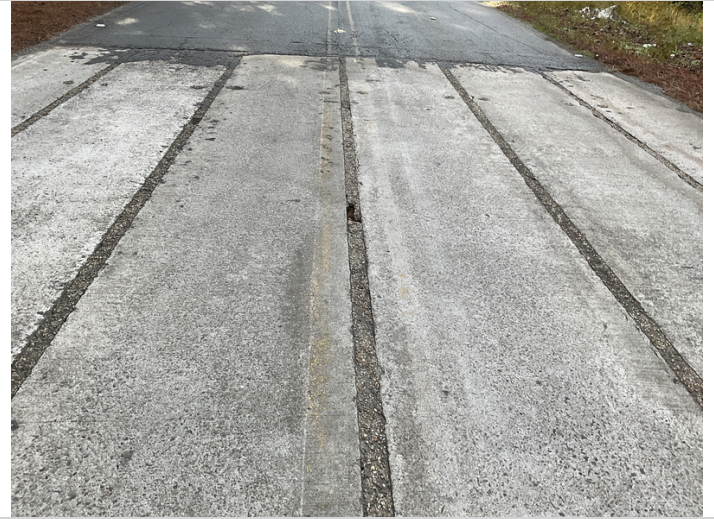
Span 1 girders 4 & 5 grout missing in keyways.

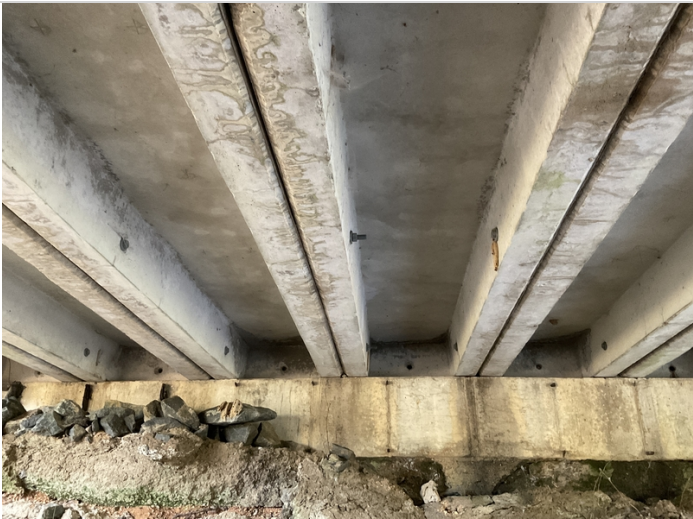
Under view.

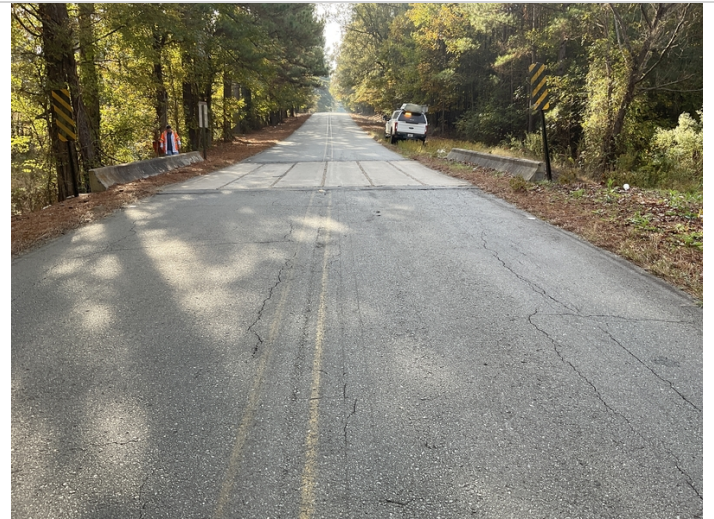
Approach.

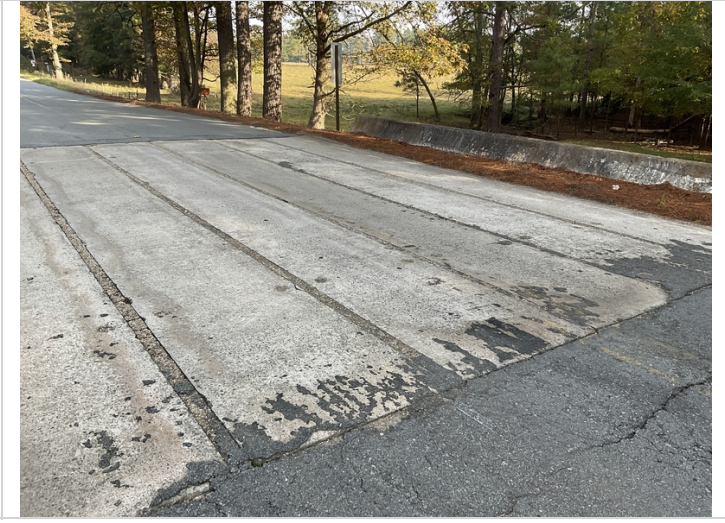
ELEMENTS	DESCRIPTION	UNITS	TOTAL	CS1	CS2	CS3	CS4
16	Reinforced Concrete Top Flange	SF	860	860	0	0	0
<p>(16) Deck: 28'-8" wide (separate curb unit NOT included) x 30' long = 860 sqft.</p> <p>Joints are completely grouted and grout is in very good condition.</p> <p>Gutterlines - both sides: Some build-up of debris - mostly pine-straw, blocking drains and restricting stormwater from flowing off bridge.</p>

Deck over view.

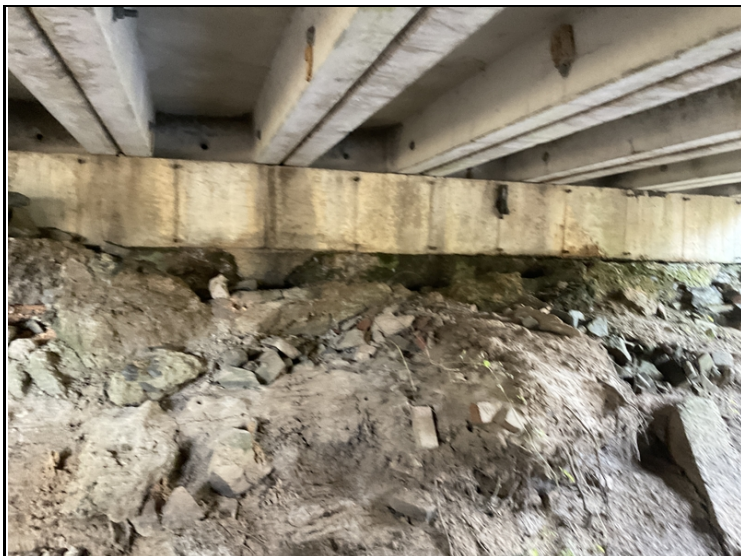
Endslopes – Bents 1 & 2: Some erosion, mainly concentrated near centerline – active scour at Bent 1 with undermining of abutment.

Slopes have become vertical and are encroaching on caps.

Bent 2 erosion.

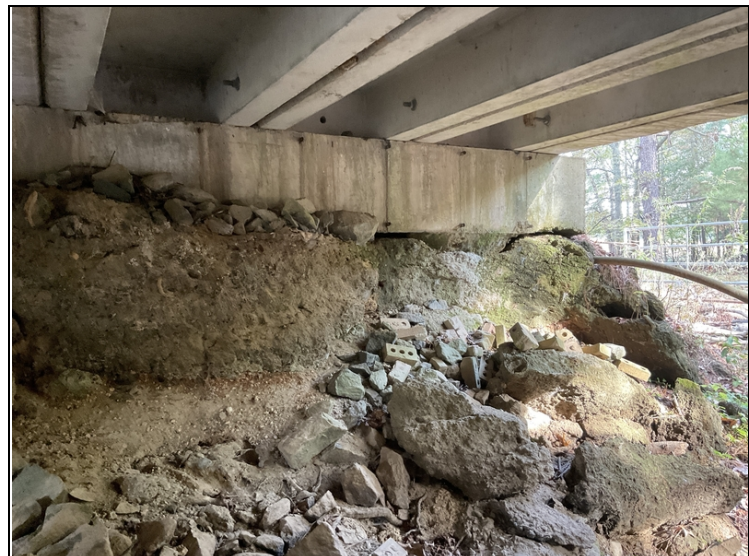
Bent 1 left erosion .

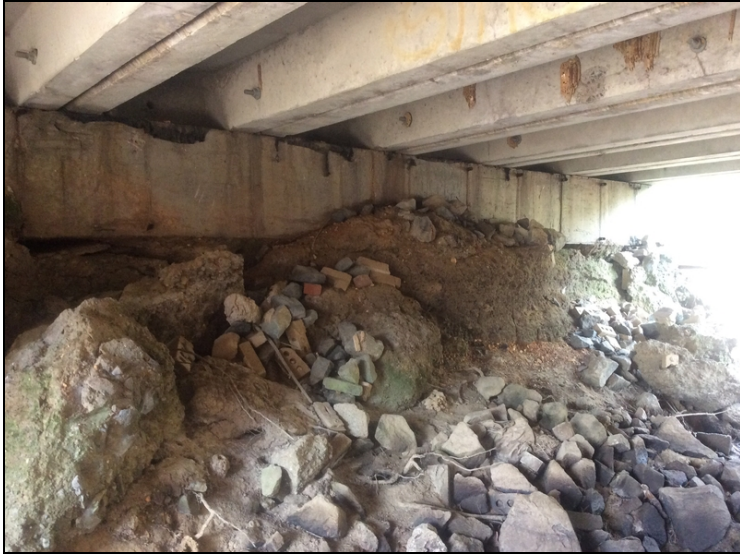
Endslope - Bent 1: Erosion/scouring

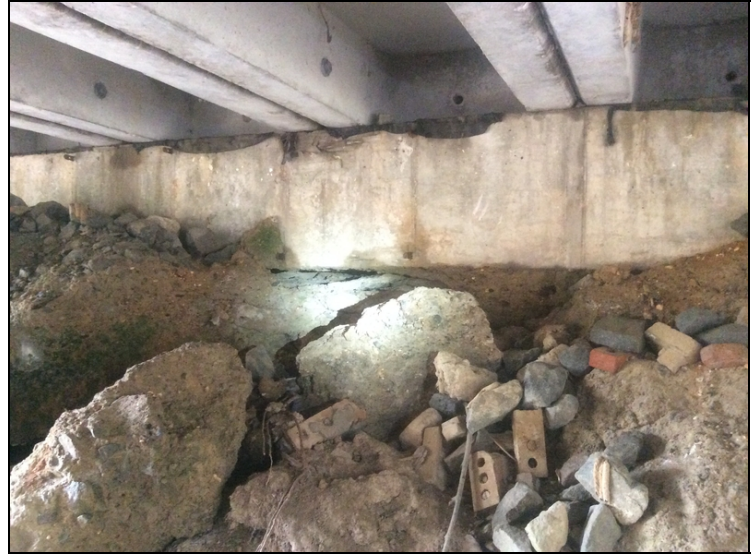
Hole eroded under Bent 1 abutment cap near centerline extends approximately 8' deep towards approach roadway - could possible be undermining pavement and fill material and prove a hazard to traffic.

Abutment 1 scour under cap at mid span

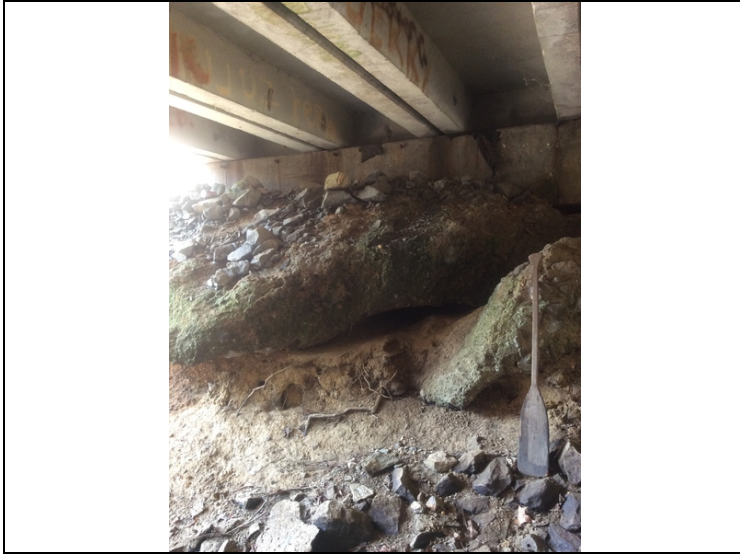
Endslope - Bent 1: Erosion (minimum 8' hole under abutment cap)

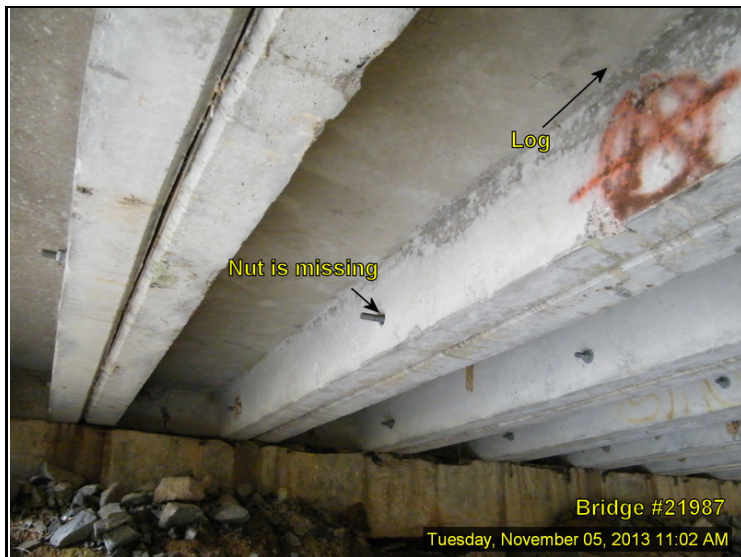
Girders – Span 1 Unit 7: Nut missing off bolt between Units 6 & 7 at 1/3 span.
