Asset #04145(Routine)

CR 3451 over Spadra Creek

Team Lead: Kevin Milligan, Inspection Date: 02/13/2023

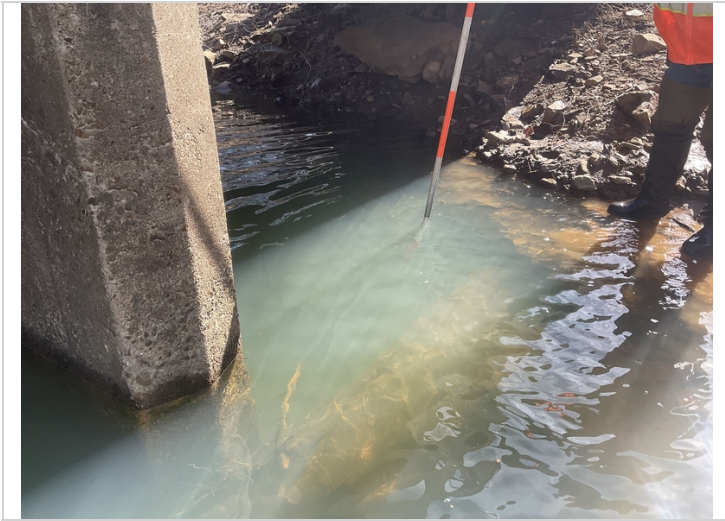
Spans 1 and 2 is approximately 4ft deep around bent 2 but there is no undermining.

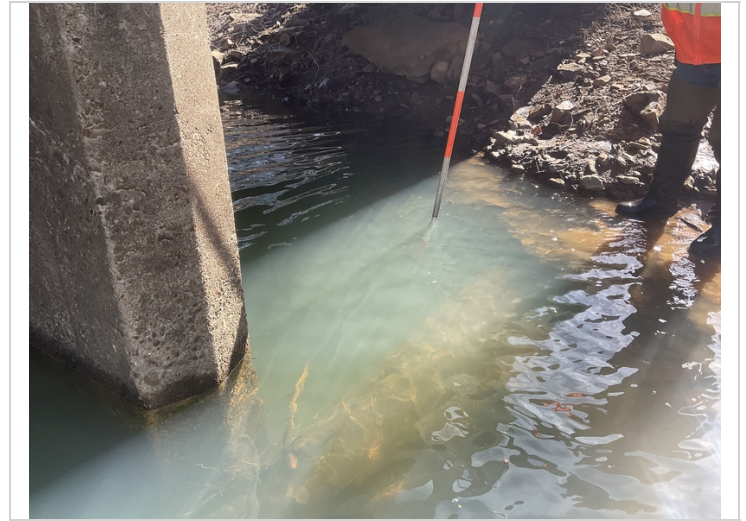
Spans 1 and 2 is approximately 4ft deep around bent 2 but there is no undermining.

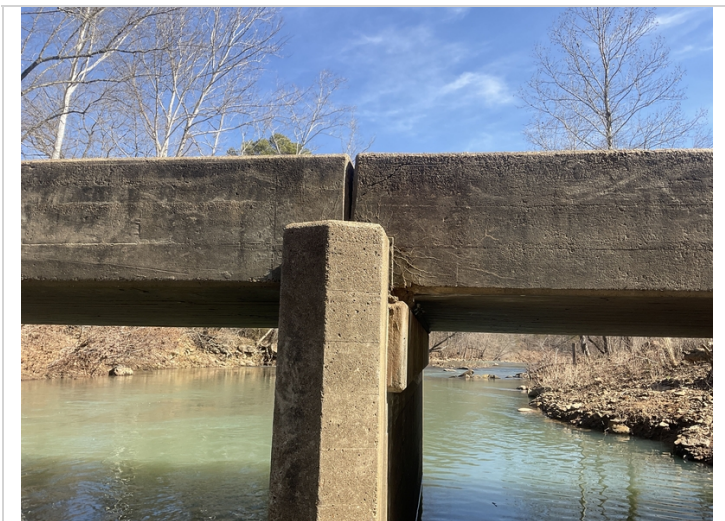
Bent 2 has vertical and diagonal cracks in the edge of slab on the left side, this is typical at all bents.

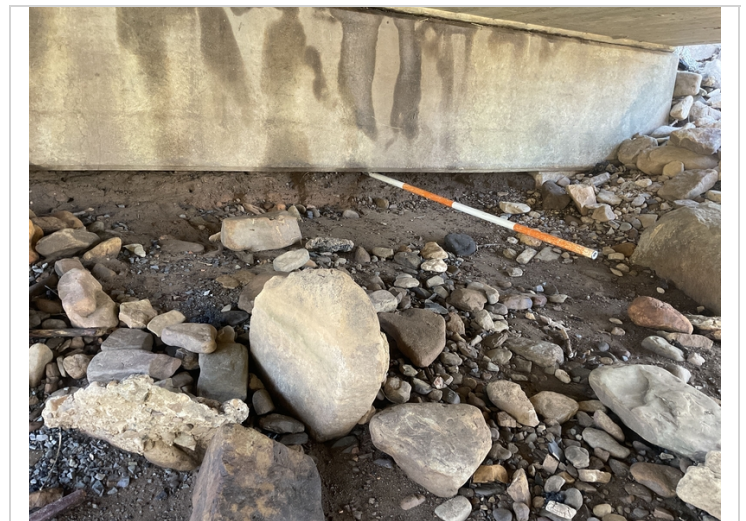
Abutment 1 has approximately 1ft of undermining under abutment cap, this is approximately 8ft in length, also there is 1 exposed concrete pile.

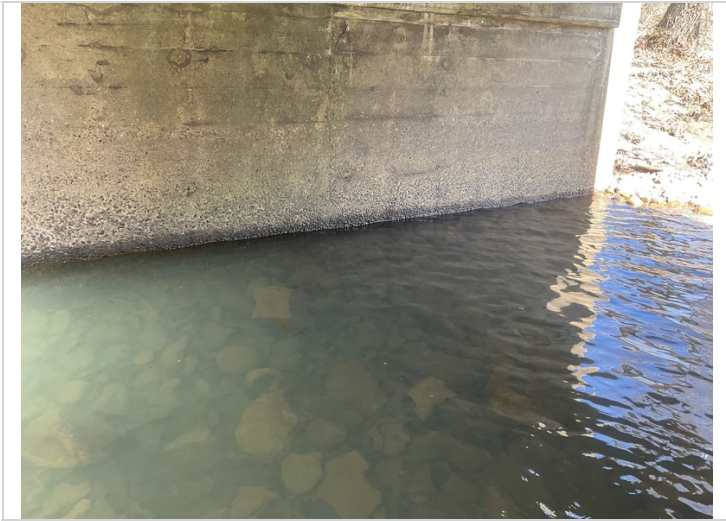
Pier walls have minor abrasion along the flow lines.

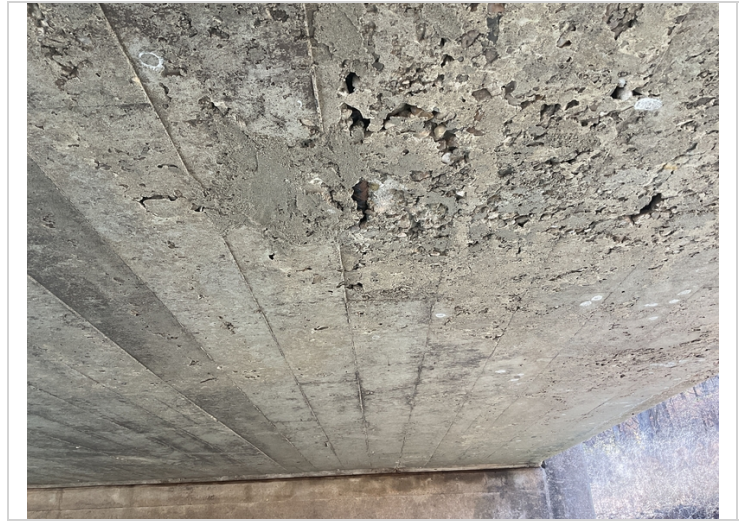
Span 3 soffit has 1 area of exposed reinforcing steel.

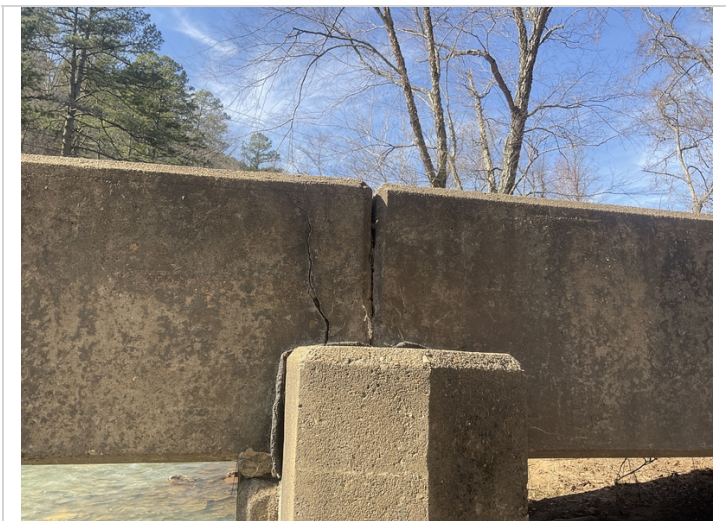
Bent 4 has vertical and diagonal cracks in the edge of slab on the right side, left side is typical.

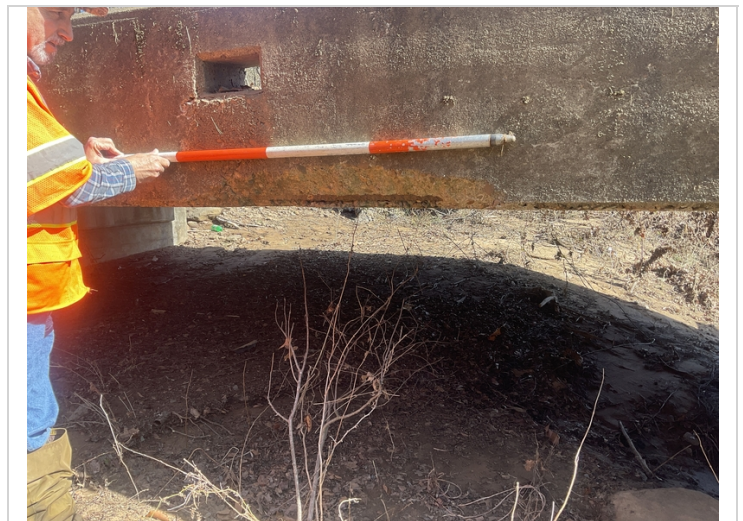
Span 4 has a large spall with exposed reinforcing steel, reinforcing steel has no section loss.

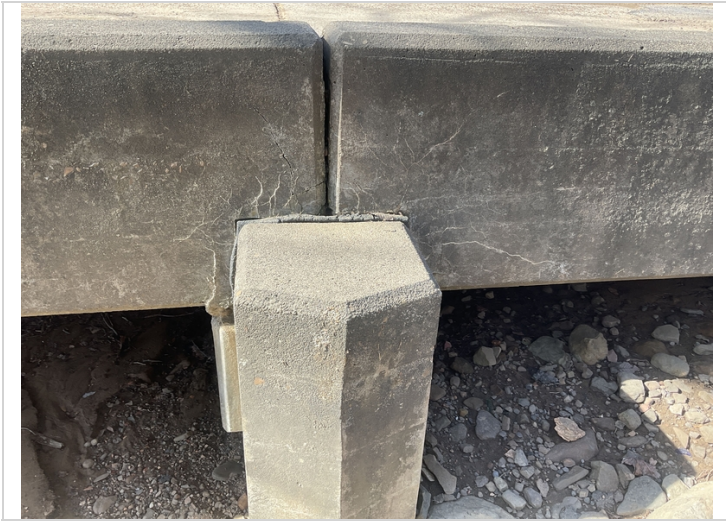
Bent 5 has diagonal cracks in the edge of slab on the right side, the left side is typical.

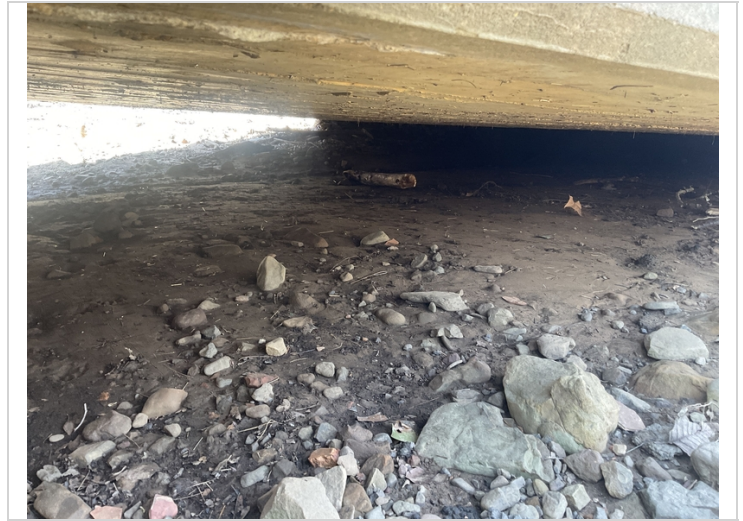
Unable to access span 5.

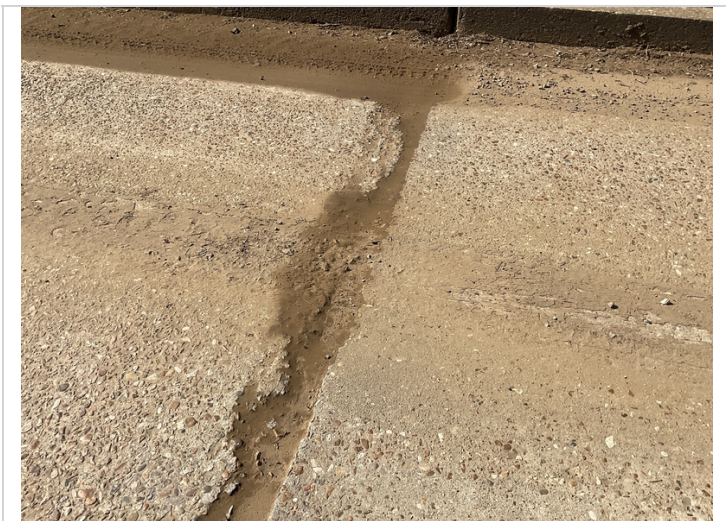
Joints are impacted with dirt.

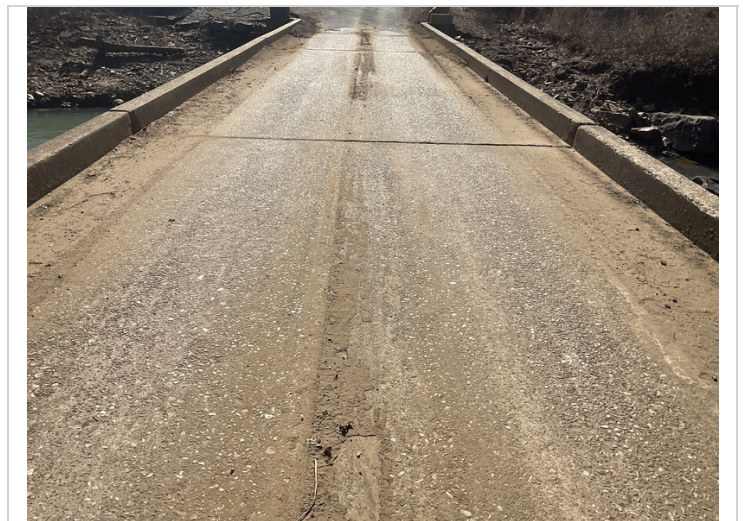
Minor abrasion throughout deck, there is exposed aggregate throughout the deck but it is still attached.

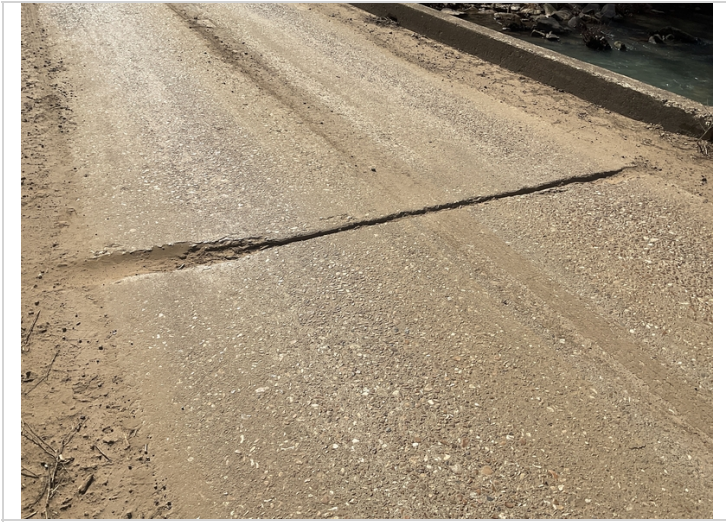
Bent 4 has 2 minor spalls along the edge of the joint.

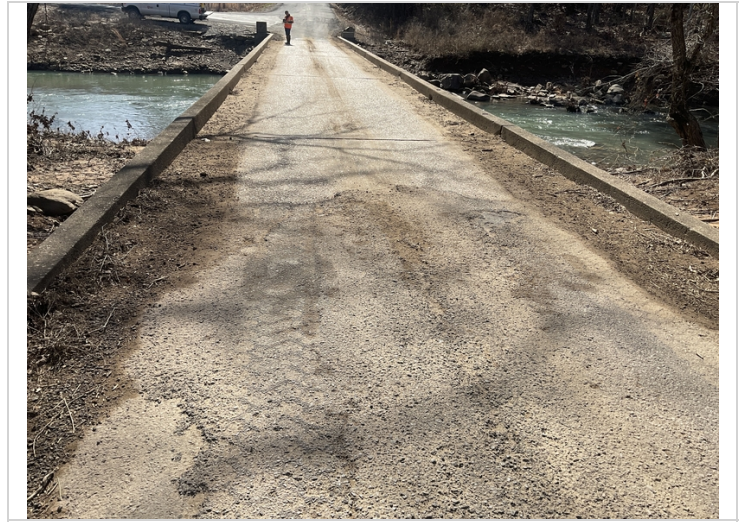
Spans 1 and 5 has asphalt that lays approximately 10ft onto the deck.
