Asset #14351(Routine)

CR16/Local 2243 over Slough Creek

Location: 0.64 Mi N. of SH 64

Team Lead: Kevin Milligan, Inspection Date: 02/15/2023

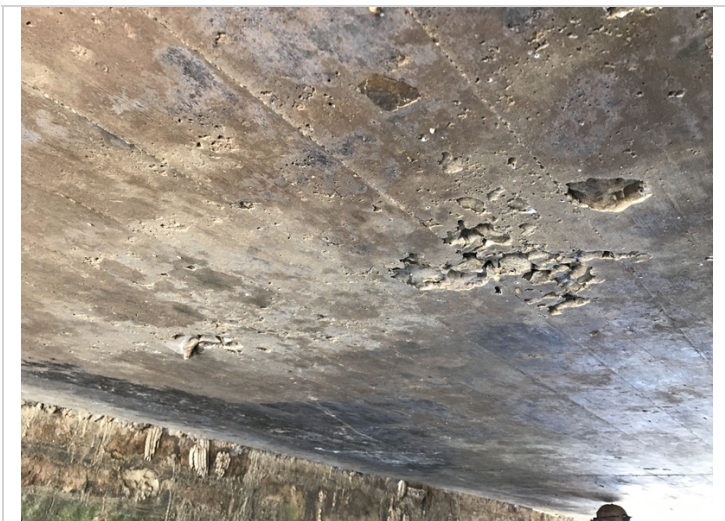
Span #2 has some minor honeycomb in the soffit area.

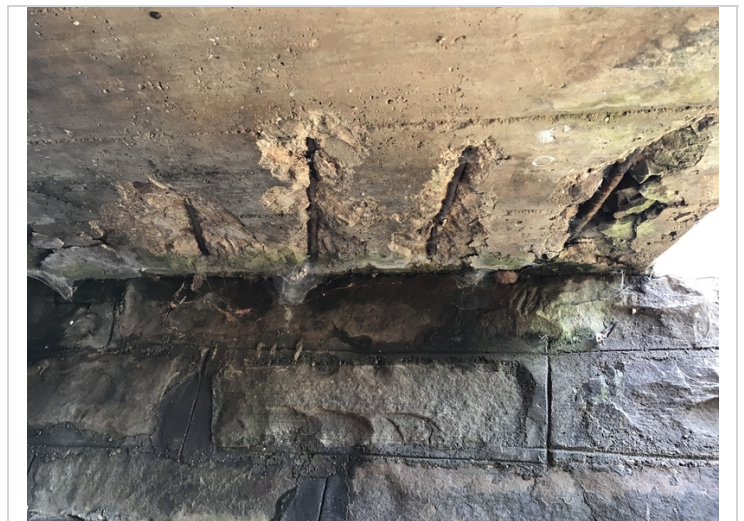
Span #2 right side at abutment #3 there are some moderate spalls with exposed rebar in the soffit area.

Span #2 right side at abutment #3 has some moderate spalls with exposed rebar in the soffit area.

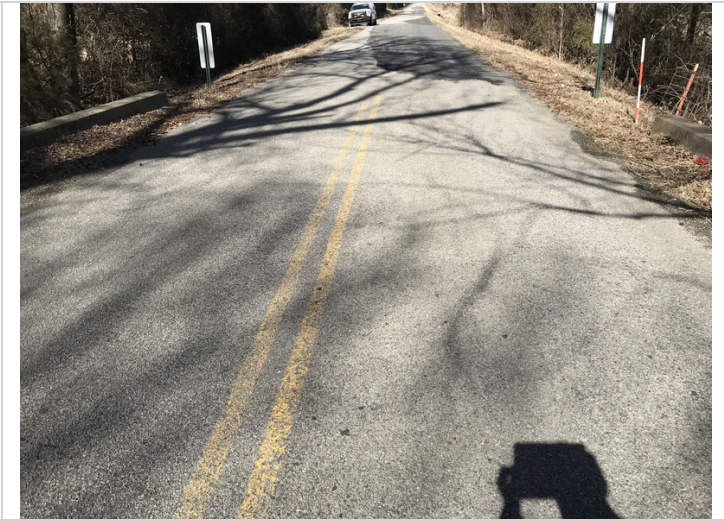
Wearing surface looks good

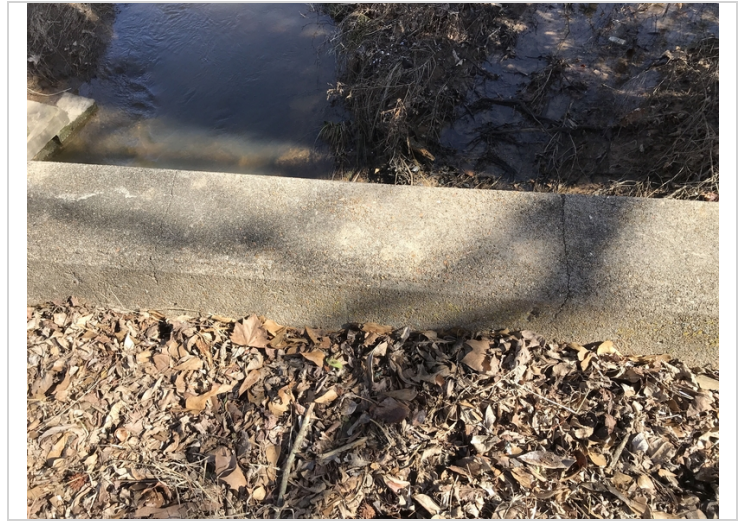
Both curbs have a few moderate cracks.

Both curbs have a few minor to moderate cracks in places.

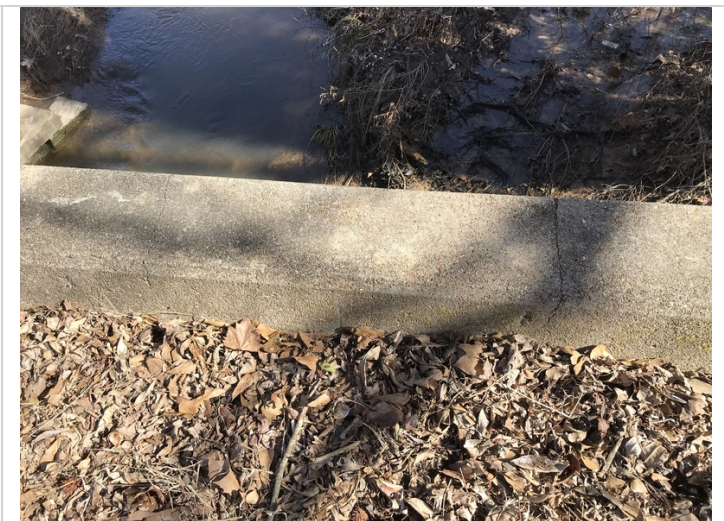
Dirt, leaves and debris are covering the deck drains.

A-55 - Deck Washing Needed (Y)

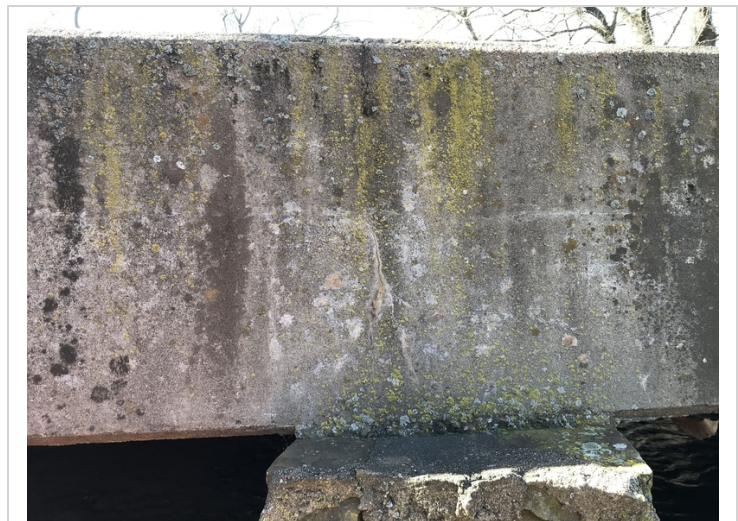
Vertical cracks in the side of the slab over pier #2 on both sides of the bridge.

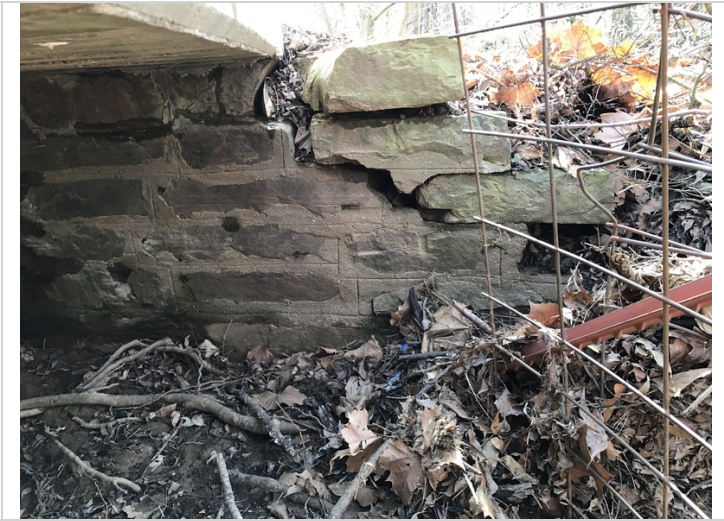
Abutment #1 left side wing has a few masonry stones broken loose.

Abu#1 left side wing has a few masonry stones broken loose.

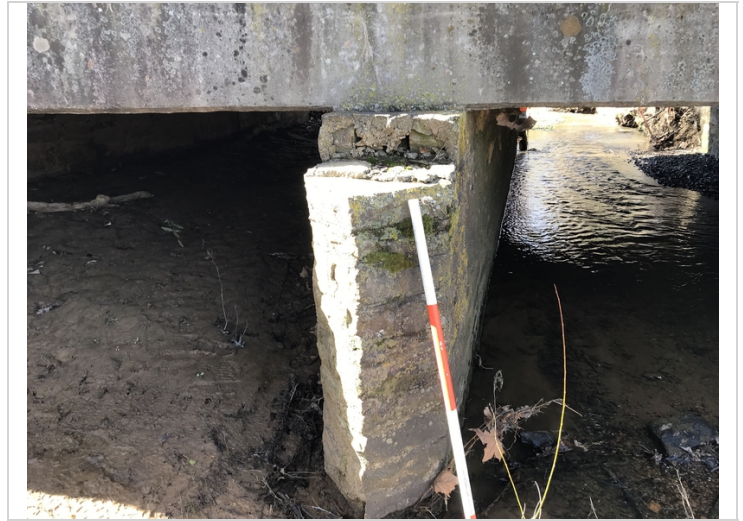
Pier #2 right end has a missing masonry stone from the top of the pier.

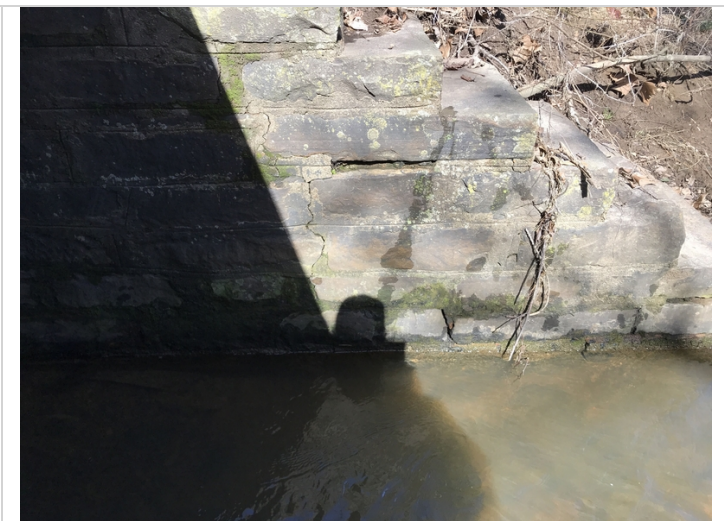
Abutment #3 has a few minor to moderate cracks in mortar joints in places throughout.

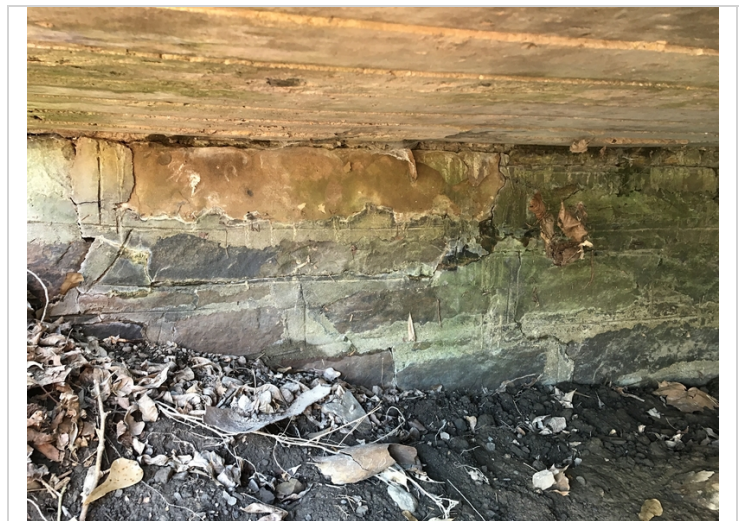
Abutment #1 has several minor to moderate cracks in the mortar joints in a few areas.
