**Asset #14369(Routine)**  
**CR 3451 over Curtis Creek**  
**Location: 4.1 M N Jct 103**

**Team Lead: Kevin Milligan, Inspection Date: 02/13/2023**

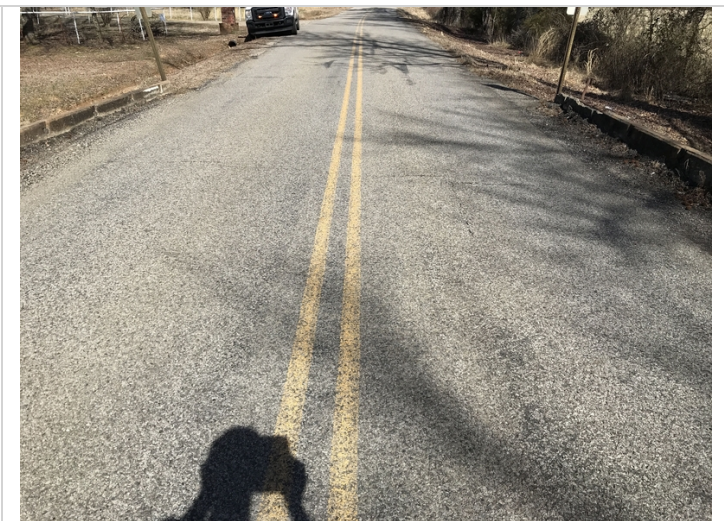
Wearing surface has a few minor cracks.

Wearing surface has a few minor cracks in places.

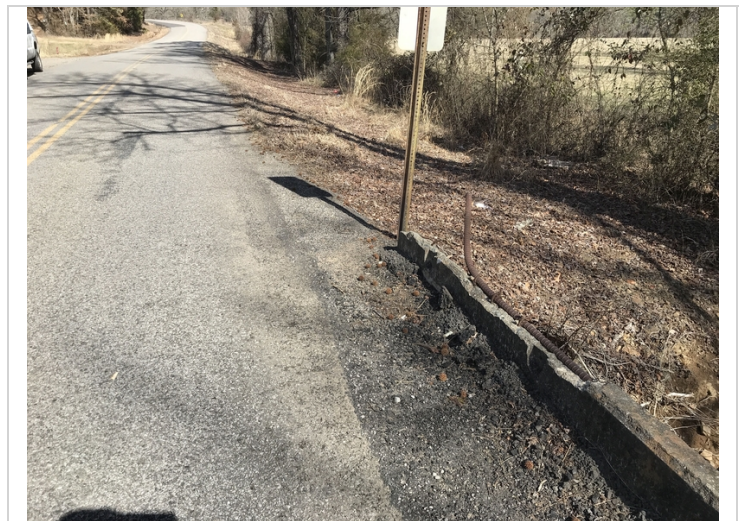
End of bridge on the right (east) side curb has approximately 8 ft. of moderate spalling with exposed rebar that is bent outward.

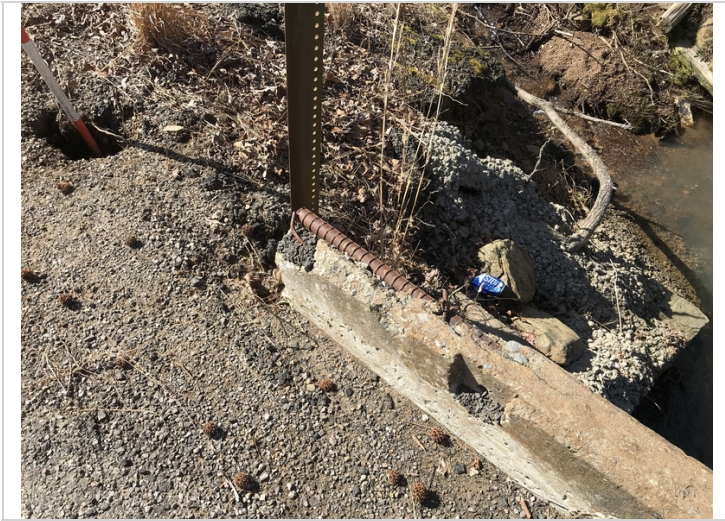
Beginning of the bridge left side curb has moderate spalling with exposed rebar.

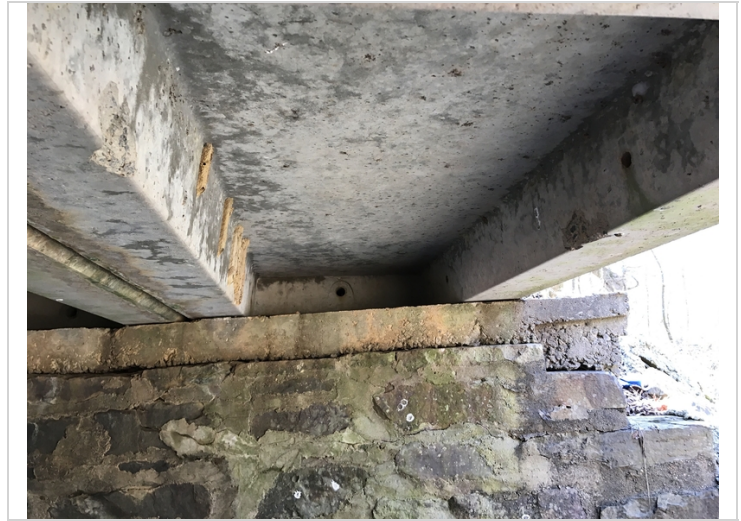
Span #1 channel unit #1 has a couple very minor spalls, this is typical in a few areas of channel units throughout both spans.

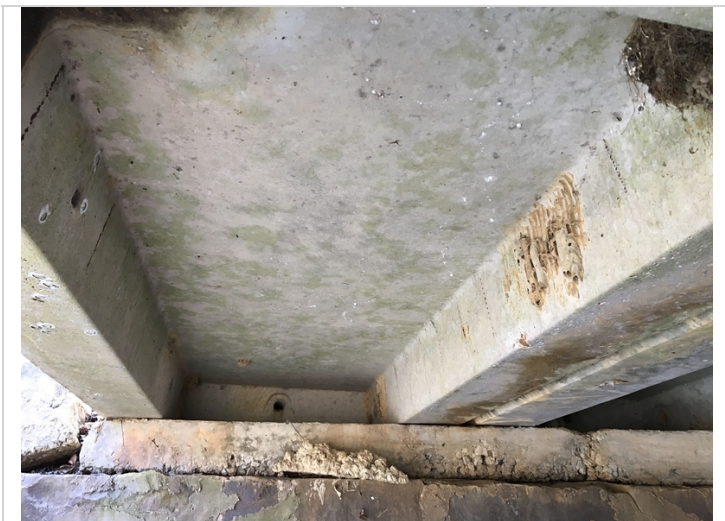
Span #1, channel unit #6 has some minor efflorescence in the soffit area.

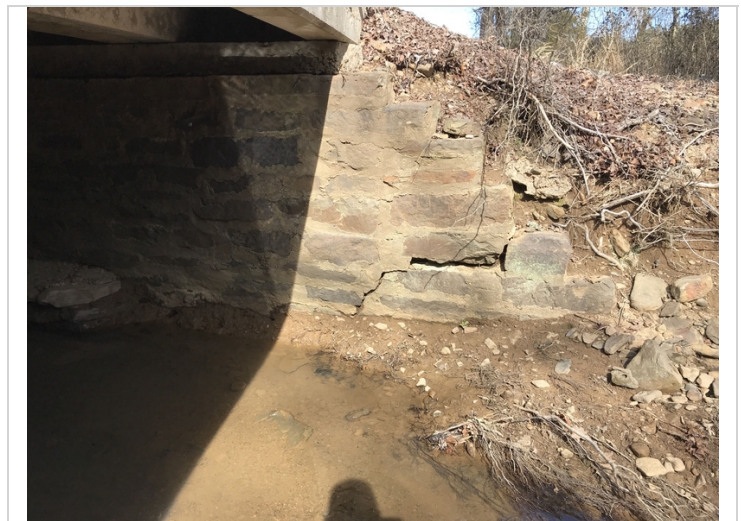
Abutment #3 right end has a wide crack in the mortar joints.

Abutment #3 right end has a large crack in the mortar joints.

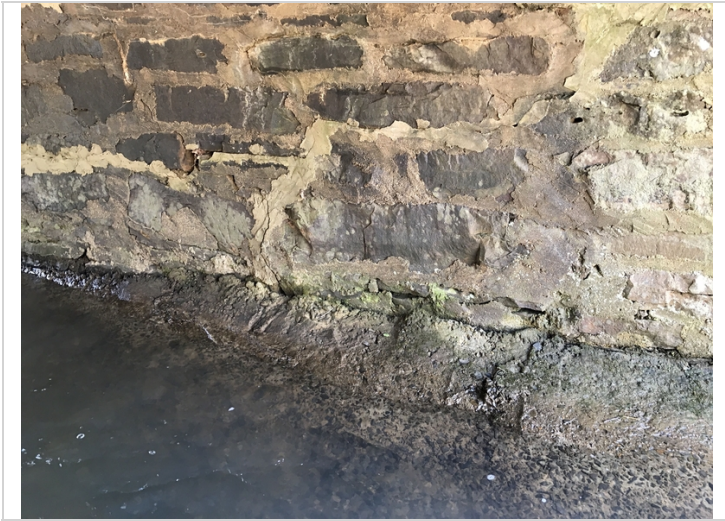
Abutment #1 has some minor to moderate cracks in the mortar joints.

Abutment #1 has some minor to moderate cracks in the mortar joints in a few places.

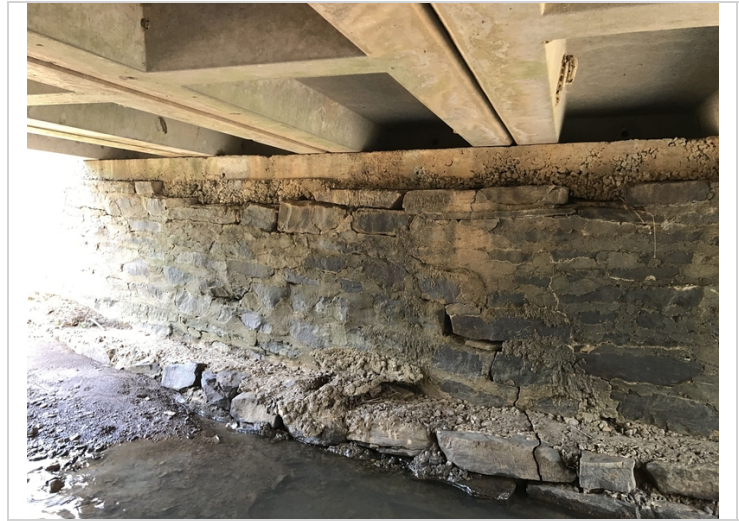
Abutment #3 has cracks in the mortar joints, also it has missing mortar in some joints and missing masonry stones in a few areas.

Abutment #3 has cracks in the mortar joints, has missing mortar in some joints and missing masonry stones in a few areas.

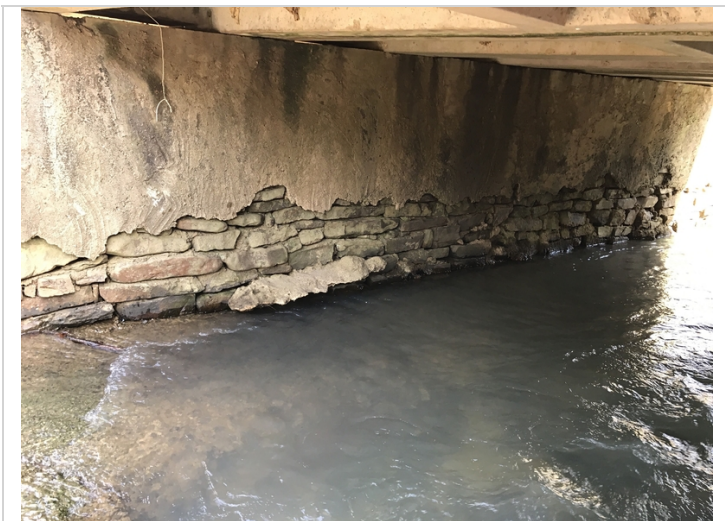
Pier #2 back side is missing grout in all the lower section of the pier wall, this is typical on the ahead side.

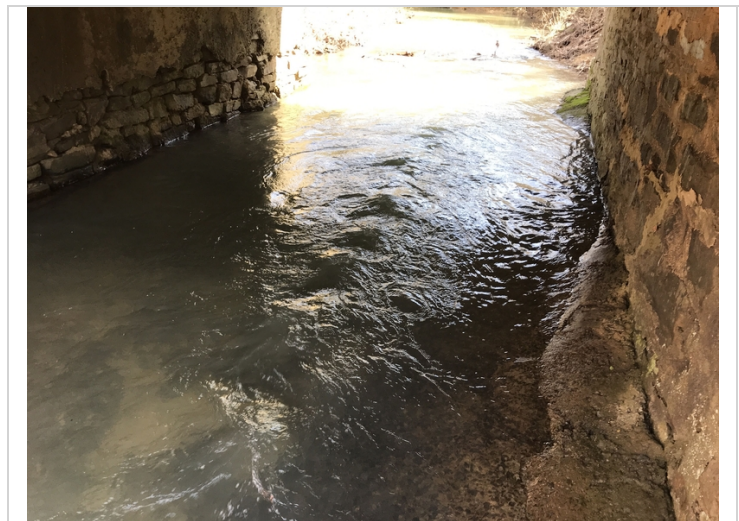
Insignificant scour in span #1, no undermining.

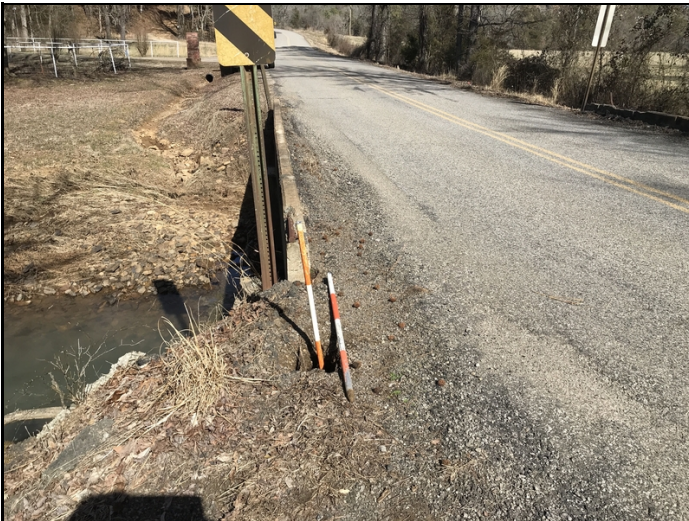
Beginning of the bridge (south end) has some moderate erosion that has created a hole approximately 2 ft. deep by 2 ft. across on the west side.

**Type of Work:** Approach Leveling/Maintenance

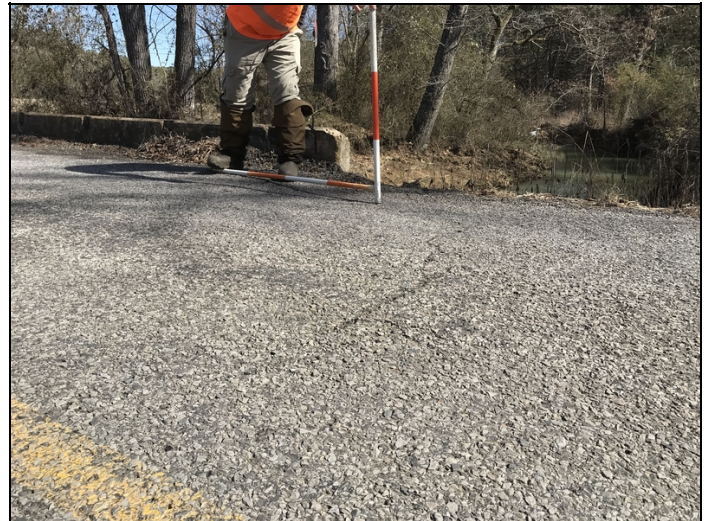
There is also approximately 2-3" of settlement on the south/east side.

There is approximately 2-3" of settlement on the south/east side at the beginning of the bridge.

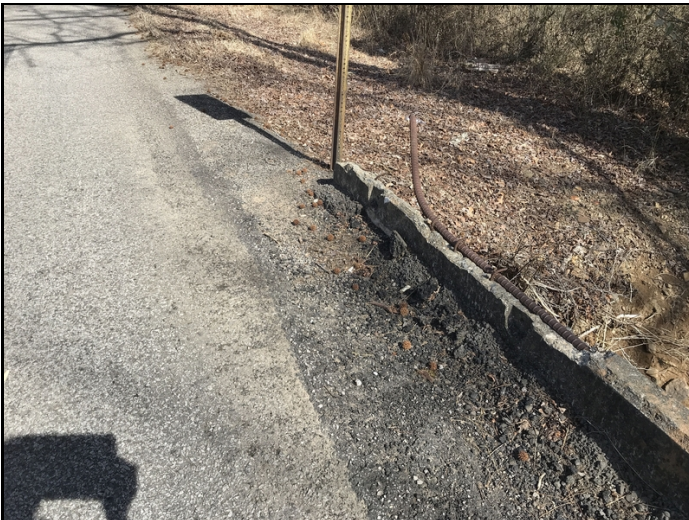
End of bridge on the right (east) side curb has approximately 8 ft. of moderate spalling with exposed rebar that is bent up and outwards.

End of bridge on the right (east) side curb has approximately 8 ft. of moderate spalling with exposed rebar that is bent outward.

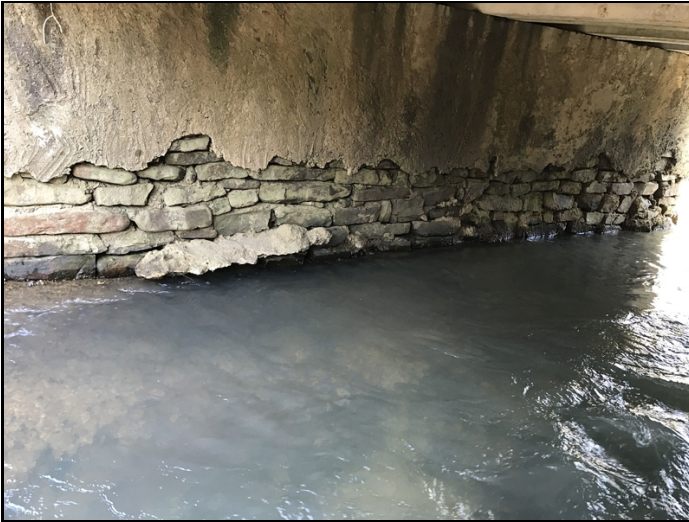
Pier #2 back side is missing grout in all the lower section of the pier wall, this is typical on the ahead side.

**Type of Work:** Substructure Repair
