Asset #14370(Routine)

CR 3451 over Rock Creek

Location: 4.72 M N CR77 & SH103

Team Lead: Kevin Milligan, Inspection Date: 02/13/2023

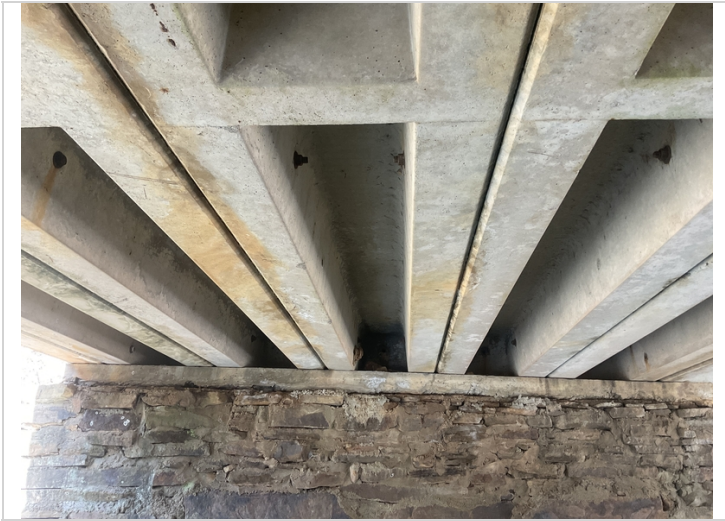
Typical condition of channel units.

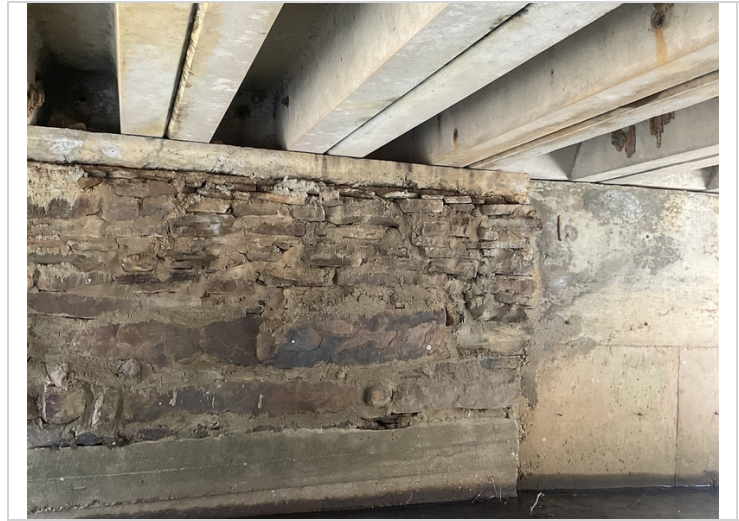
60 - Substructure (6 - SATISFACTORY CONDITION - structural elements show some minor deterioration.)

Abutment 3 has moderate mortar loss along the top portion of the masonry wall.

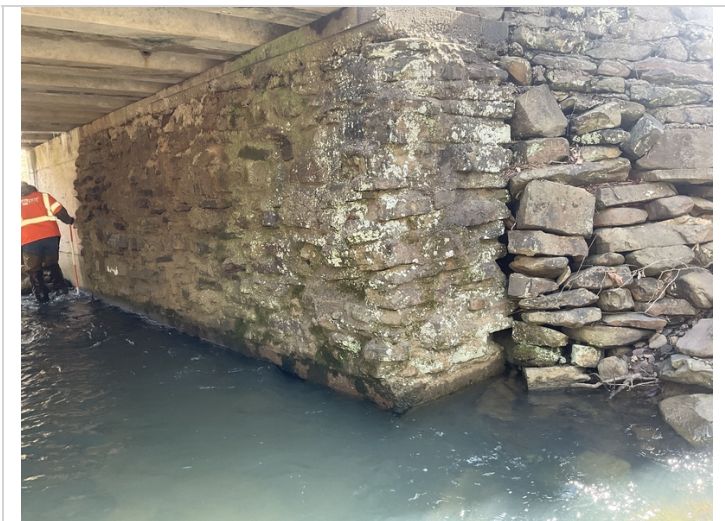
Comment: Top of footing is exposed on the left side of abutment 1 but there is no undermining and the masonry wall has minor joint deterioration.

Abutment 1 has minor joint deterioration.

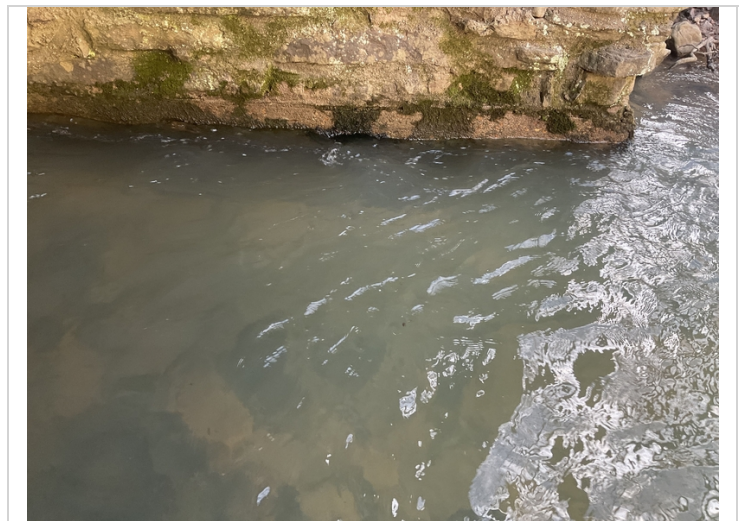
A-B.C.11 - B.C.11 Scour Condition Rating (New NBIS) (8 - Insignificant scour.)

Top of footing is exposed on the left side of abutment 1 but there is no undermining.

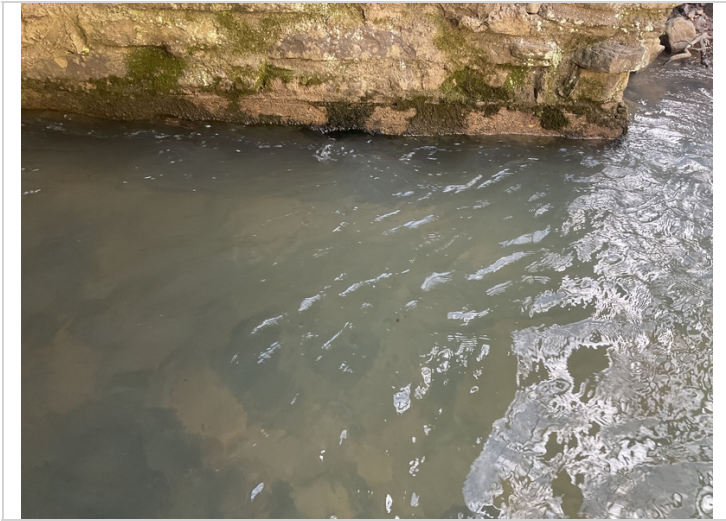
Top of footing is exposed on the left side of abutment 1 but there is no undermining.

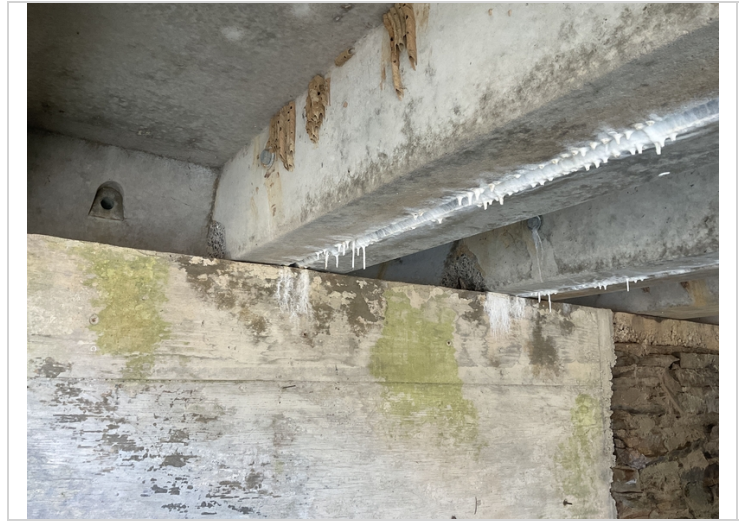
59 - Superstructure (7 - GOOD CONDITION - some minor problems.)

Comment: Channel units 7 and 8 have spalls on the end of right stems at abutment 1.

Channel units 7 and 8 have spalls on the end of right stems.

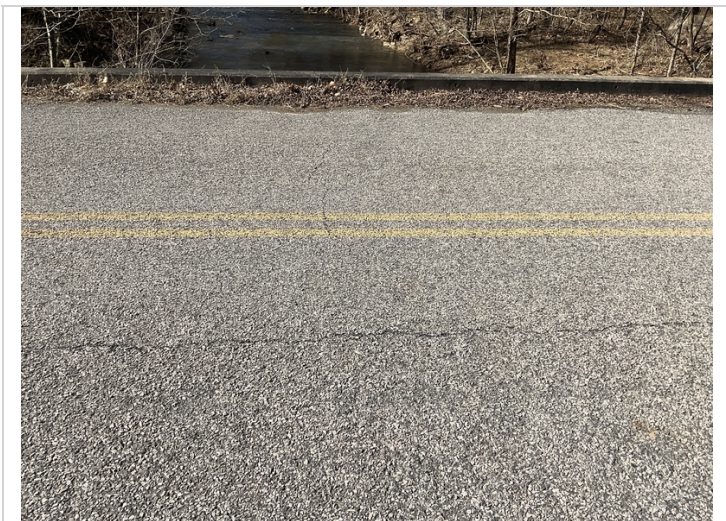
58 - Deck (7 - GOOD CONDITION - some minor problems.)

Comment: Deck has a few transverse cracks in the wearing surface and 1 longitude crack right of the center line.
Soffit is good.

Deck has a few transverse cracks in the wearing surface and 1 longitude crack right of the center line.
