Asset #14366(Routine)

CR 3390 - D over Spadra Creek

Location: 1.8MI E 103

Team Lead: Rhett Franks, Inspection Date: 01/25/2024

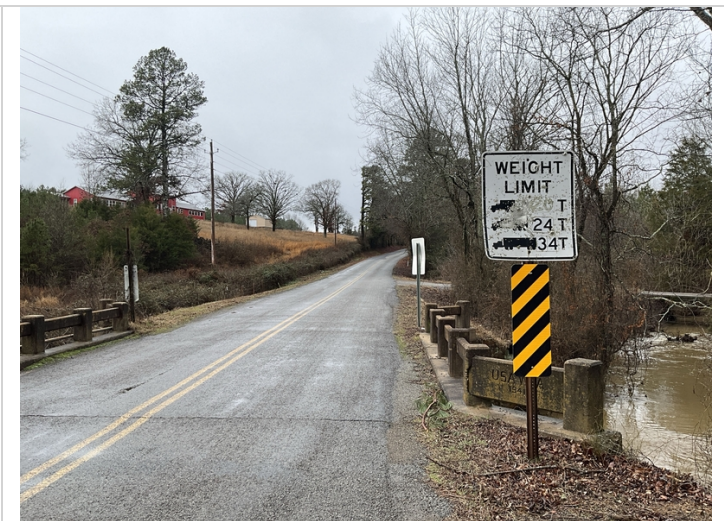
Sign in place at end of bridge. Not required.

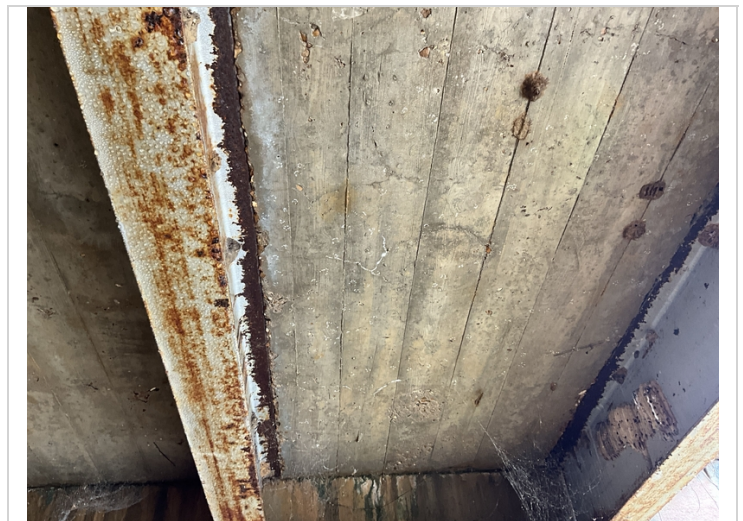
Bay 5 in between girders 4 and 5 has minor cracking with efflorescence.

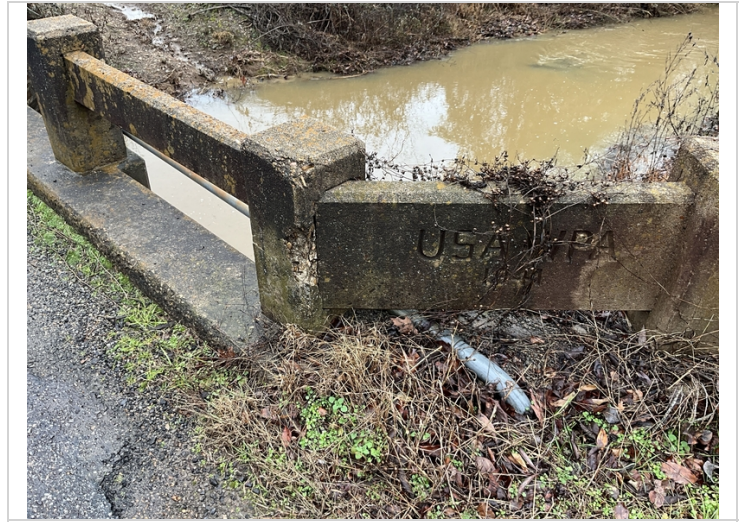
Bridge rail has minor spalling from collisions on the left and right side.

Spalling in bridge railing left and right sides.

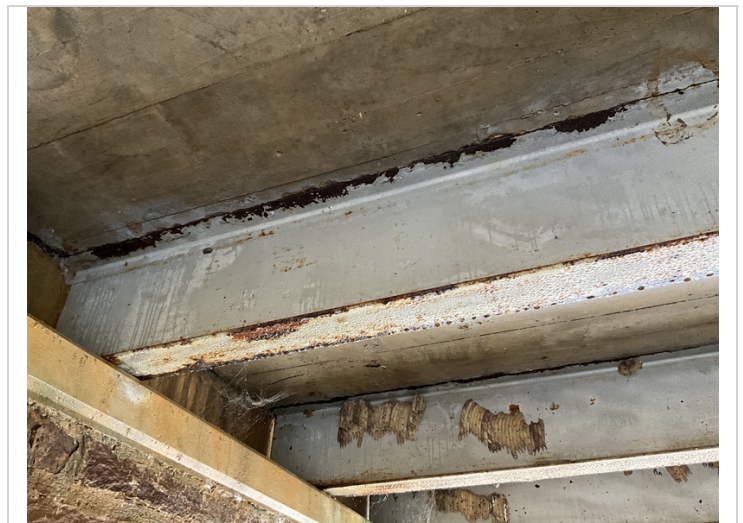
Minor rust on the beam ends and rust with a failing paint system throughout the girders.
Paint system is failing on all girders and needs to be repainted.

Minor rust on beam ends.

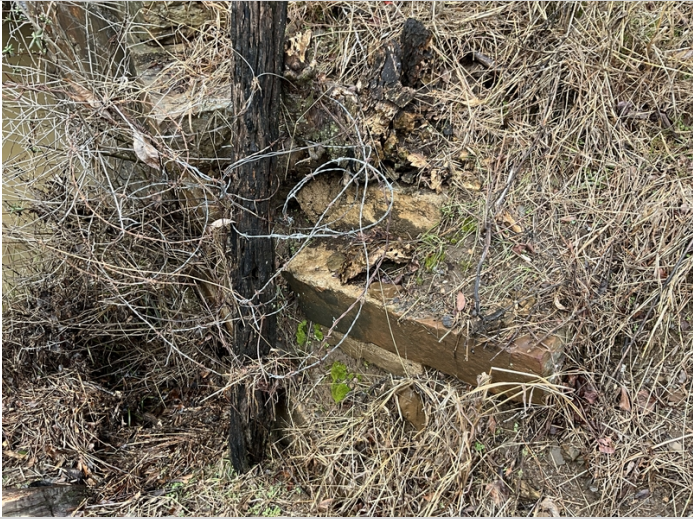
Bent 2 Light efflorescence in the wing wall with minor stone displacement.

Stone displacement at abutment 2 right side.

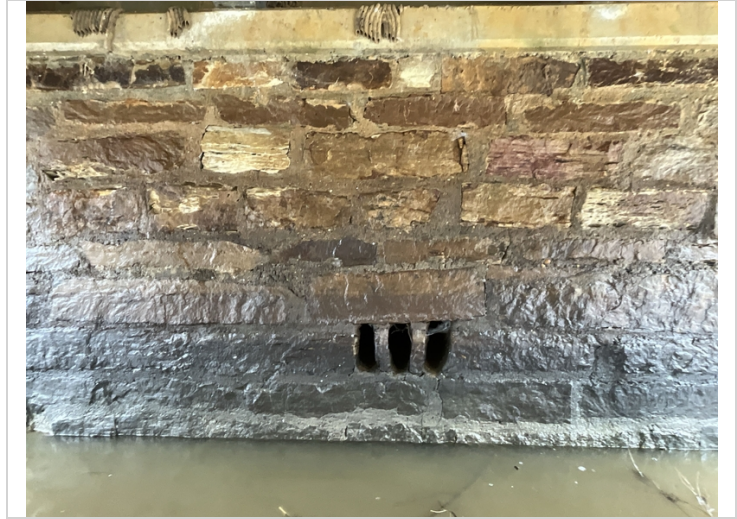
Bent 2 has minor cracking with mortar breakdown at the drain outlet.

Cracking and mortar break down in abutment 2.

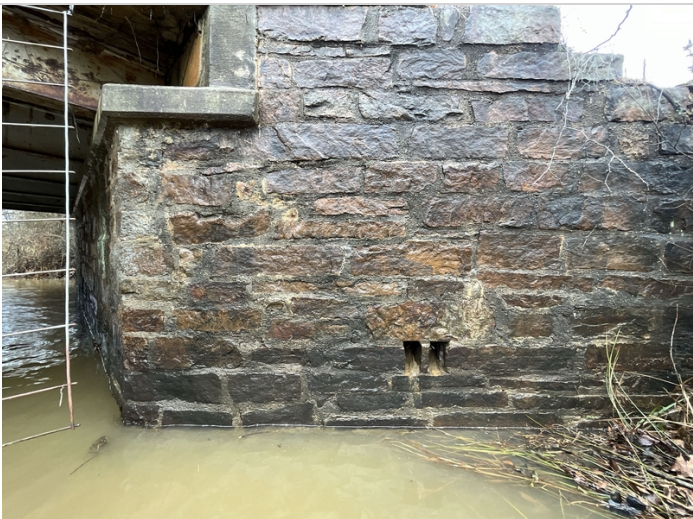
Minor cracking with efflorescence in the wing wall.

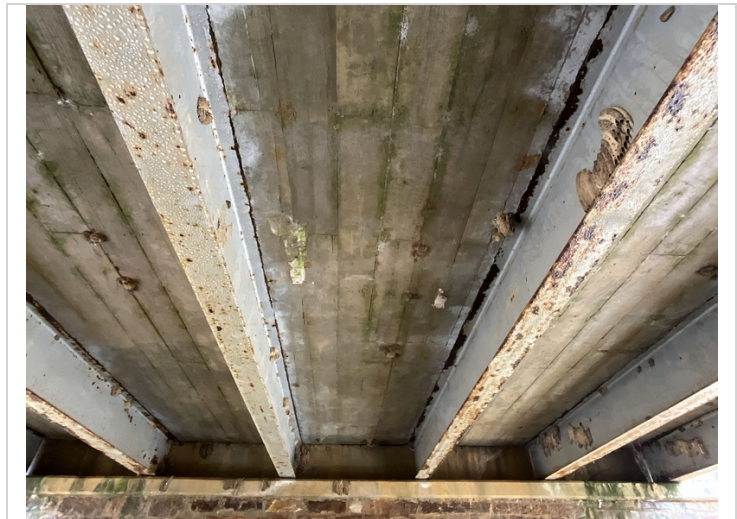
Beams need to be painted.

A-60 - Full Beam Painting Needed (Yes)

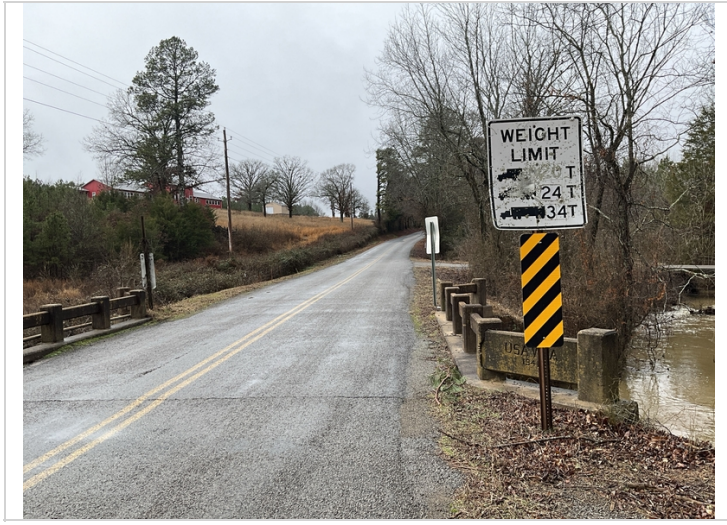
Load posting sign is damaged

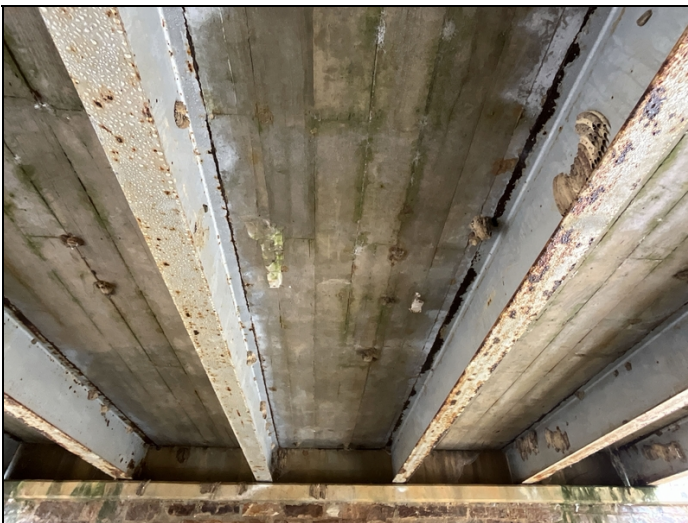
Beams need to be painted.
