Asset #14367(Routine)

CR 3390 over Spadra Creek

Location: 3.56 M E CORD 76 & SH 103

Team Lead: Kevin Milligan, Inspection Date: 02/13/2023

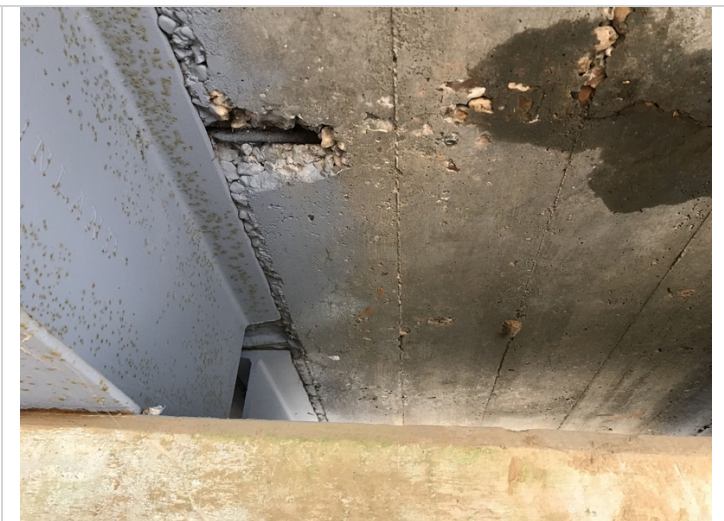
Soffit in bay #5 over pier #4 has minor spall with exposed rebar with no section loss.

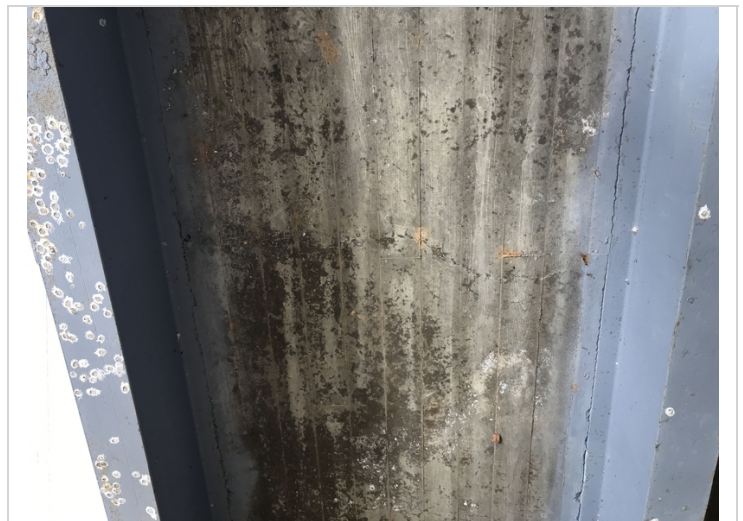
Span #1 has a few minor cracks in the soffit area of bay #4. Typical in a few areas of both spans.

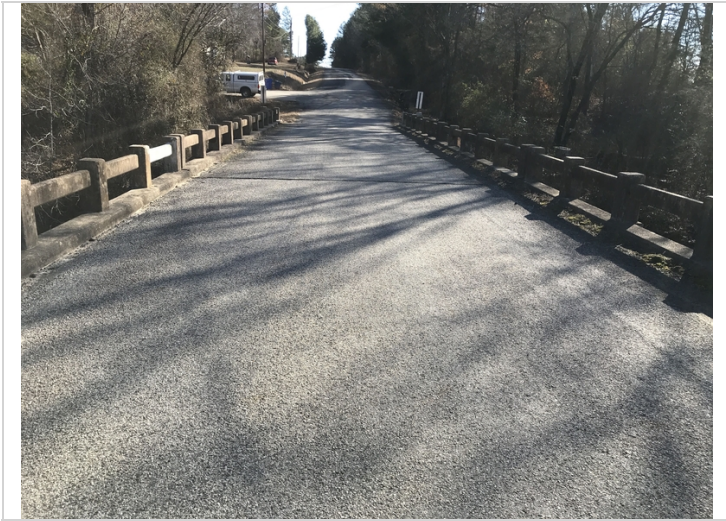
Asphalt wearing surface looks good.

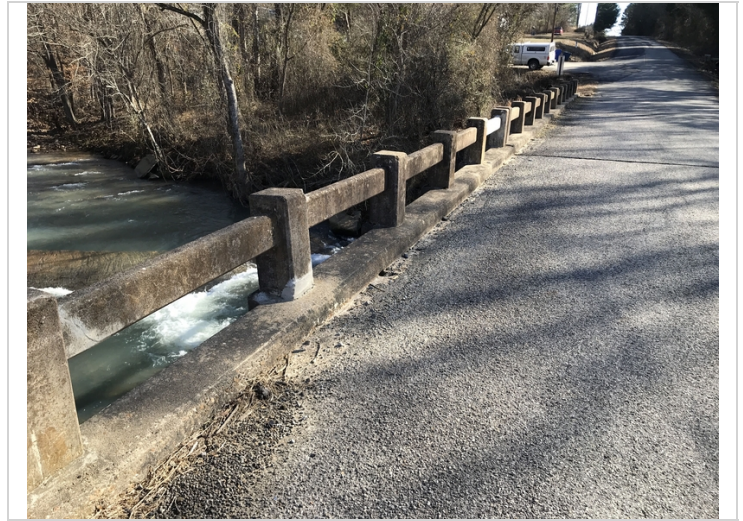
Concrete rail has been repaired and looks good.

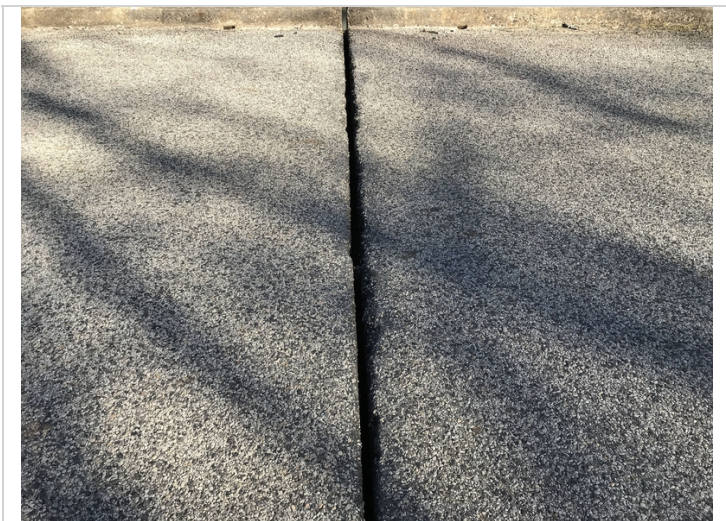
Deck has open joints .

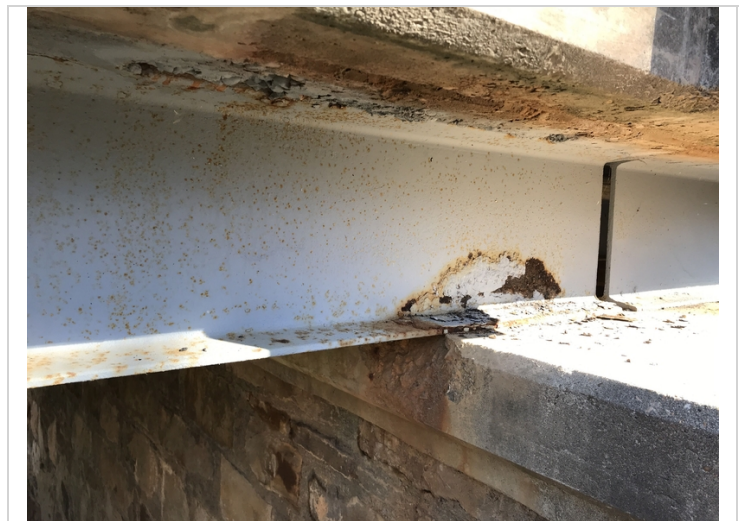
Girder #7 over pier #4 has minor corrosion with minor section loss at the end of the beam. Girder #1 is typical over pier #4.

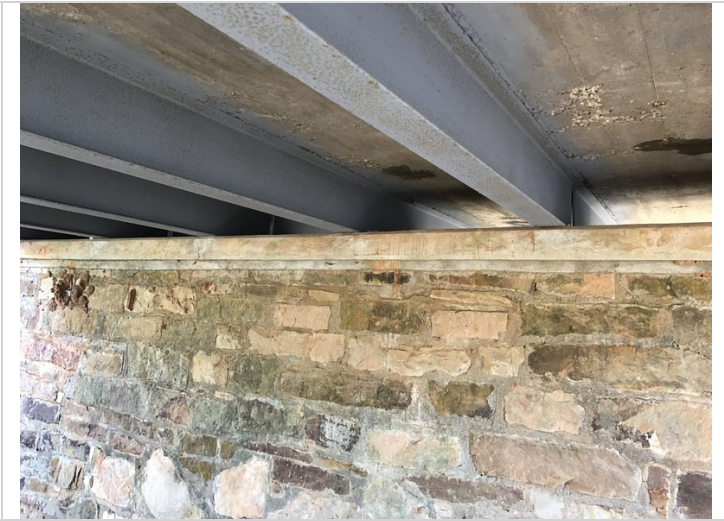
Typical girders over pier #4.

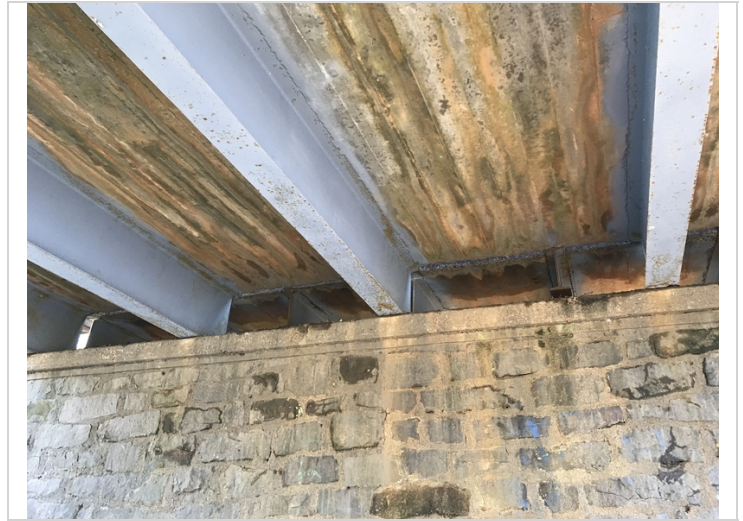
Typical girders at pier #3.

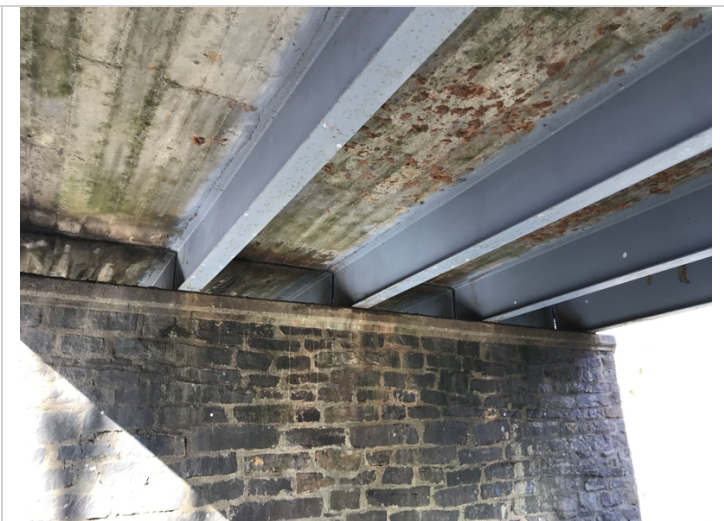
Girders over pier #2

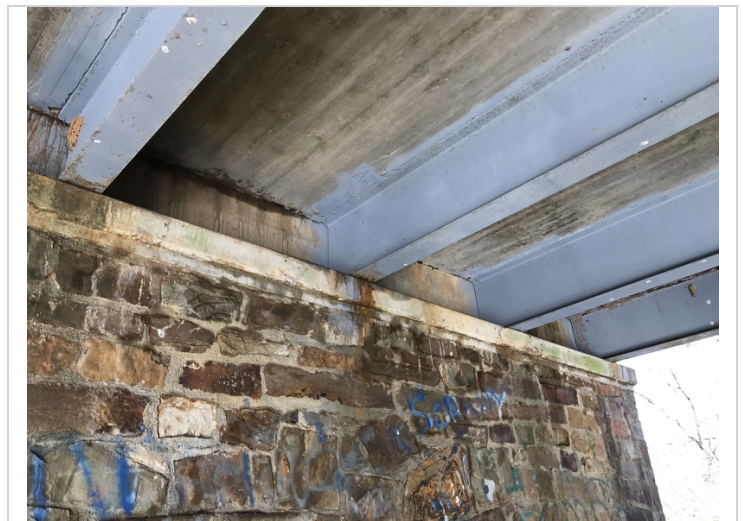
Girders over abutment #1, girders have been painted throughout all spans.

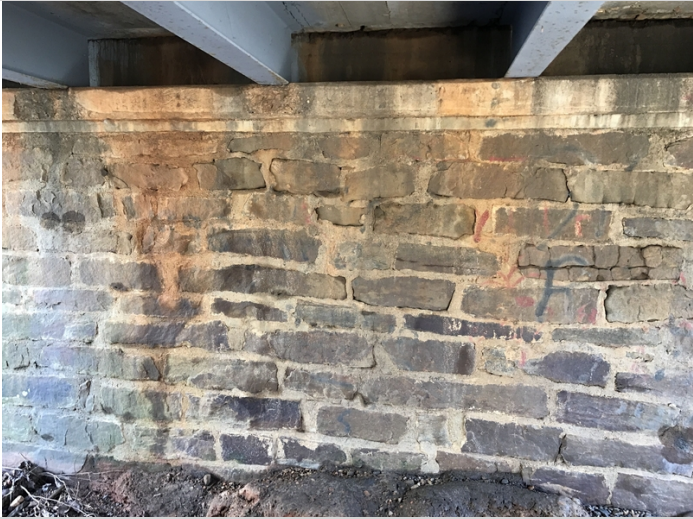
Abutment #5 has minor cracking in a few of the stones and in mortar joints, also there are a few minor spalls in the concrete cap.

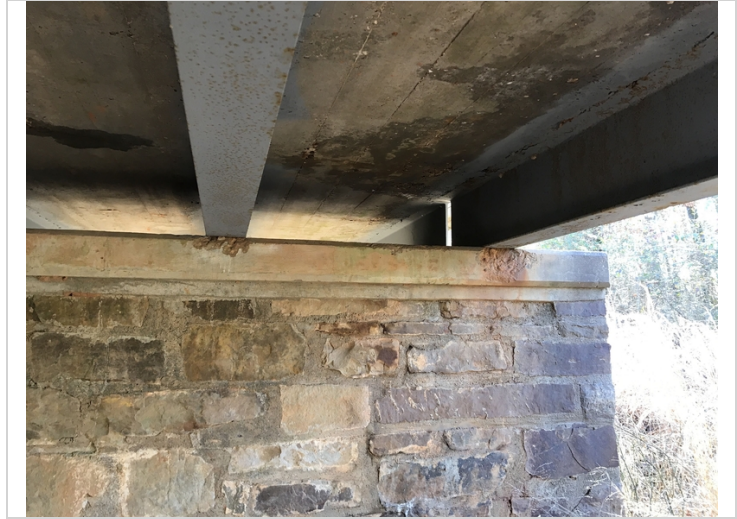
Pier #4 back side has a couple minor spalls under girders 6 and 7.

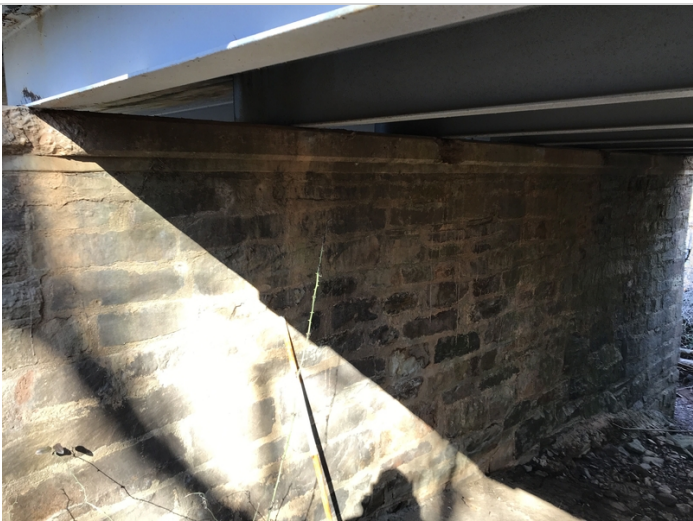
Ahead side pier #3 has a few minor spalls in the concrete cap under girders 1, 3, 5 and 7.

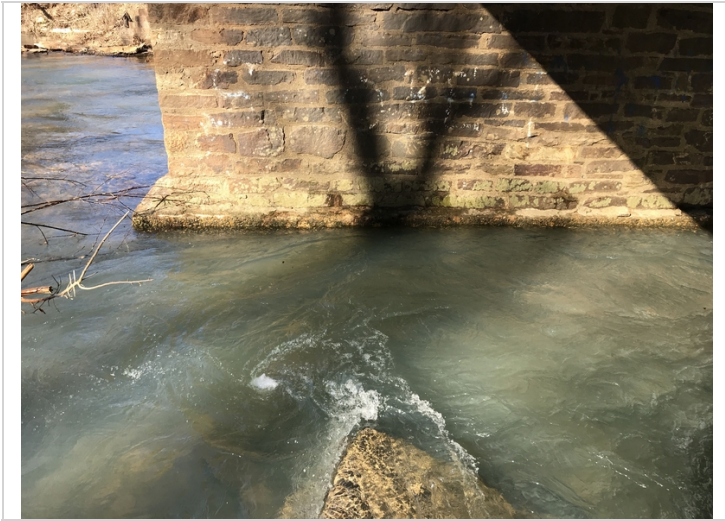
Ahead side of pier #2 has some minor insignificant scour (approximately 18"-24") with no undermining.

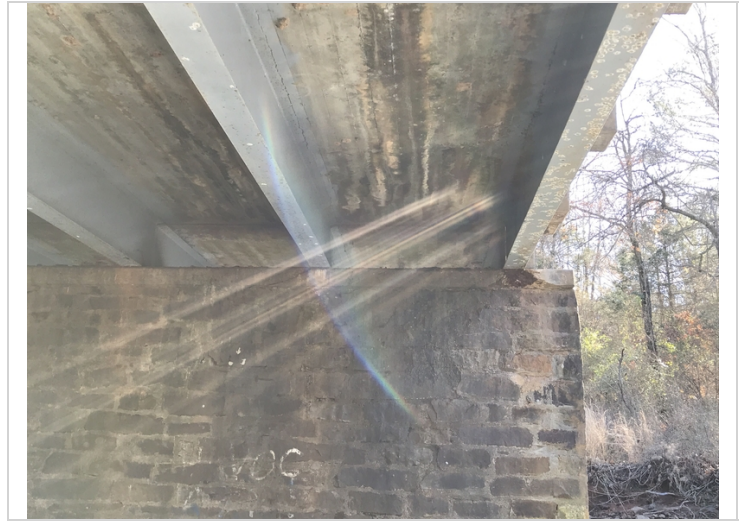
Pier #2 back side has minor spall under girder # 5, there is a moderate crack under girder #4.

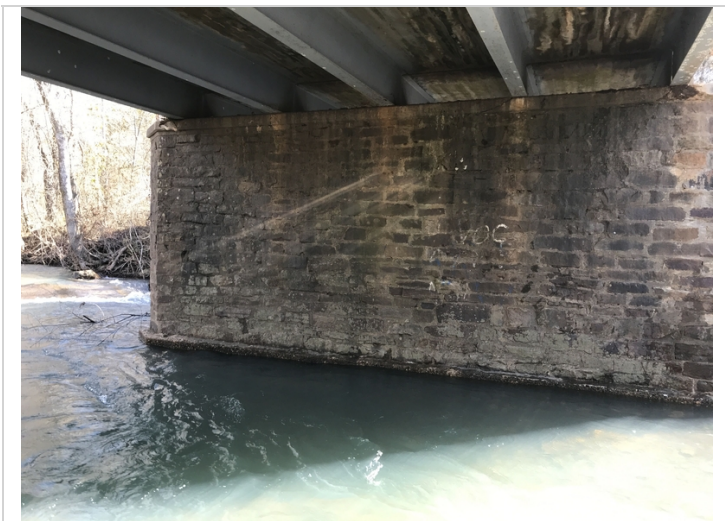
Pier #2 back side has some minor cracking in the mortar joints and some missing mortar in a few areas.

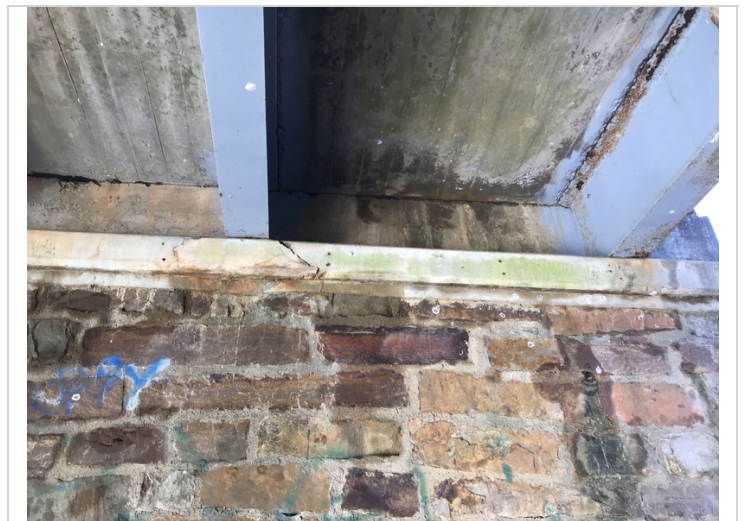
Abutment #1 has some minor delam in the concrete cap under beam #2. There is a couple cracks in the concrete cap.

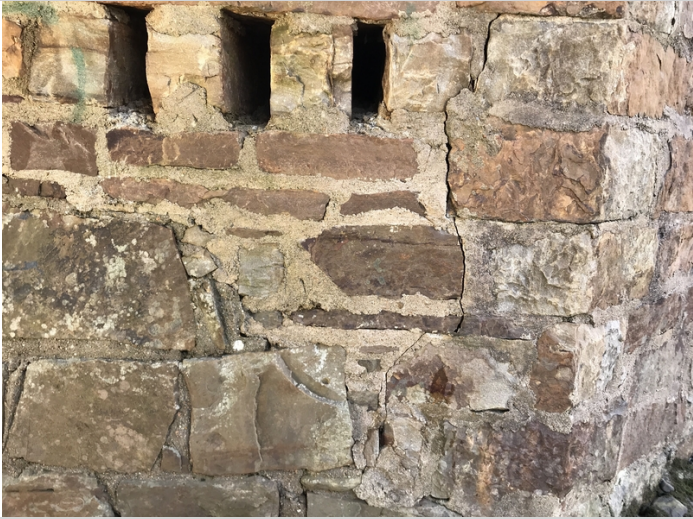
Abutment #1 - Cracking in the mortar joints, few of the stones are cracked in places and mortar is missing in a few areas.

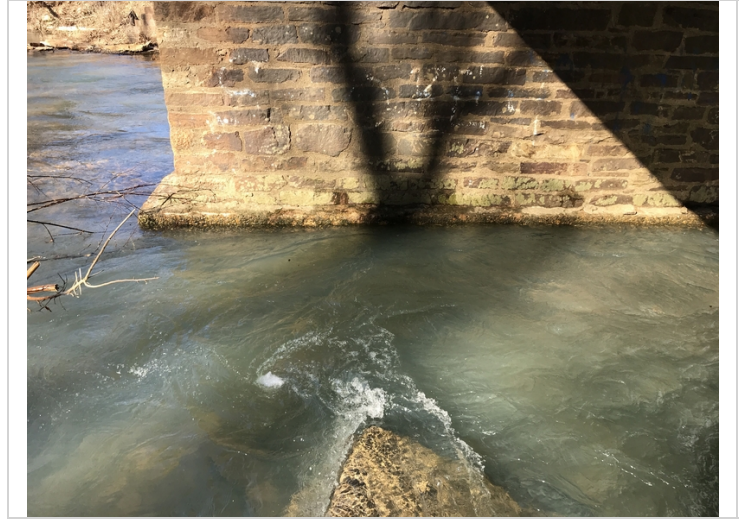
Ahead side of pier #2 has some minor insignificant scour (approximately 18"-24") with no undermining.

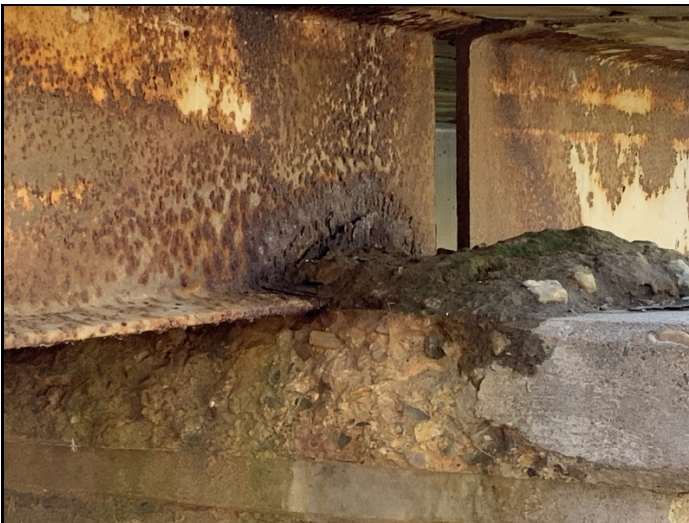
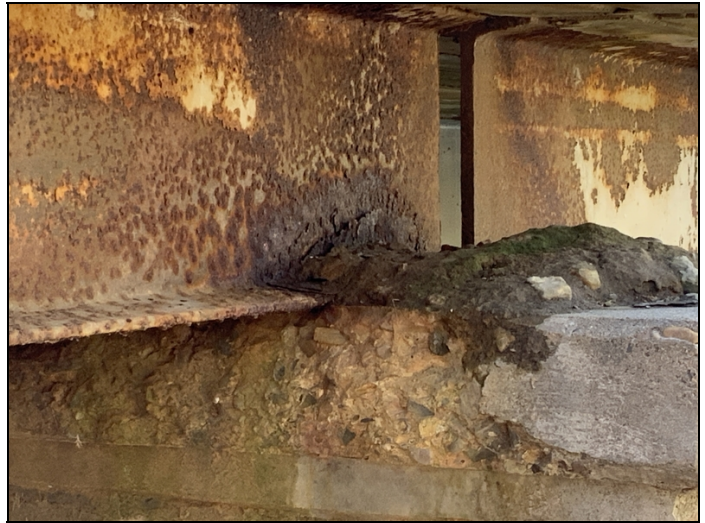
BEAMS - PAINT SYSTEM FAILED. MINOR TO MODERATE SURFACE & FRECKLED RUST ON BEAMS. MINOR TO MODERATE RUST & PITTING ON BEAMS IN SPANS 1, 2 & 3. MINOR TO MODERATE RUST & SECTION LOSS ON APPROX. 1' OF ENDS OF BEAMS AT VARIOUS LOCATIONS. SECTION LOSS MAINLY ON ENDS OF BEAMS AT PIERS 2 & 3.

Typ. Rust & Section Loss on Ends of Beams at Piers 2 & 3.

(2-13-2023 KRM and MLM - This condition no longer exists, the girders have been painted.)

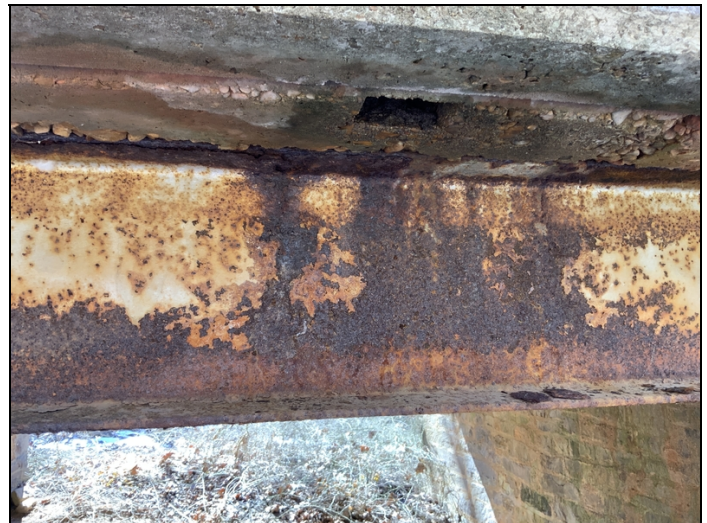
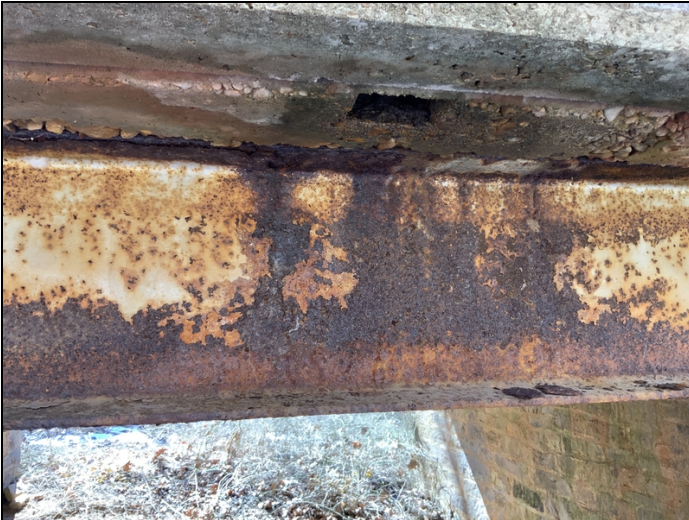
Typ. Rust & Pitting on Outside Beams.

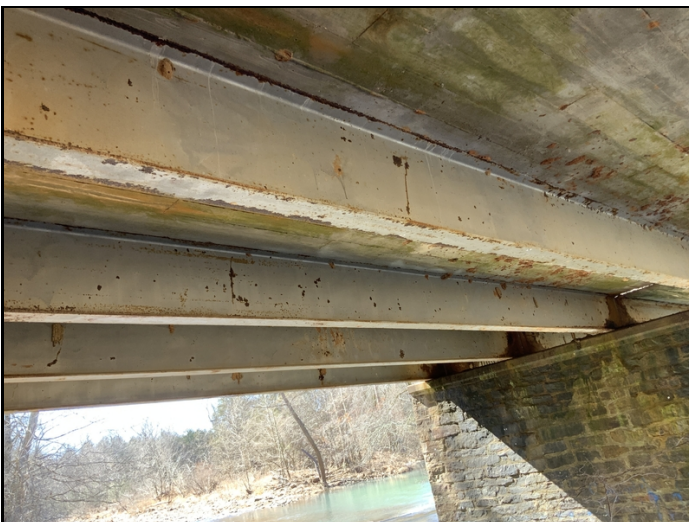
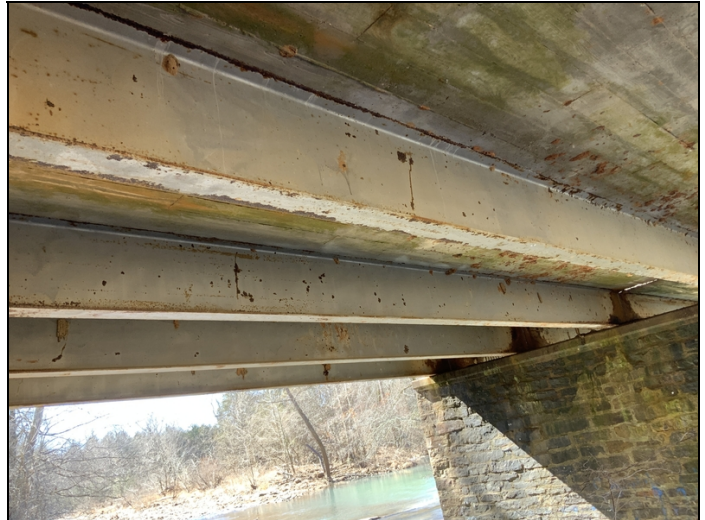
Typ. Condition of Beams 2, 3 & 4.

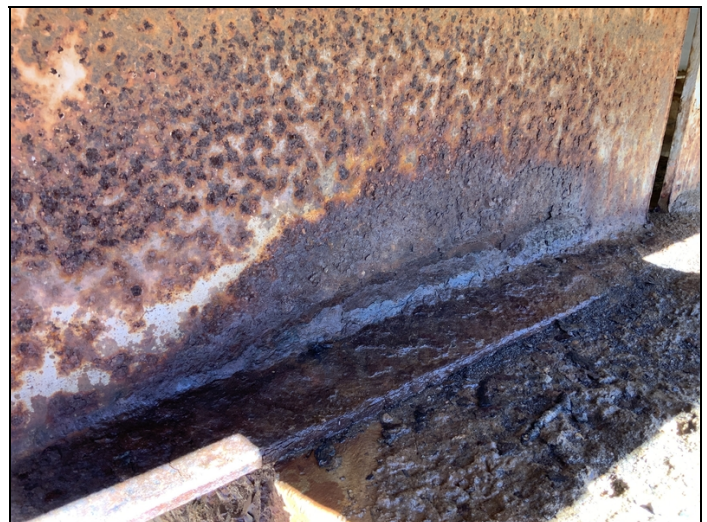
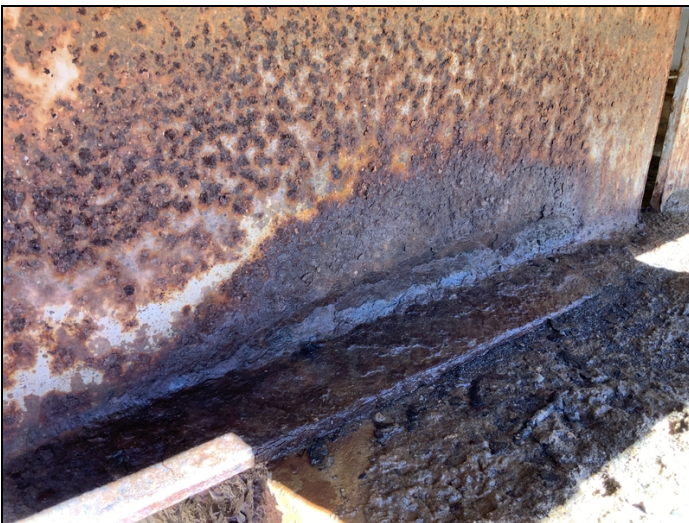
Typ. Section Loss on Ends of Beams.

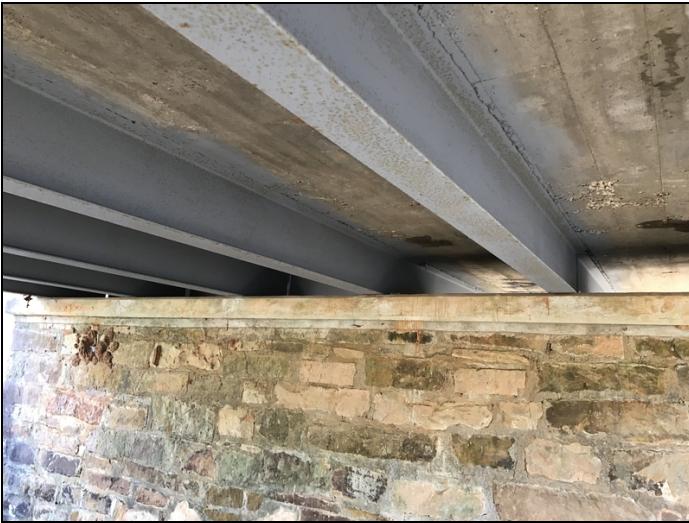
Girders have been painted.

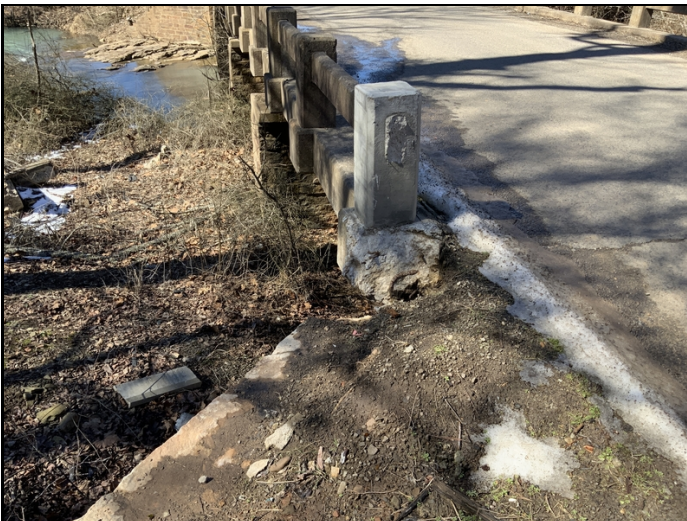
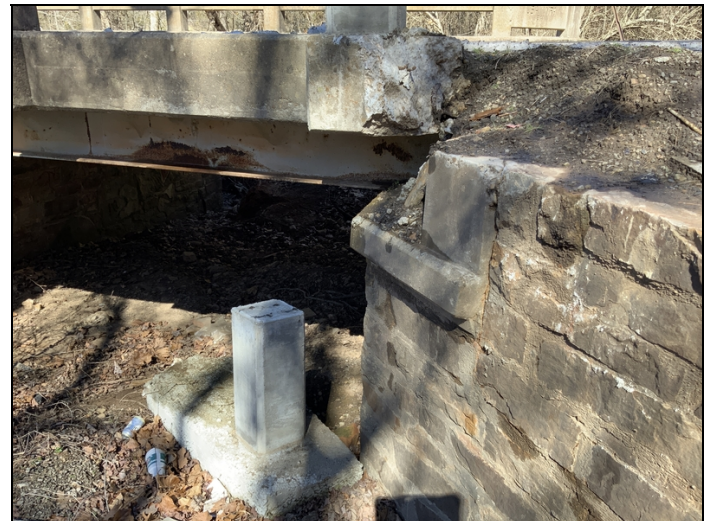
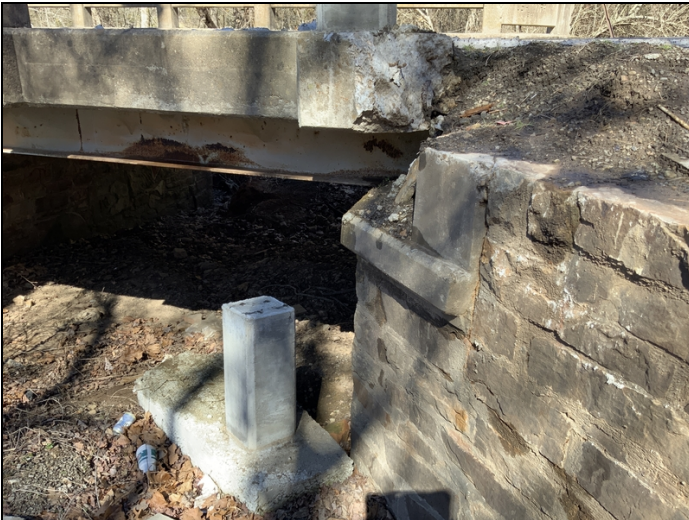
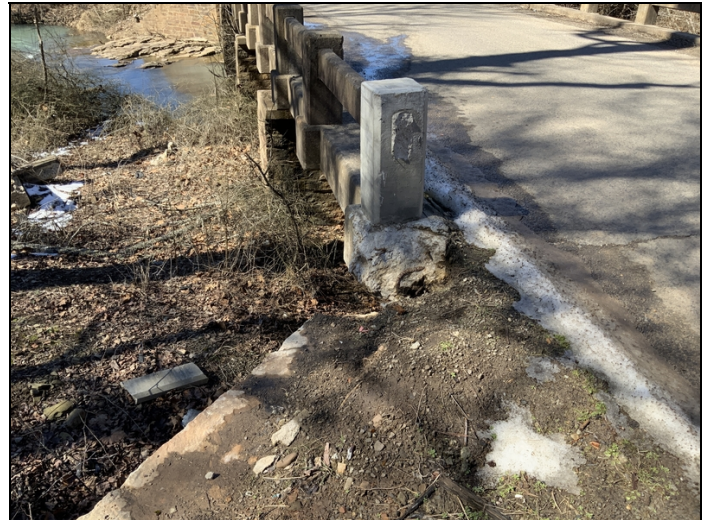
GUARD RAIL - IMPACT DAMAGE TO END POST AT ABUTMENT 5 RT. SIDE. POST BROKE OFF.
IMPACT DAMAGE TO 1st POST AHD OF ABUTMENT 1 LT. SIDE.

Rail & Curb Broken off at Abutment 5 Rt. Side. East End

Repairs have been made at the bridge ends.

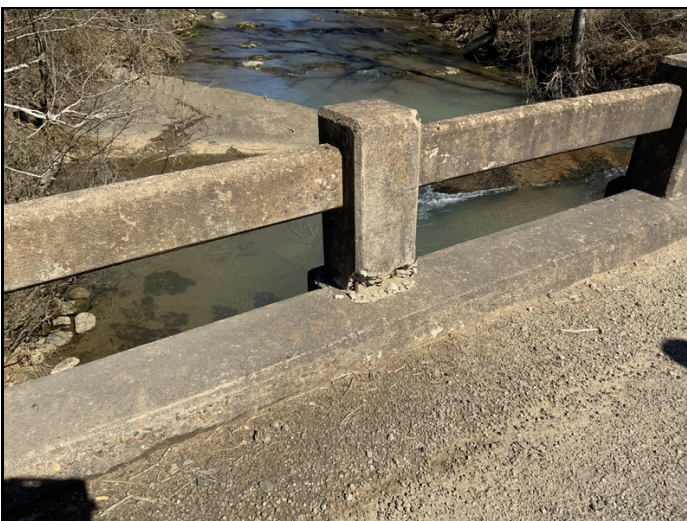
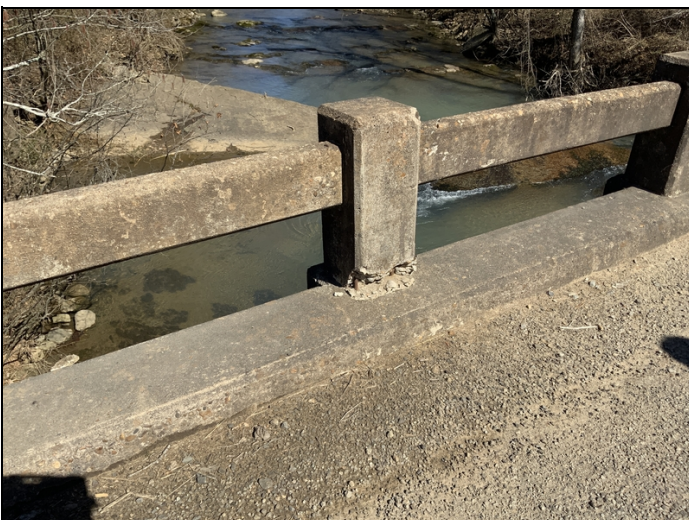
Impact Damage to 1st Rail Post Ahd. of Abutment 1 Lt.
Side. West End

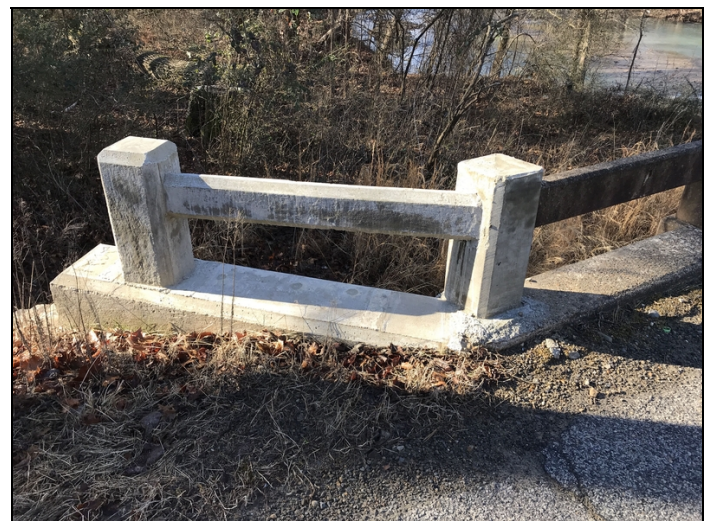
End of bridge rail and post on the right side.

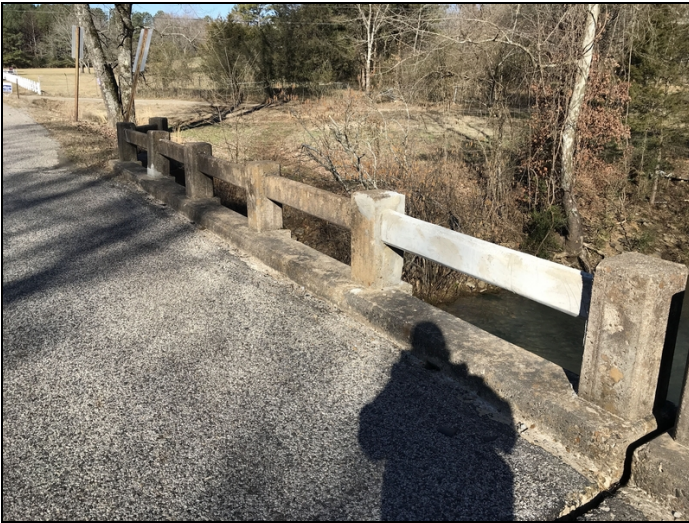
End of span #1 on the left side rail.

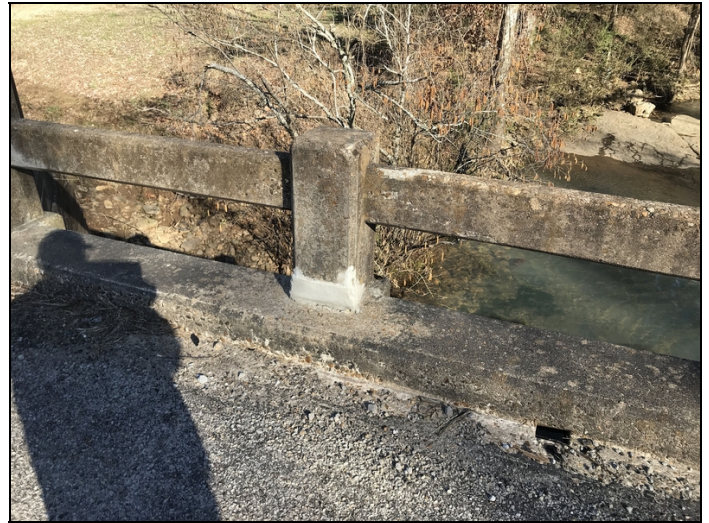
2 nd. post on the left side.
