Asset #14368(Routine)

CR 4400 - D over Rock Creek

Team Lead: Rhett Franks, Inspection Date: 01/25/2024

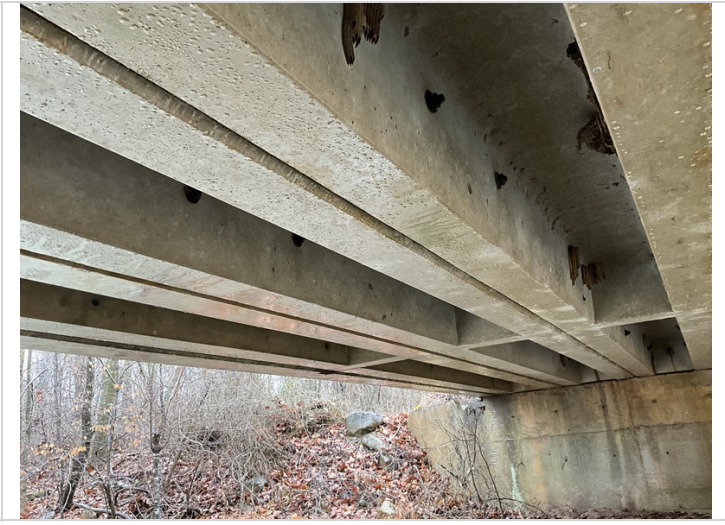
Channel units are transverse bolted and they are in good shape.

Units are bolted together

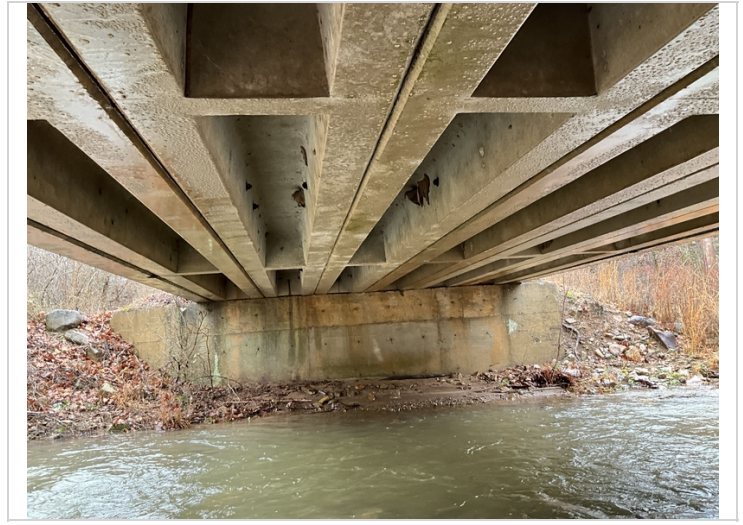
Undersurface has light scaling.

Typical undersurface

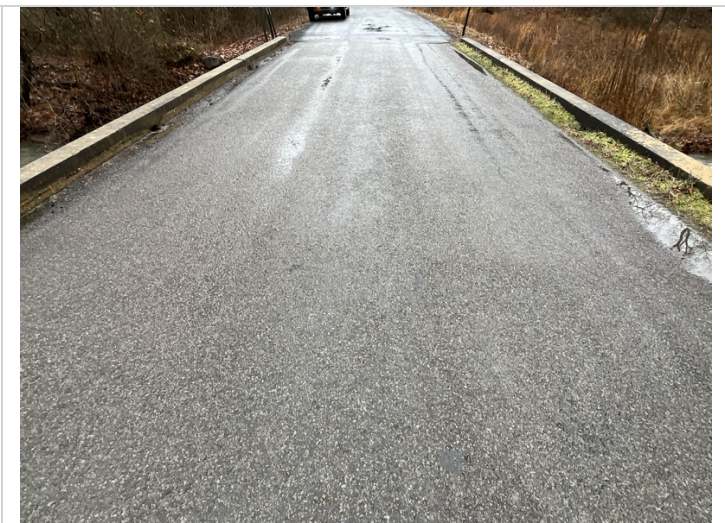
Overall, the deck is in good condition with light wear and dirt and debris in the gutters.

Deck has a asphalt wearing surface, wearing surface in good shape.

Typical deck

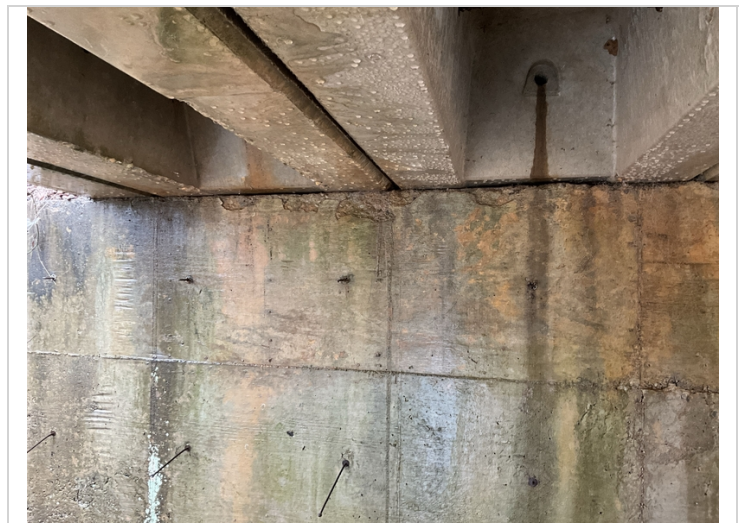
Abutment 2 has delaminated areas along the top of abutment wall under units 2 and 3.

Bent 2 Minor scaling in top of abutment

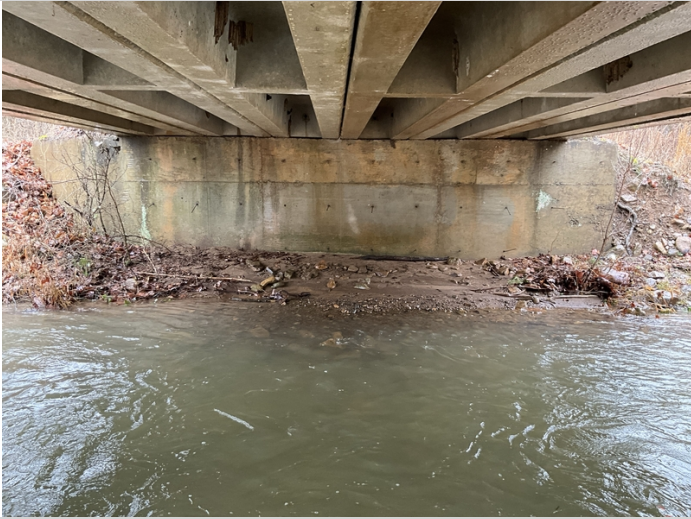
Bent 2 typical

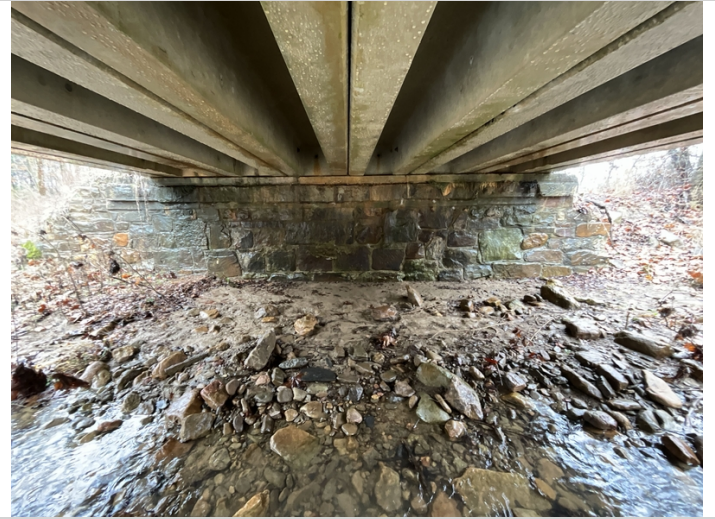
Abutment 1 has minor cracks in the mortar.

Bent 1 Typical

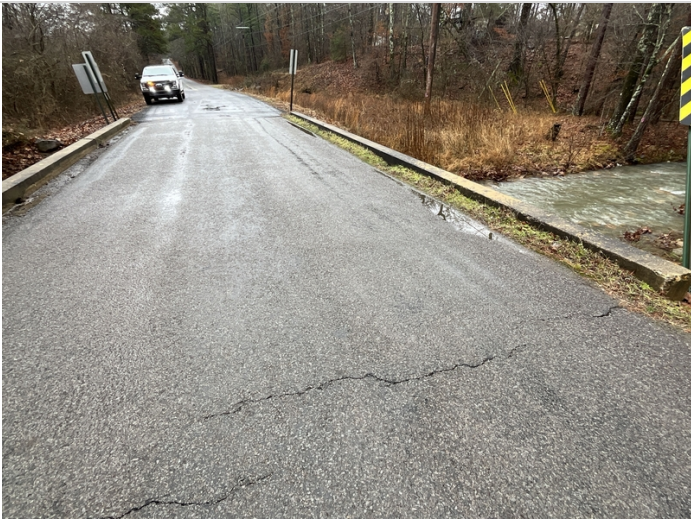
(67) Structural Evaluation	
(68) Deck Geometry	3
(69) Clearances, Vertical/Horizontal	N
(71) Waterway Adequacy	8
(72) Approach Roadway Alignment	7
(36A) Bridge Railings	0 - Inspected feature does not meet
(36B) Transitions	0 - Inspected feature does not meet
(36C) Approach Guardrail	0 - Inspected feature does not meet
(36D) Approach Guardrail Ends	0 - Inspected feature does not meet

No bridge railing
