Asset #20655(Routine)

CR 4400 - D over Teagle Creek

Location: 0.3 M W Jct SH 21

Team Lead: Rhett Franks, Inspection Date: 01/25/2024

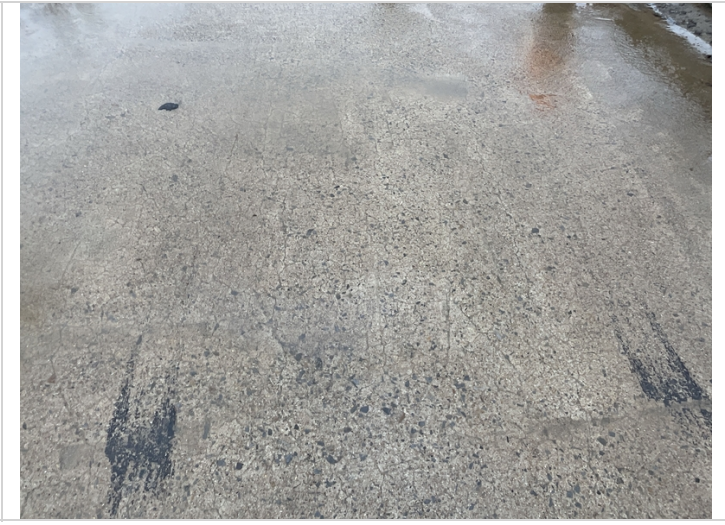
Overall, the deck is in satisfactory condition with light map cracking throughout, ponding water, with dirt/gravel restricting the deck drains.

Typical map cracking through towering surface

Sealabe map cracking throughout the driving surface.

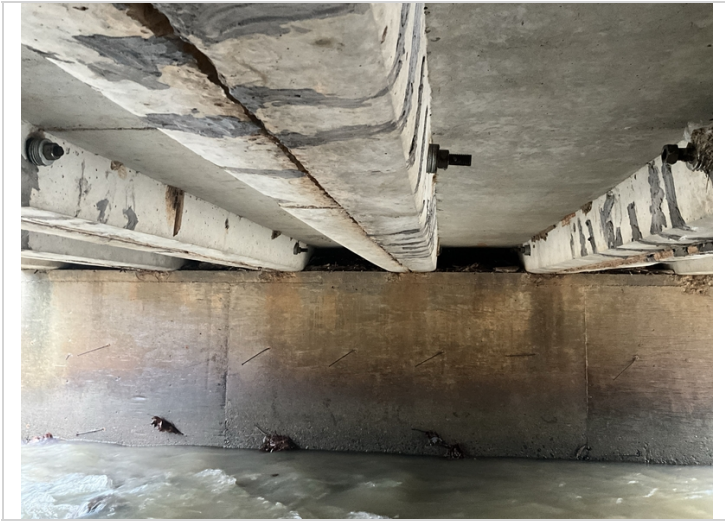
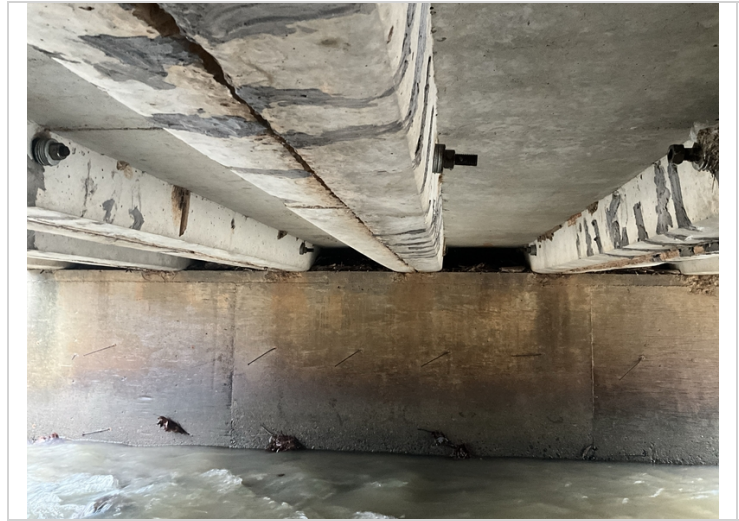
Span 1 has loose bolted connections.

Span 1 Units have lose bolted connections

Channel units need bolts tightened between units in both spans.

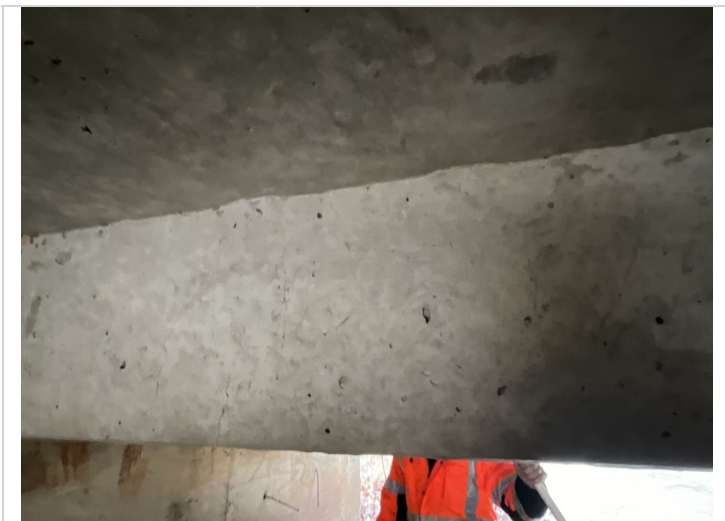
Spans 1 & 2 minor hairline flexural cracking visvable in units that have not been sealed yet.

Typical hairline flexure cracking 1' centers

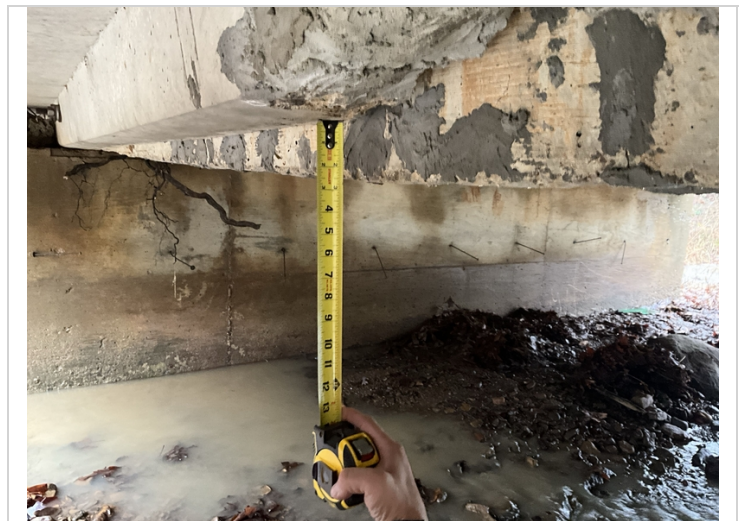
Span 1 unit 2 has approximately 2 1/2" deflection at midspan, there has been no change since last inspection.

Span 1 Unit 2 has 2 1/2 " deflection no change

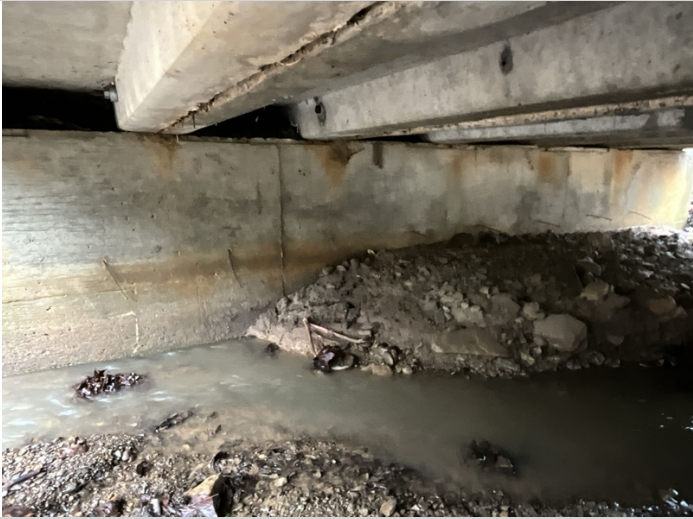
Bent 3 Typical

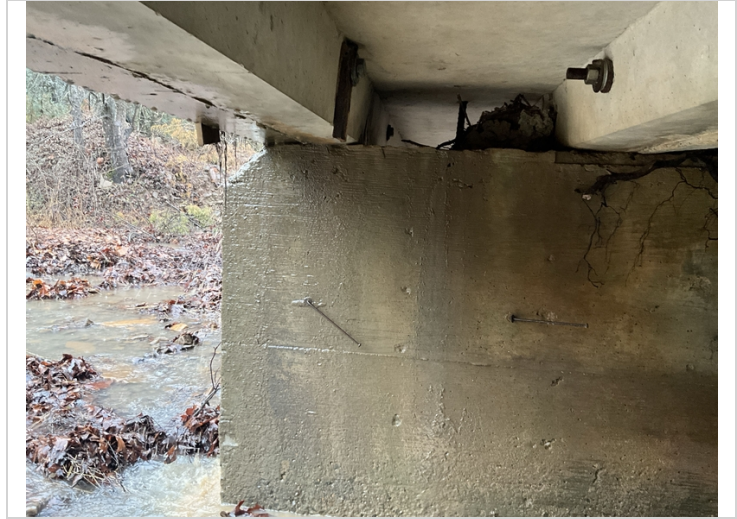
Bent 2 left has some minor deamination in the top of the pier wall.

Bent 2 Spalling in top of pier wall

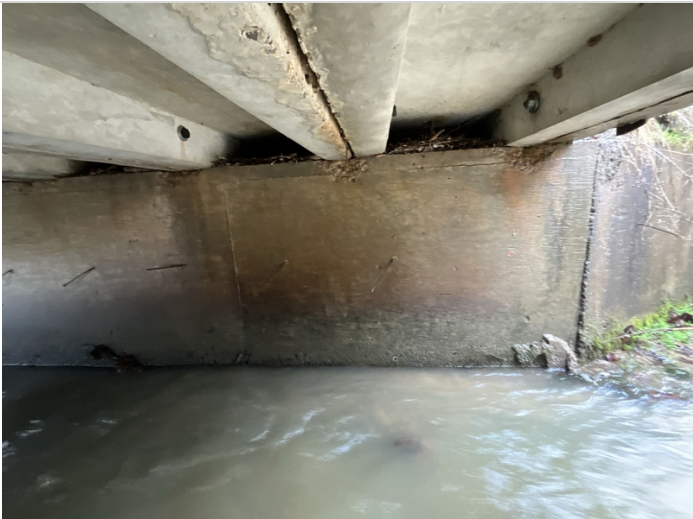
Bent 1 has a few minor spalls in the top of the abutment wall.

Bent 1 Units 1,2 3 spalling in bearing area

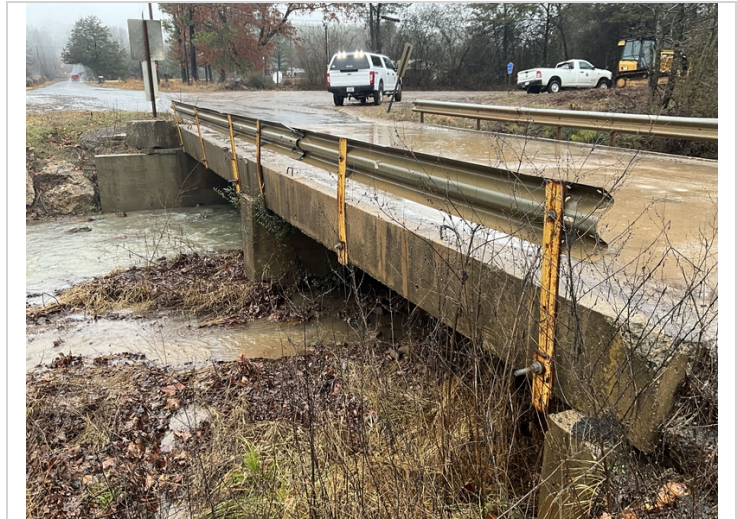
Grader blades are attaching the bridge railing.

Typical bridge railing

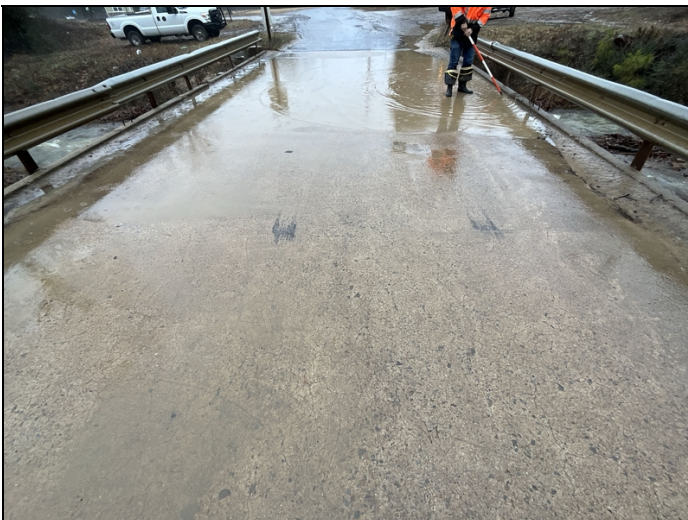
Typical deck

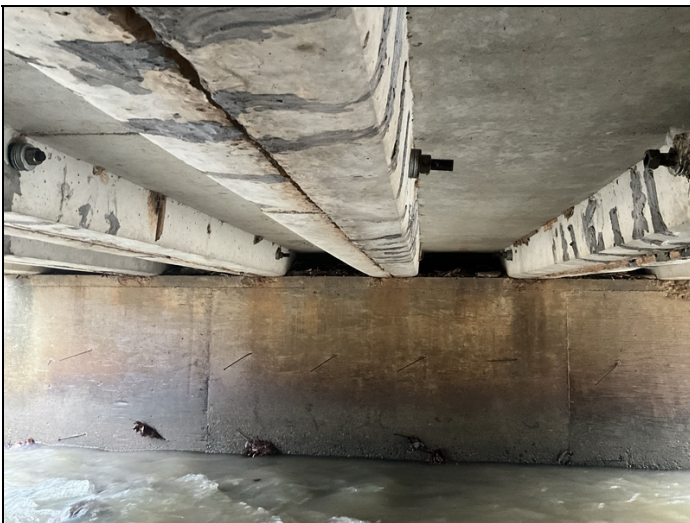
Span 1 Units have lose bolted connections
