Bridge 04566 Inspection Report

National Bridge Inventory Data Sheet

CO RD 28-C- 3.44 over BODCAW CREEK

Team Lead: John King Inspection Date: 05/08/2023

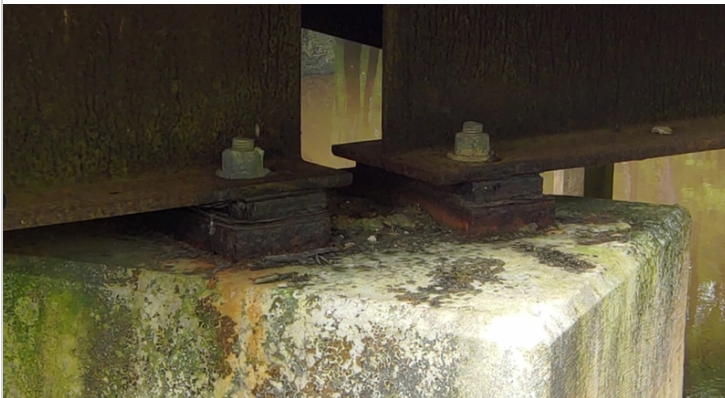
Span 1 efflorescence in overhangs and cracking
Cracking in various locations of overhang
Bearings have beginning stages of flaking of rust
05/2023 Drone Photo of rust on Bearings TYP all Bents
Weathering steel beams

05/2023 Drone Photo of rust on Bearings TYP all Bents

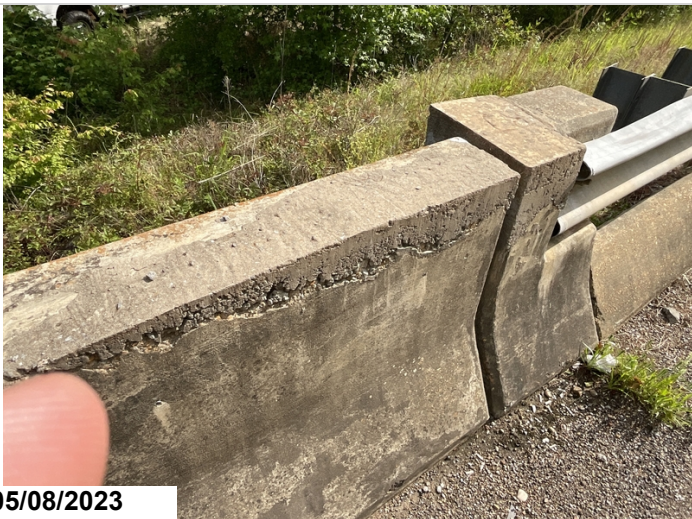
Old patch work on parapet wall various locations left side end of bridge.
Cracking in parapet wall various locations.
Minor spall in parapet wall various locations.
Seal damage bent 6
Minor cracking in various locations on deck

Old patch work on parapet wall various locations

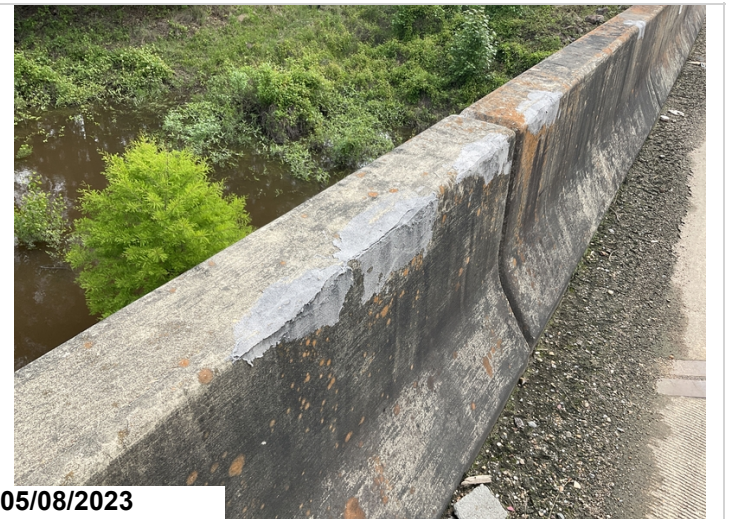
Old patch work on parapet wall various locations

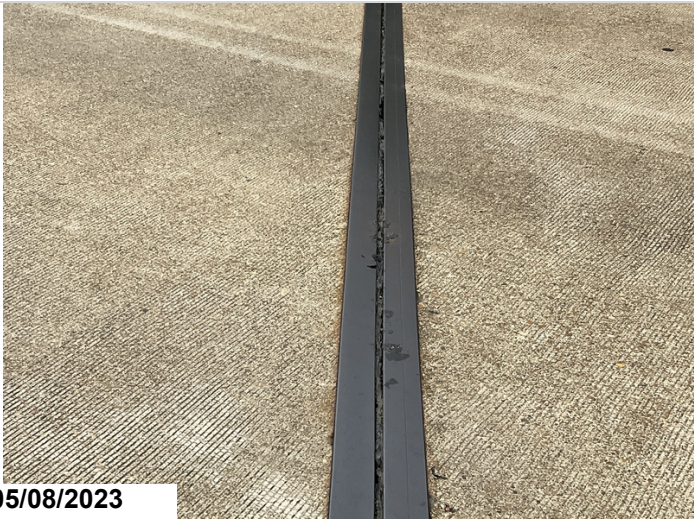
Seal damage bent 6

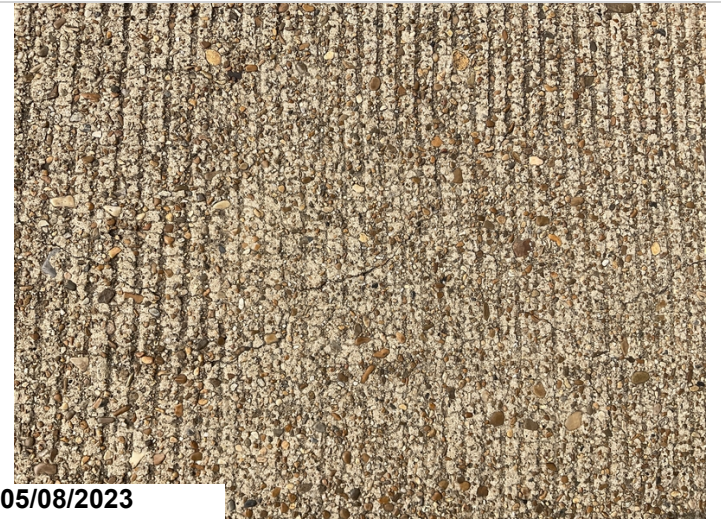
Minor cracking in various locations on deck

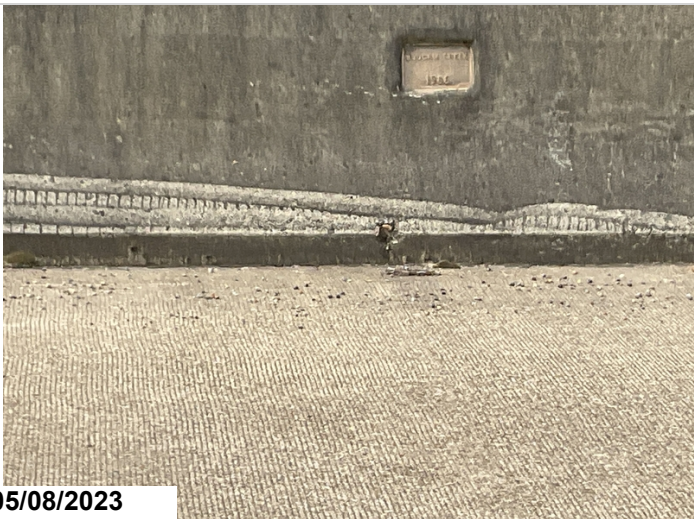
Minor spall in parapet wall various locations

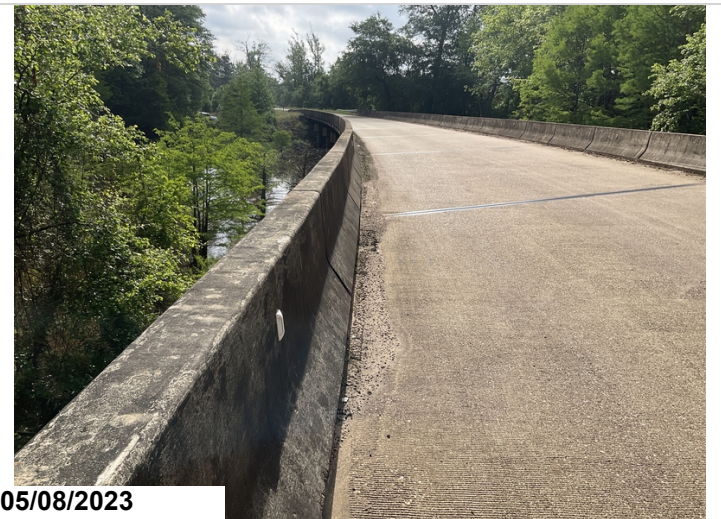
Deck washing needed. small amount of dirt starting to collect on bridge deck.

Deck washing needed

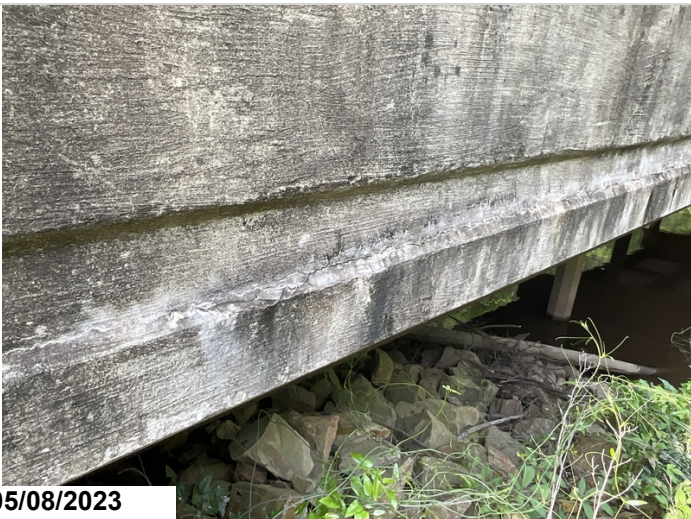
Cracking in parapet wall various locations

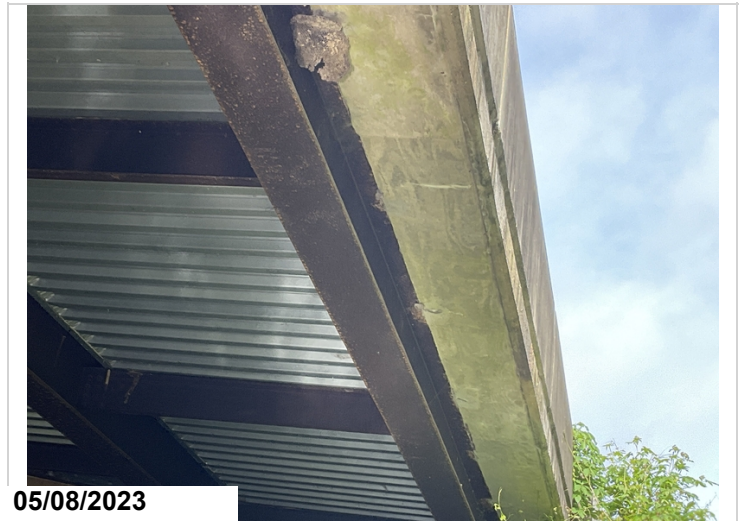
Span 1 efflorescence in overhangs and cracking

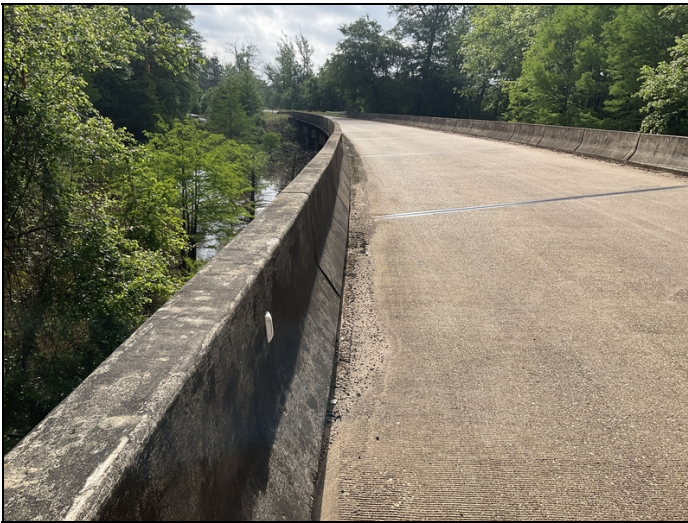
Deck washing needed. small amount of dirt starting to collect on bridge deck.

Deck washing needed
