## Bridge 14644 Inspection Report

CR 95/Dakota Road over Long Creek

Location: 3.3 Mi N US 65-Grady - Lincoln County

Team Lead: Phillip Dowell Inspection Date: 12/03/2025

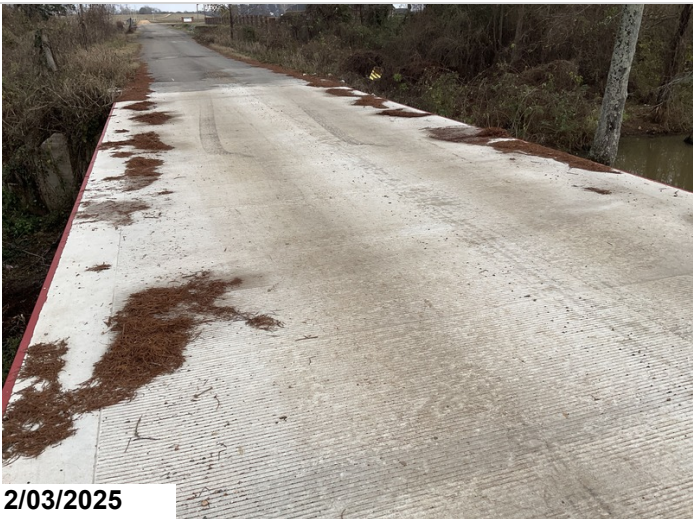
Deck is in good condition, with minor cracking in deck surface.

Deck - Span 1: Overview

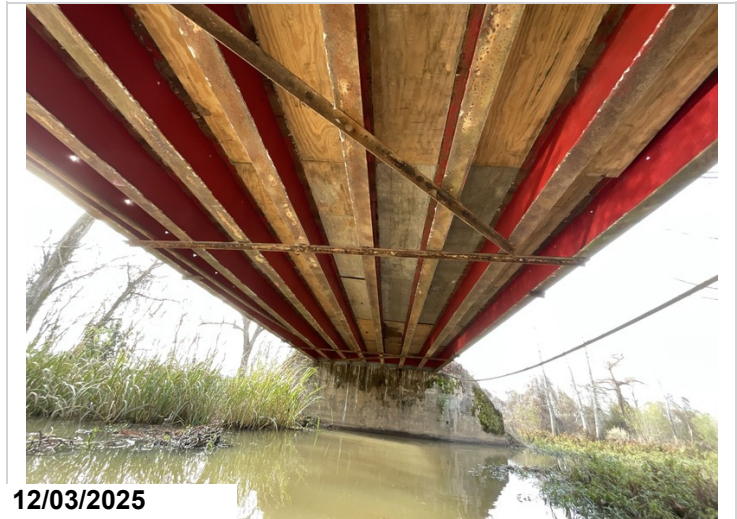
Superstructure is in satisfactory condition, with surface corrosion (mainly on bottom face of bottom flange) and some pitting/flaking on girder ends.

Undersurface - Span 1: Overview

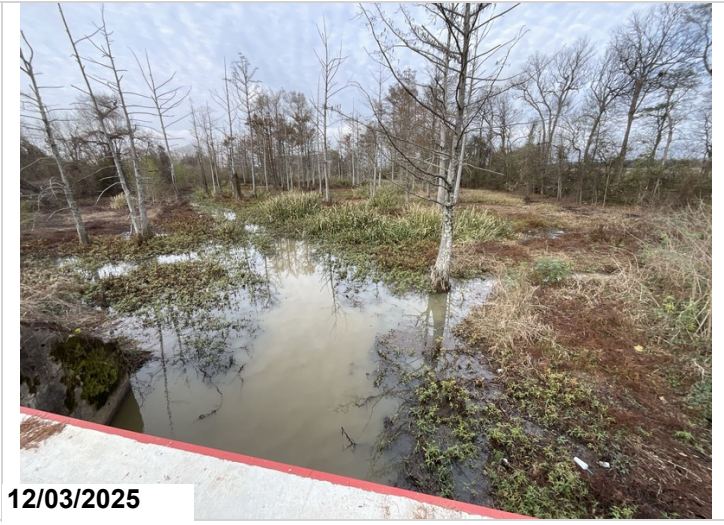
Channel is in good condition, with some minor debris and vegetation overgrowth.

Channel - Left side view

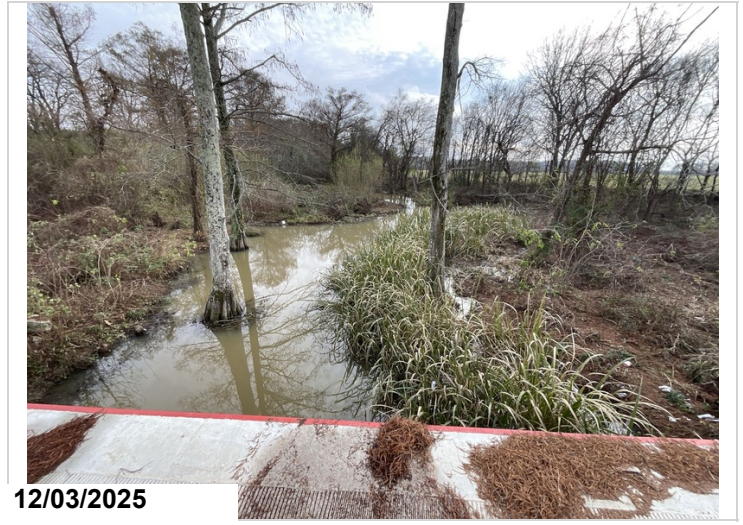
Channel - Right side view

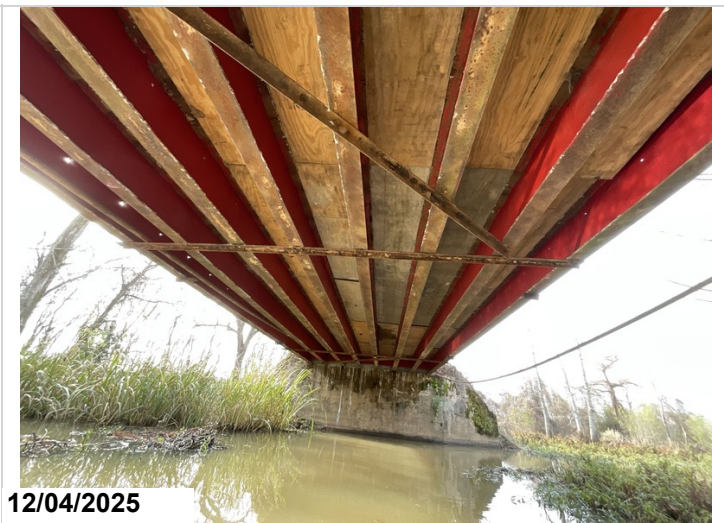
Girders: Uniform freckled rust with no paint on bottom face of bottom flange and bottom face of top flange.

Overview of girders

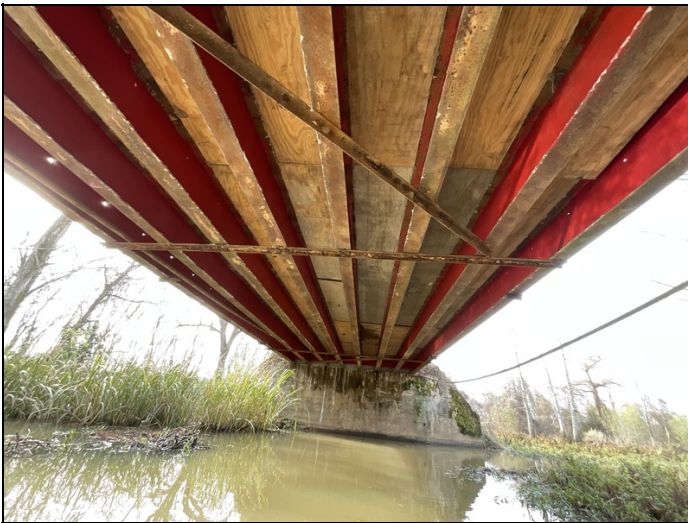
Girders: Uniform freckled rust with no paint on bottom face of bottom flange and bottom face of top flange.

Overview of girders

**A-60 - Full Girder Painting Needed (Yes)**
