Bridge #14793(Routine)

Greasy Valley Road over Gum Creek-Logan Co.

Team Lead: Eric West Inspection Date: August 23, 2018

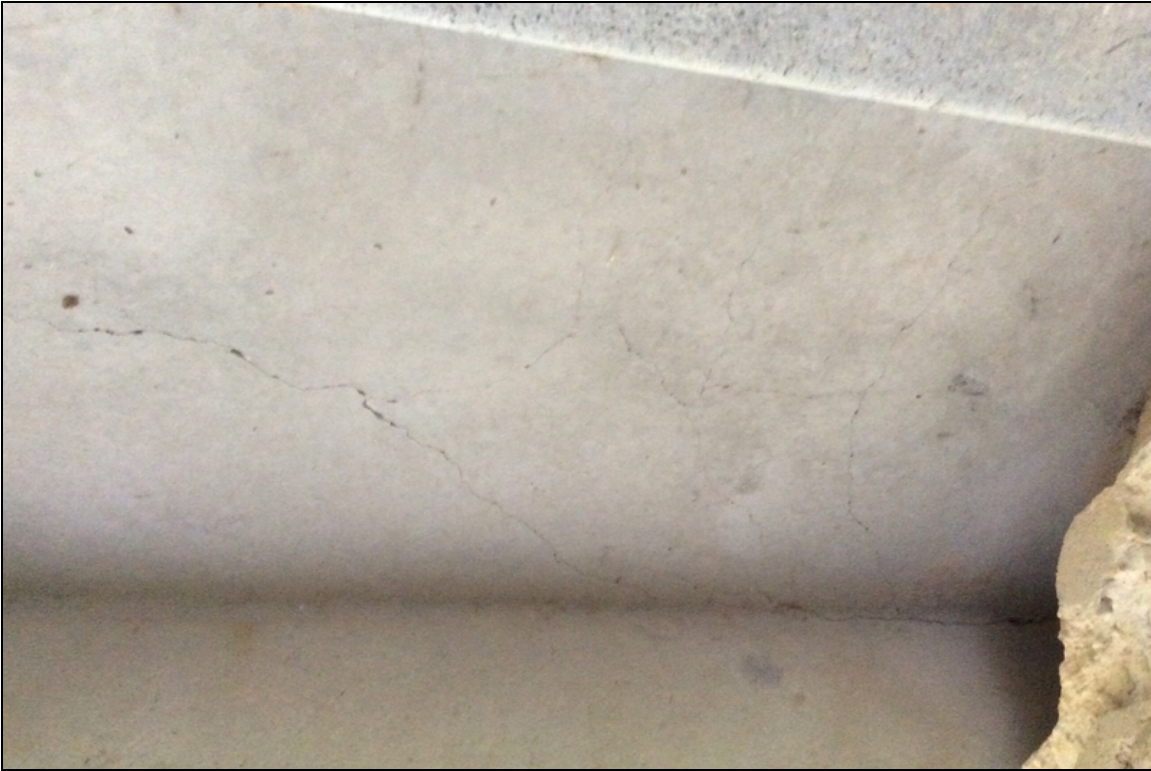
Span # 1 Unit # 2 cracks on the undersurface of the deck.

- Span # 1 has longitudinal and hairline map cracking is visible from the undersurface of the deck in Units 2, 3, 4, 6, 7 & 8.

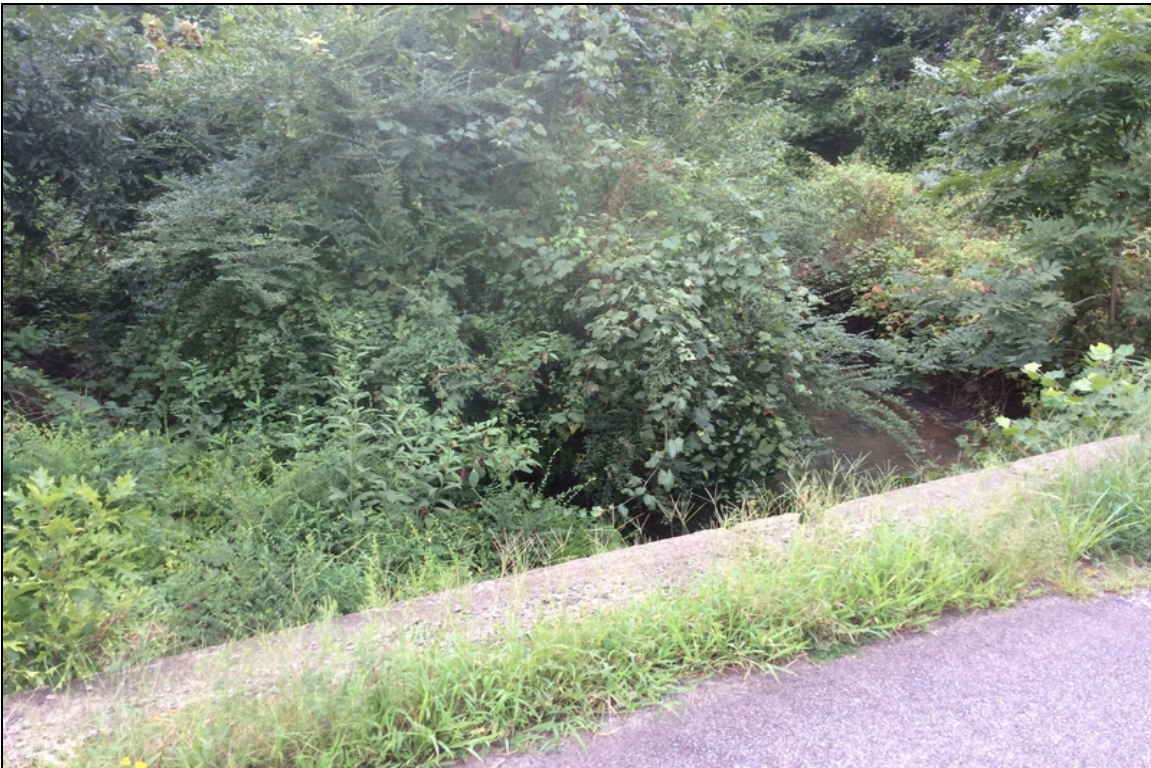
Channel restricted with trees and vegetation.

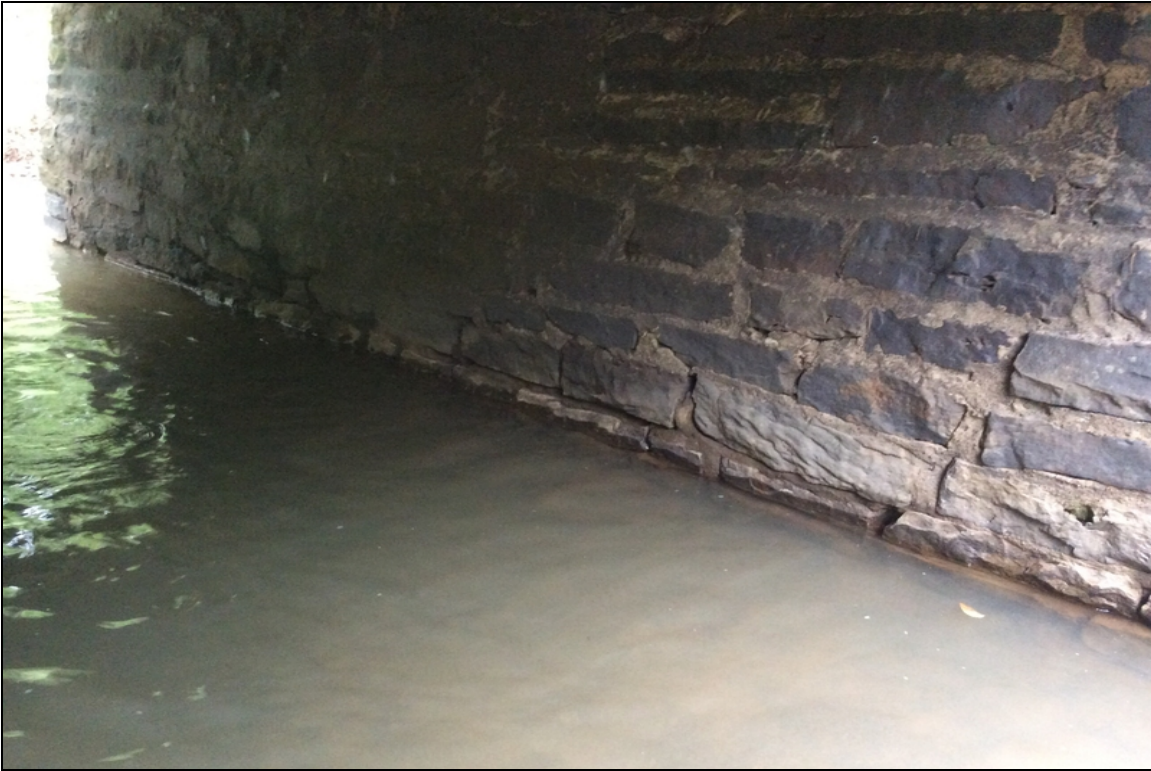
Bent # 2 grout deterioration at the base of the pier wall.

- Grout deterioration at the base of the rock masonry pier wall.

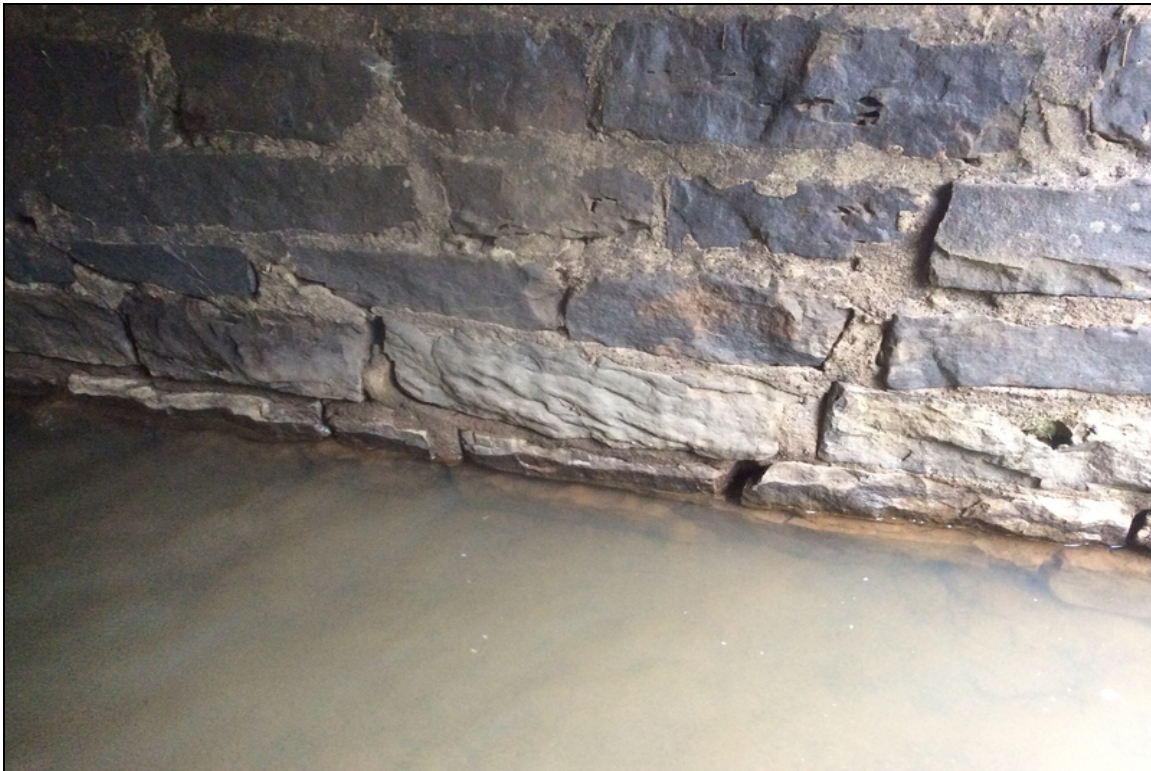
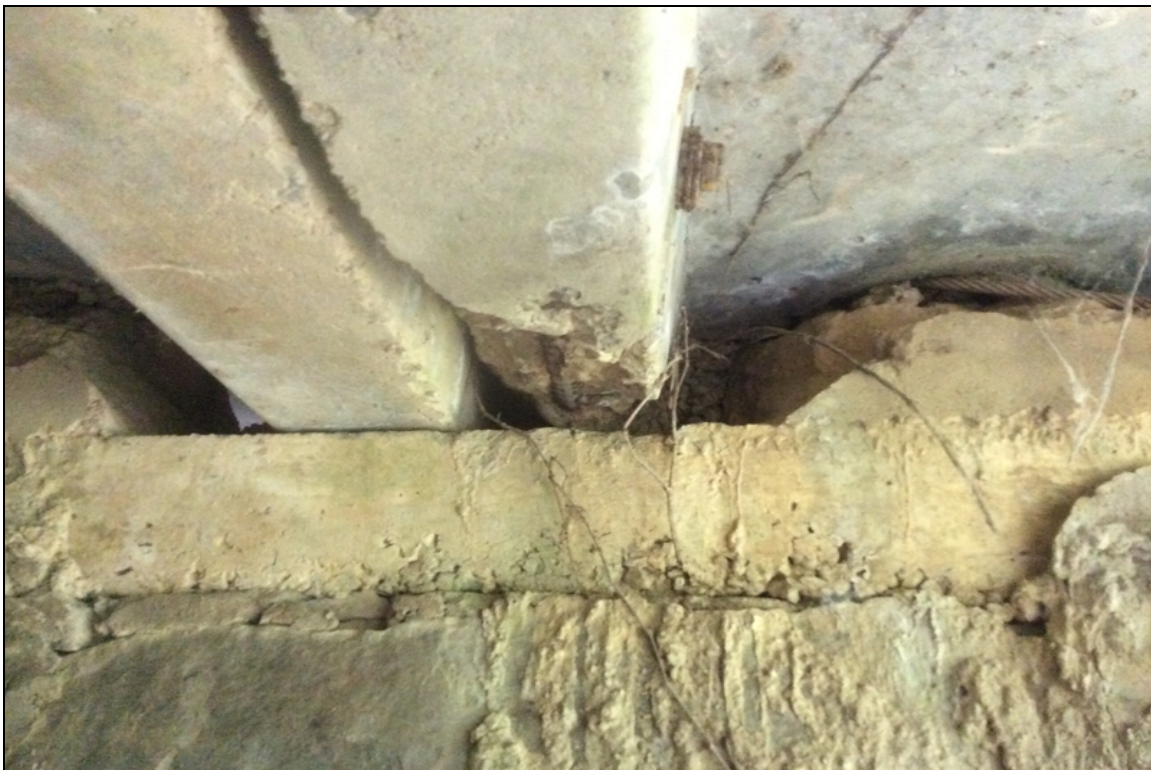
Bent # 2 Span # 1 spalling with exposed reinforcing steel on the RT stem.

- Span 2, the RT stem of Channel 1, over Bent 2, has a large 10" spall with exposed reinforcing steel. No apparent section loss to the exposed reinforcing steel at this inspection.

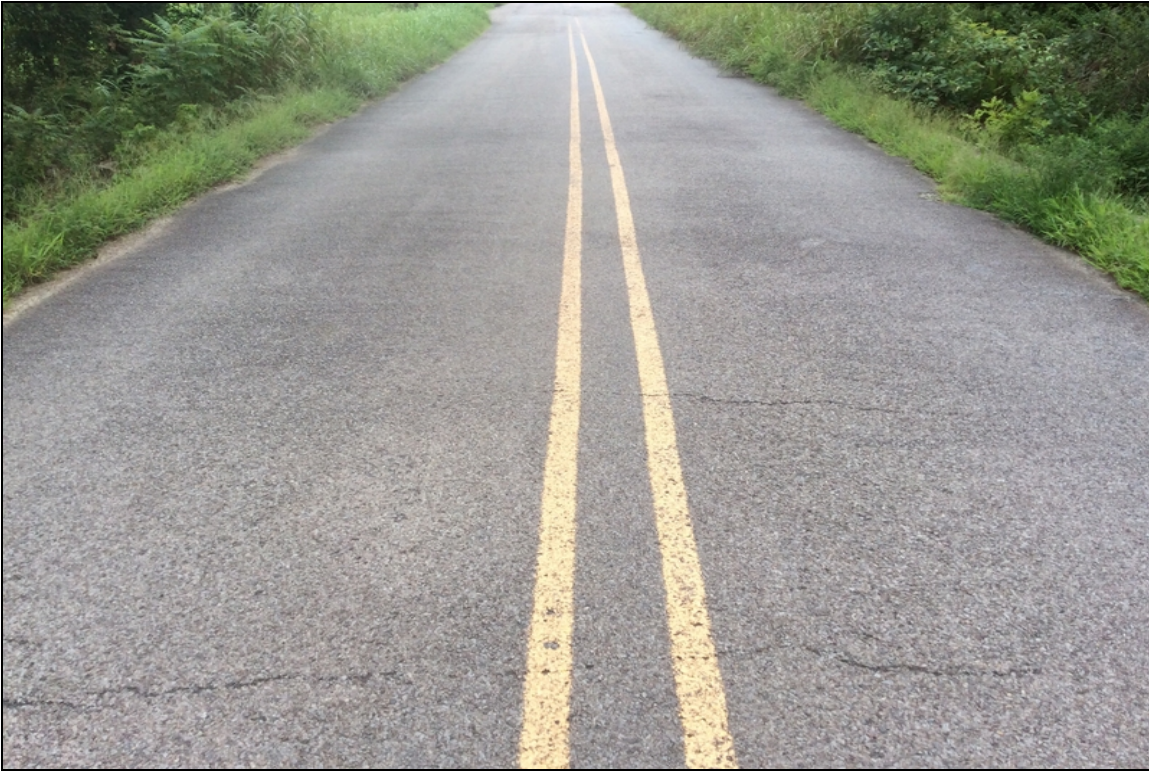
Typical driving surface.

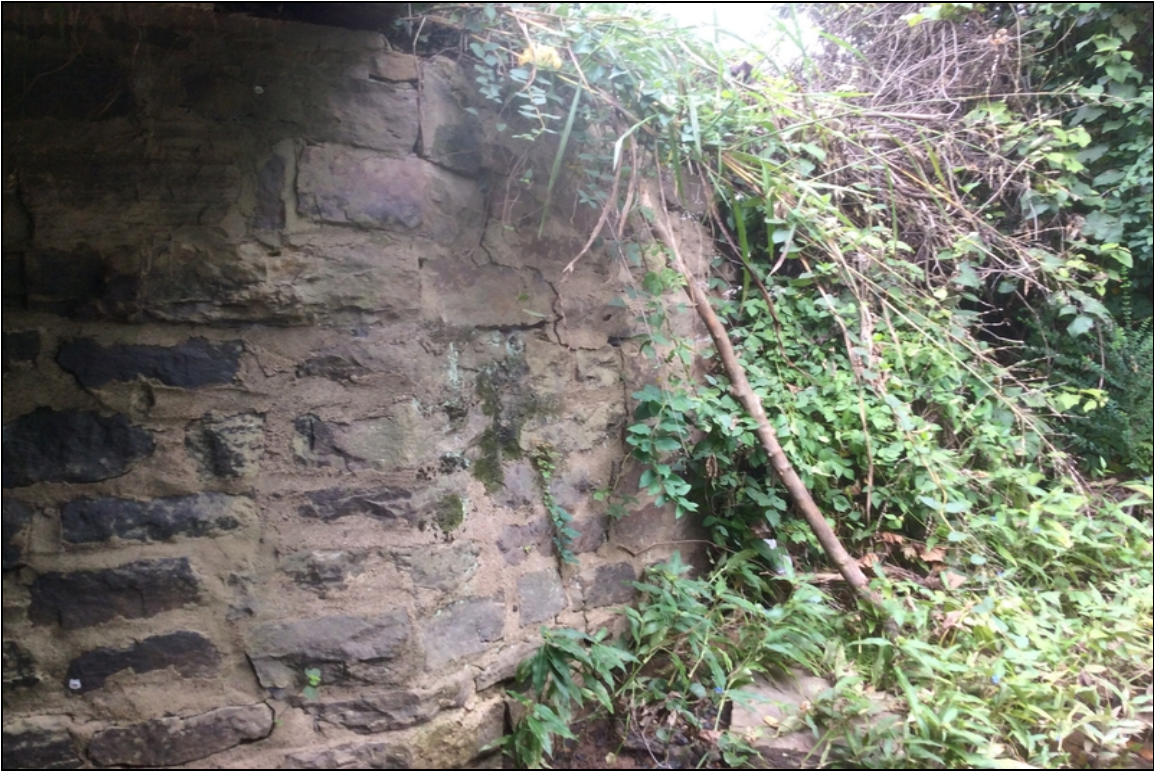
Bent # 1 Lt wing wall cracking with minor rotation towards the channel.

- Bent 1, Lt side of the cast in place concrete cap in the bearing area of the exterior stem of Channel 1 has fractured and is no longer in place. This has caused the channel unit to rotate along its longitudinal axis to the point that the Rt stem of the unit is lifted off of the bearing over Bent 2. Cracking and minor rotation of the Lt wing wall. The RT end of Bent # 1 cap has spalling with exposed reinforcing steel.

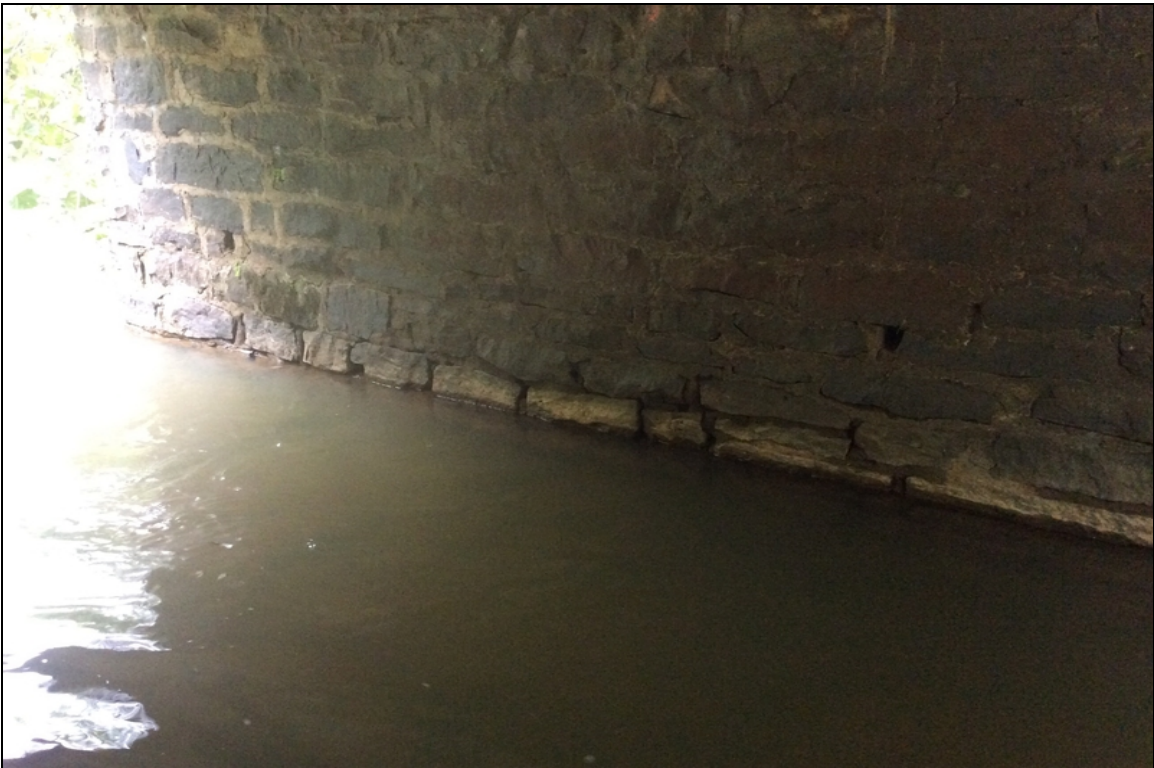
Bent # 1 grout deterioration at the base of the bent.

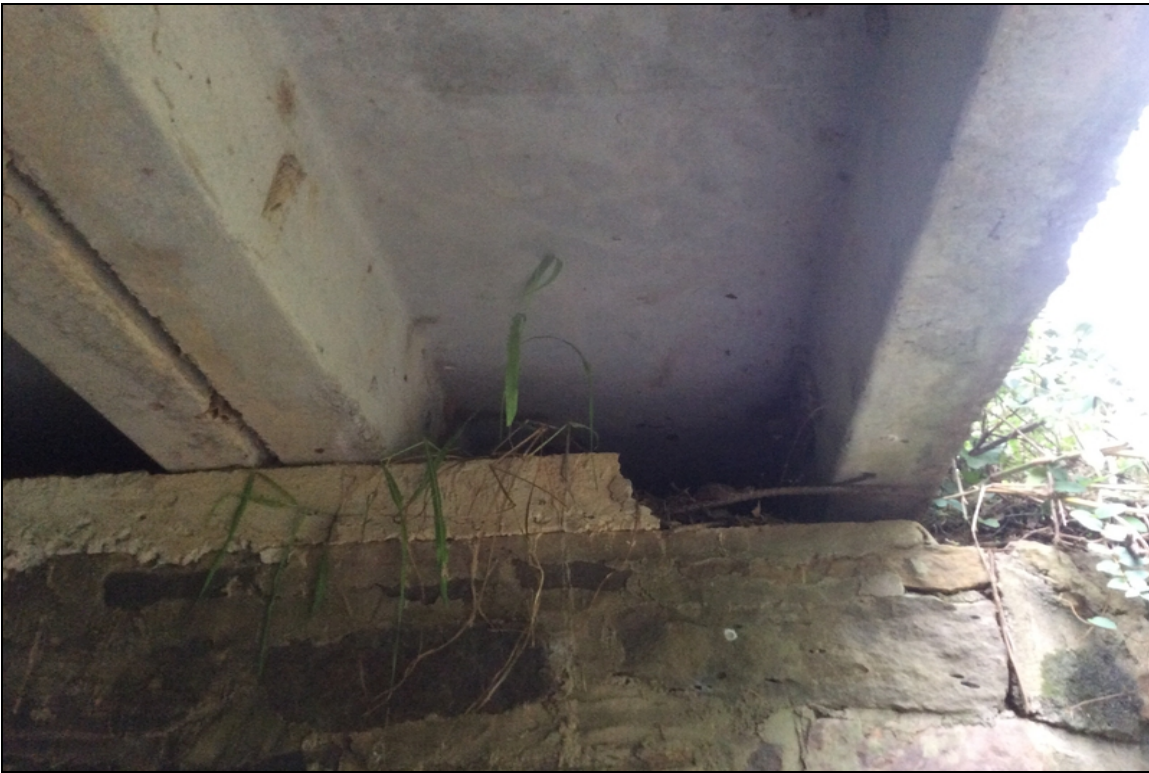
Bent # 1 Unit # 1 missing section of the cap.

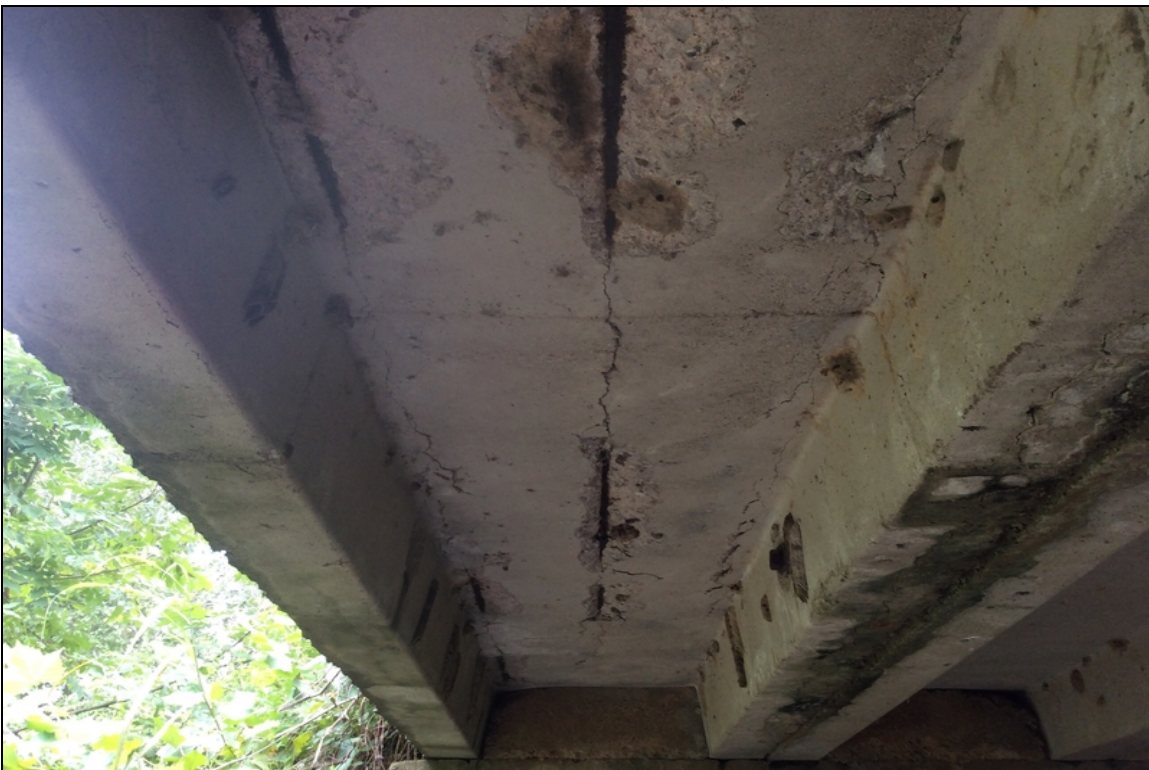
Span # 1 Unit # 8 spalling with exposed reinforcing steel on the undersurface of the deck.

- Spalling with exposed reinforcing steel with minor section loss and excessive cracking visible from the undersurface of deck in Span 1, Channel 8.

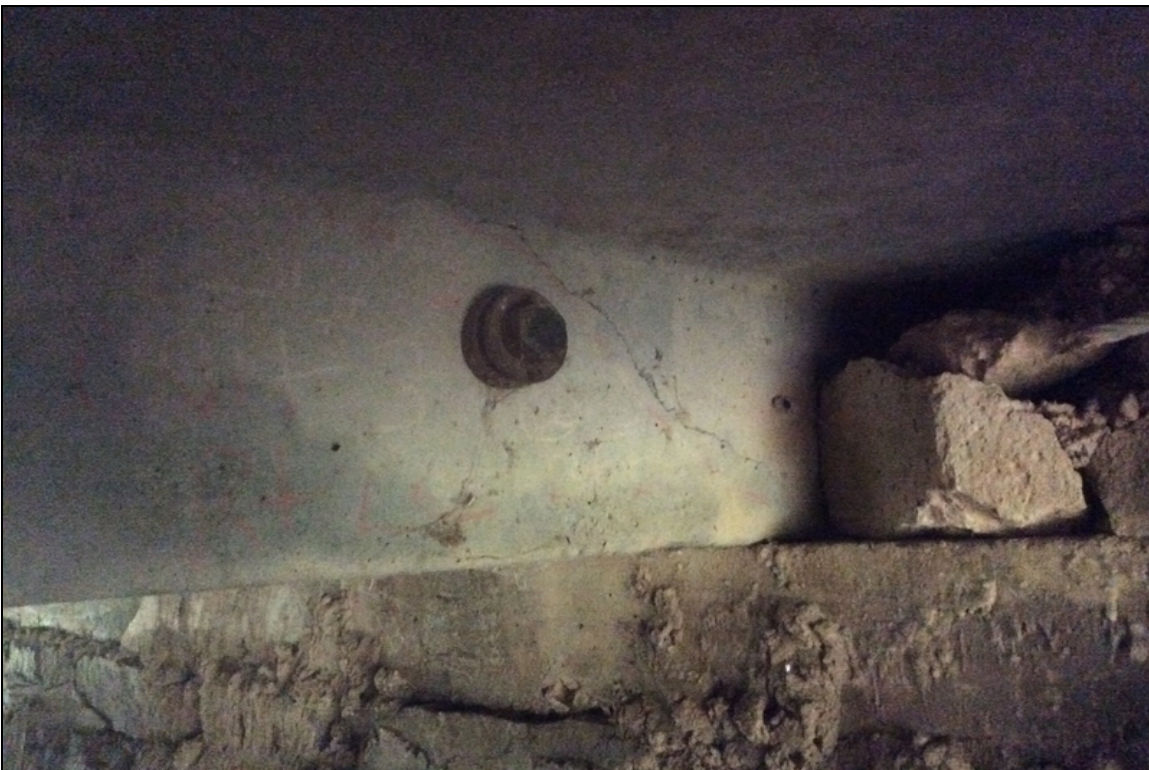
Bent # 2 Span # 2 Unit # 3 Lt & Rt stems have shear cracks.

- Span 2, Unit 3, Lt & Rt stem and Unit 5 Lt stem at Bent 2 have hairline shear cracks.
