Bridge #04630(Routine, Underwater type 2)

Elkins Road over Scotts Creek-Logan Co.

Team Lead: Jeff Jones Inspection Date: April 20, 2020

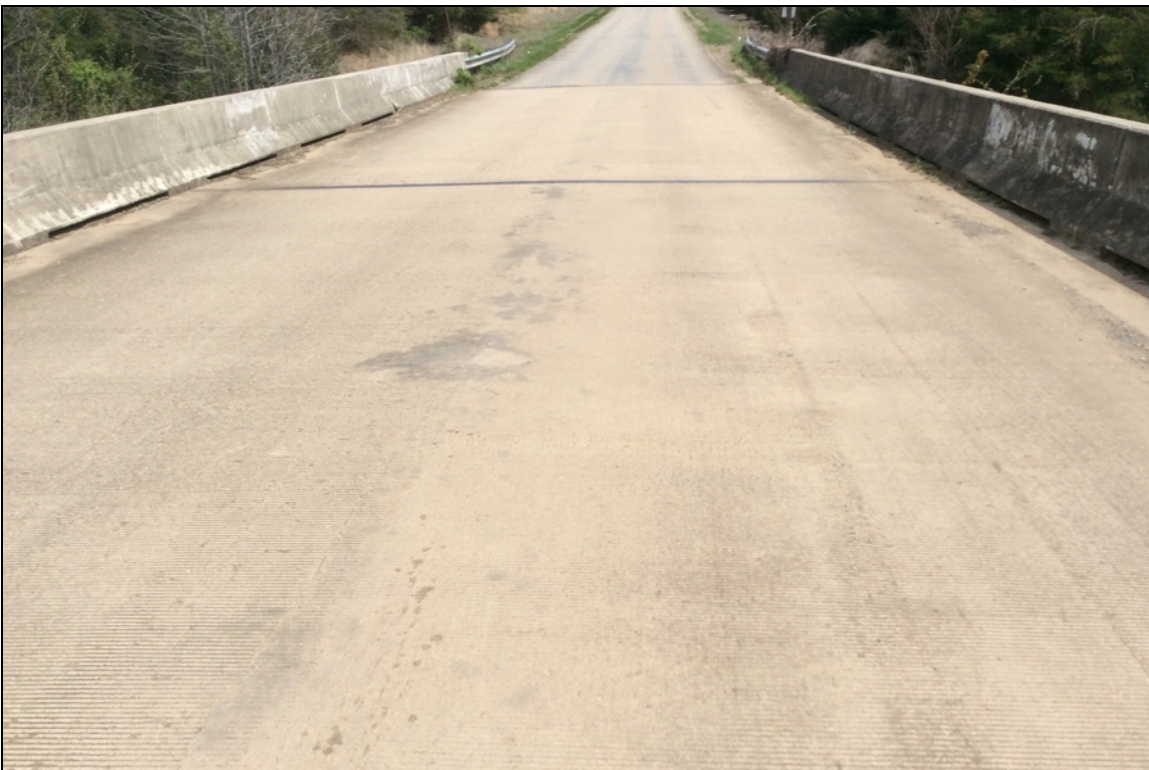
Typical driving surface of the deck.

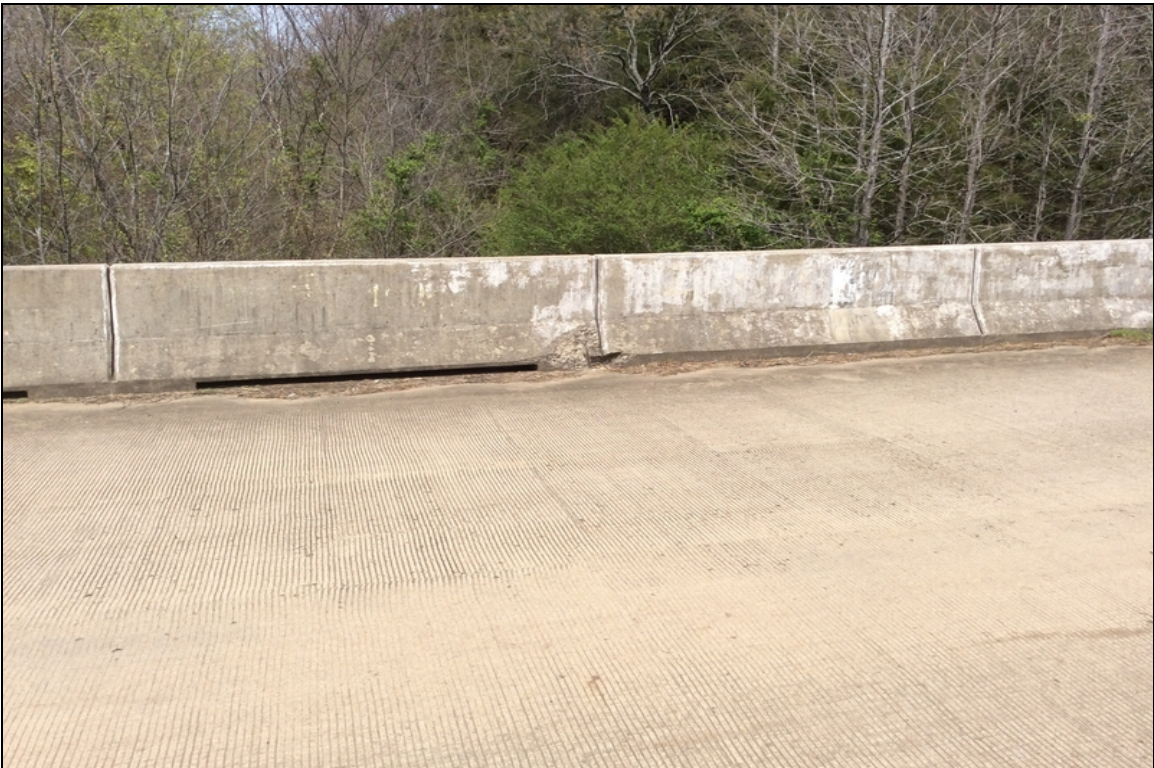
Spalling at the base of the bridge rail in span # 3.

Railing: Spalling with exposed reinforcing steel is visible on both sides of Span # 3 where wood forms were left in place during the construction process.

04/20/2020 - JCJ & TJL - Maintenance forces have grouted over the spalls with exposed reinforcing steel in the parapet walls. Also maintenance forces have covered the spalls with asphalt in the base of the parapet walls.

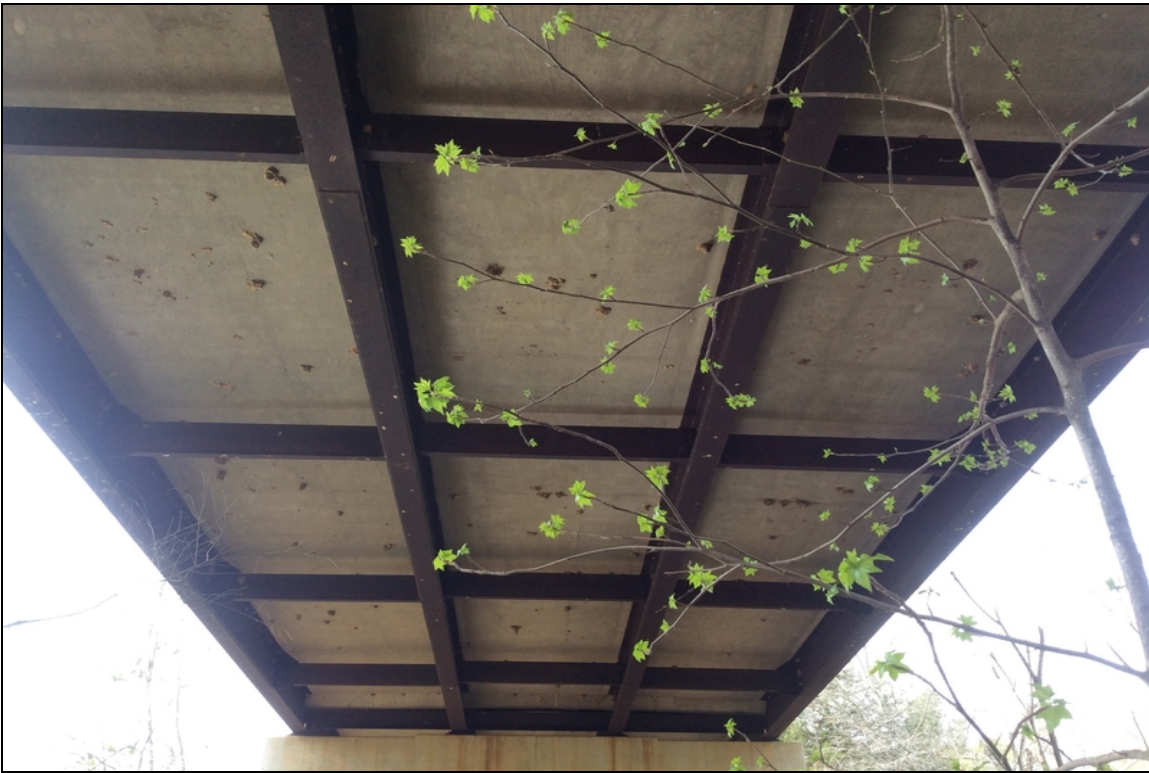
Typical undersurface of the deck.

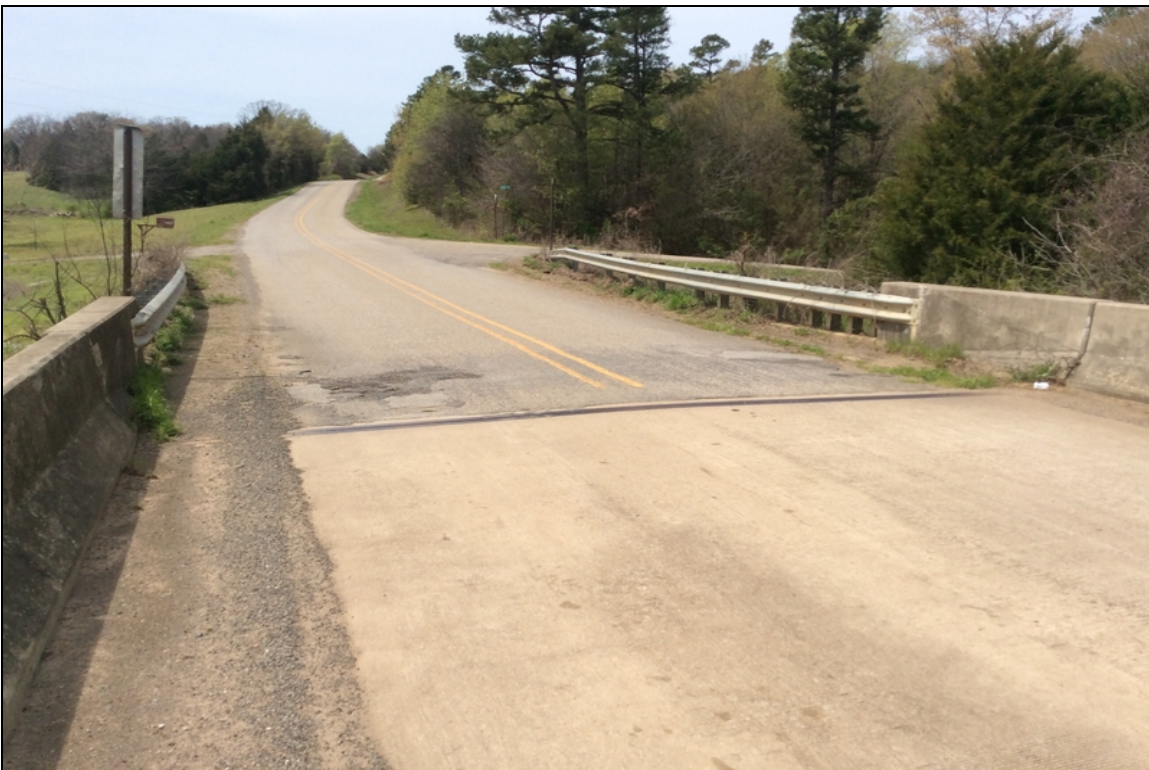
Potholes in the west approach roadway.

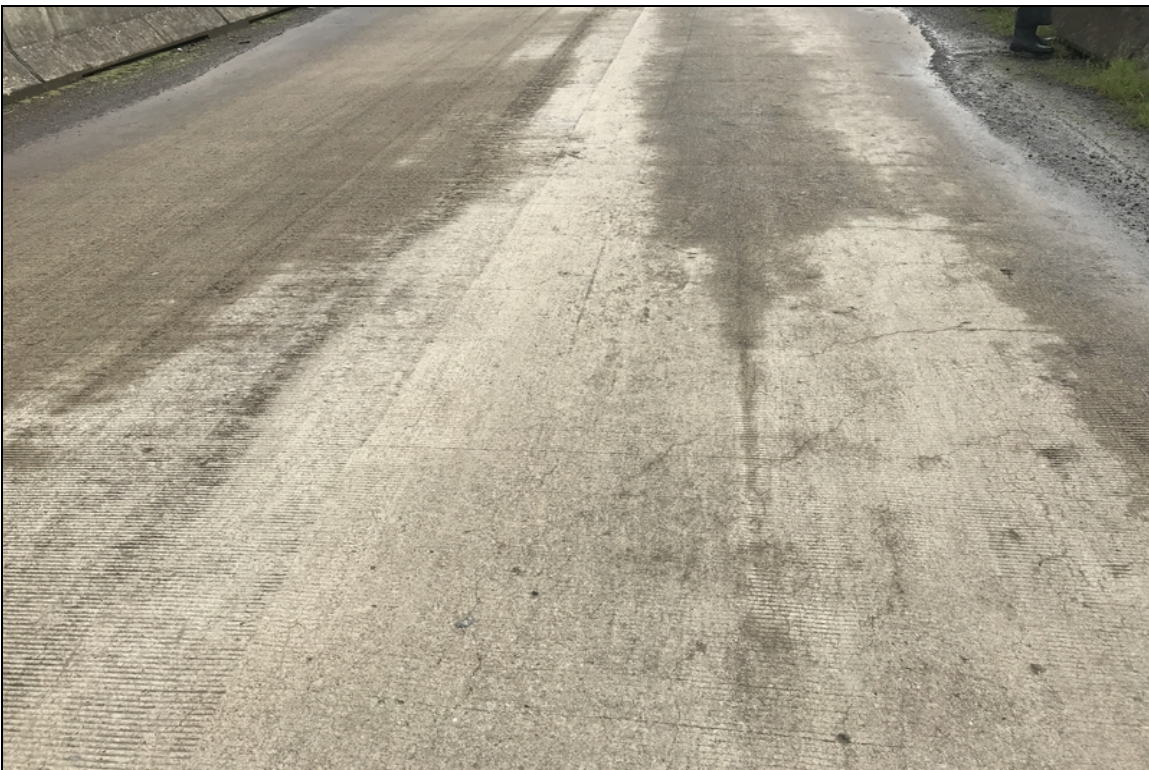
Random cracking in Span # 1.

Wearing Surface: Transverse cracking on the driving surface of the deck that ranges from 4' - 8' centers. There are areas with superficial hairline map cracking in the deck.

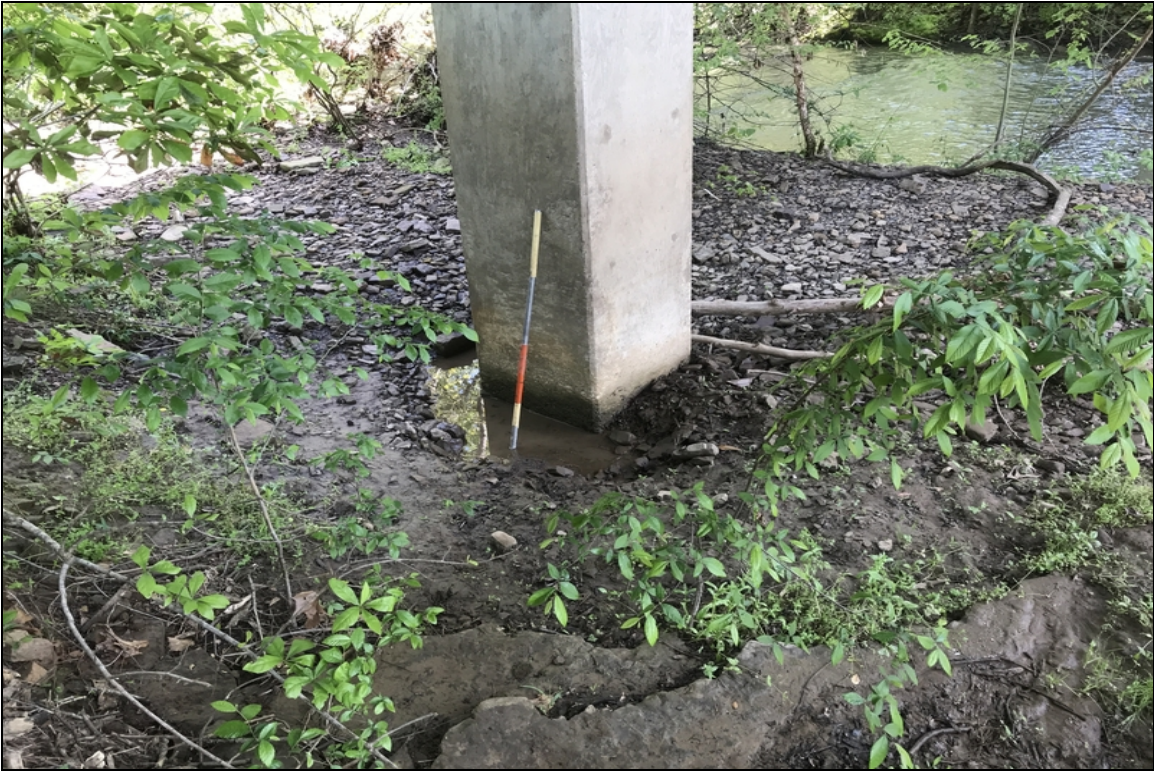
Bent # 2, Column # 1. Top of footing is partially exposed.

Underwater Inspection: Visual observation during low water conditions indicate that the top of Column # 1 footing of Bent # 2 is exposed but not undermined at this inspection. No apparent scour problems at this inspection.

04/20/2020 - JCJ & TJL - Type 2 Underwater Inspection conducted this date. Wading and probing during low and clear water conditions indicate that the top of the Left footing at Bent # 2 is exposed. All other footings have cover during this inspection.

Actual field measurement of 15'-5" from the top of Bent # 2 Left footing to the undersurface of the cap.
