Bridge 04586 Inspection Report

Asset #04586(Routine, Underwater type 2)

CR71-Graham Rd. over TWO PRAIRIE BAYOU

Team Lead: Bryan Saunders Inspection Date: 09/15/2022

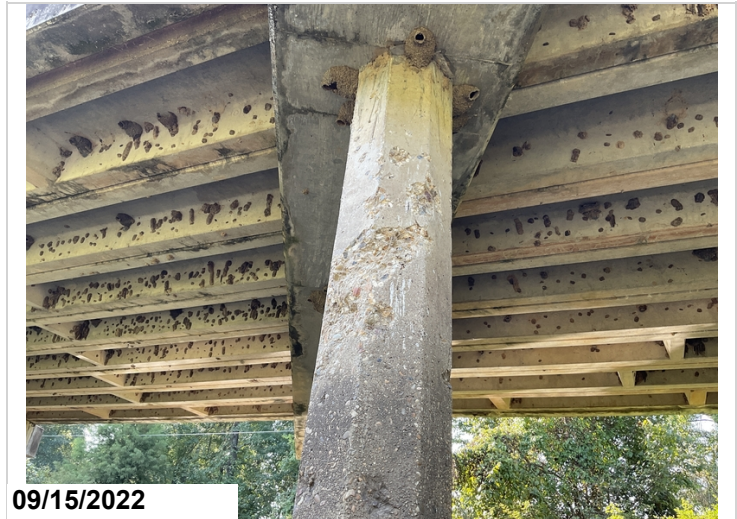
5 Piles of bents 3 4 & 5 have spalls due gun shots. See photo

Bent 4 pile 5 spalls from gun shots

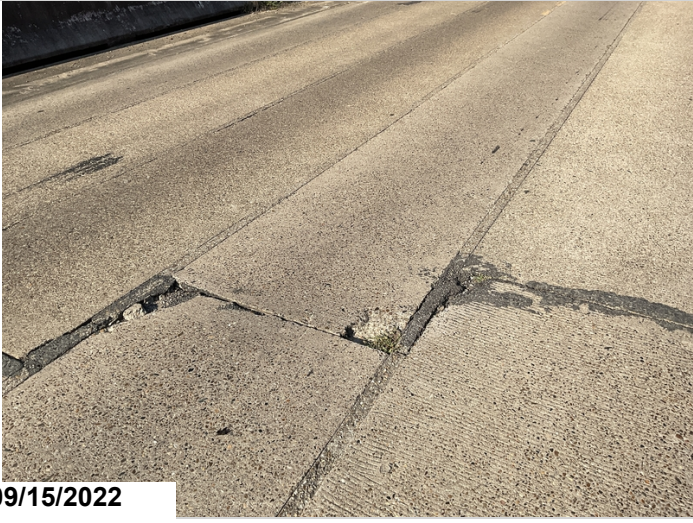
The ends channel units of all spans have small spalls and delaminations. See photo.

Bent 2 cap has four small contact spalls under unit 3 and 4

Bent 2 unit 4 and 5 have small spalls at the end of units
