Bridge #22256(Routine)

CR 180 Madison Co over DRAKES CREEK

Location: 2 MI S OF GEORGETOWN

Team Lead: Nathan Rowland Inspection Date: July 19, 2018

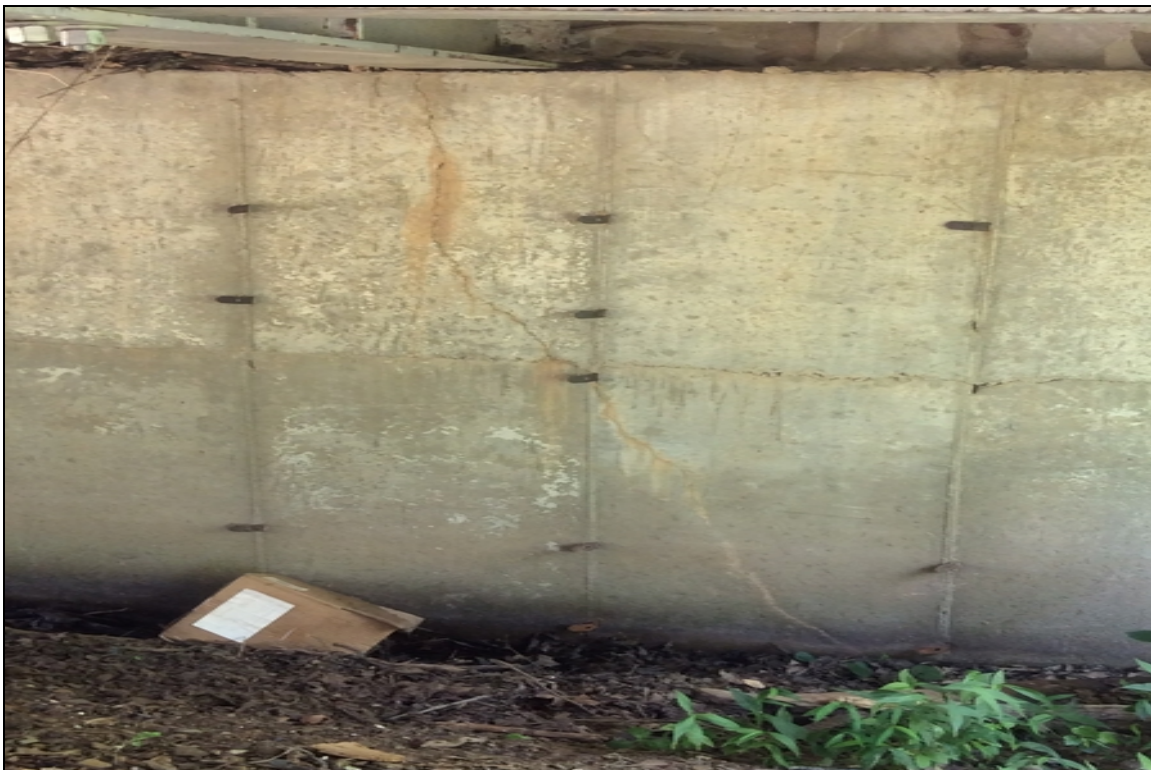
Abutment 2 under girder 3 has a large crack.

07/19/2018: -Abutment #1 (South abutment) has large spalls (approximately 16") in top of breastwall under girders #1, 3 and 4 with no exposed reinforcing steel and a large delaminated area under girder #2 approximately 24" long. The breastwall has vertical cracks under girders #2 and #3.-Abutment #2 (North abutment) has a full height diagonal crack under girder #3. - Abutment #2 has wide horizontal cracking in backwall between girders #1 and #2.

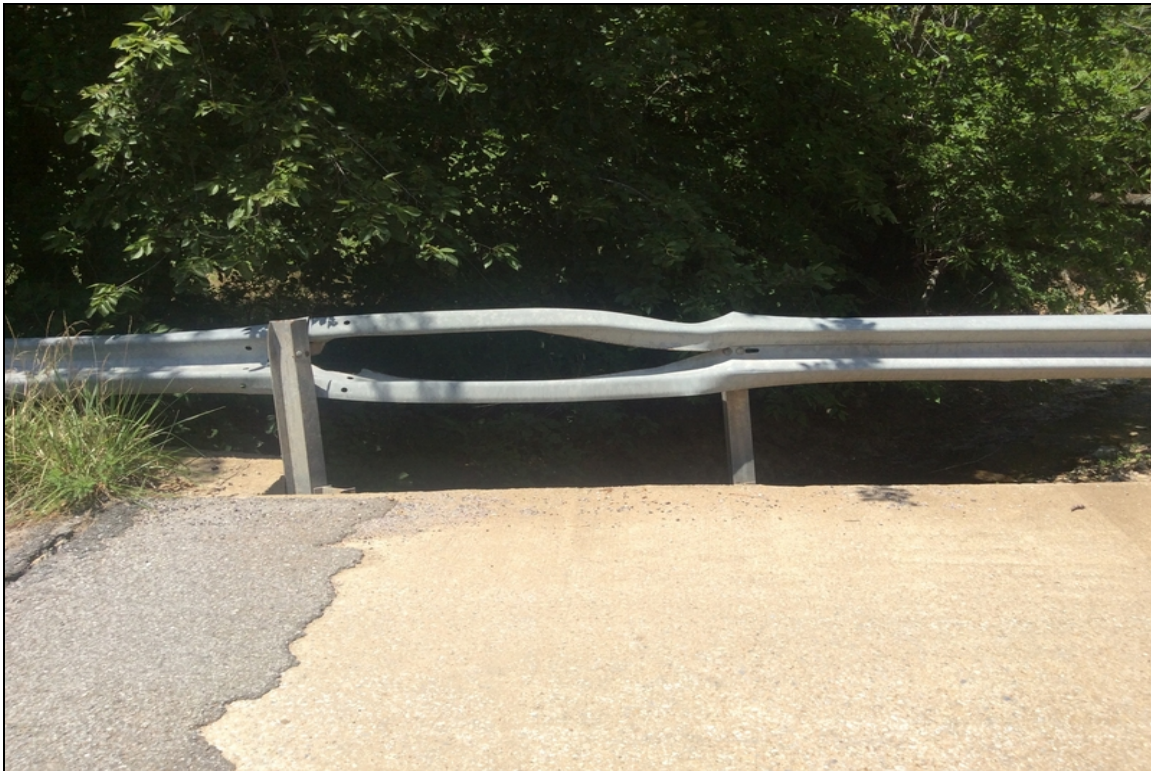
Railing left collision damage adjacent to abutment 1.

07/19/2018: -Right side bridge railing has collision damage near mid-span with out-of-plane bending to the railing and posts anchorage. The railing is not attached to posts #4.-The bridge railing on left side at abutment #1 has damage that has created a "rip" in the railing and caused a posts anchorage to fail.

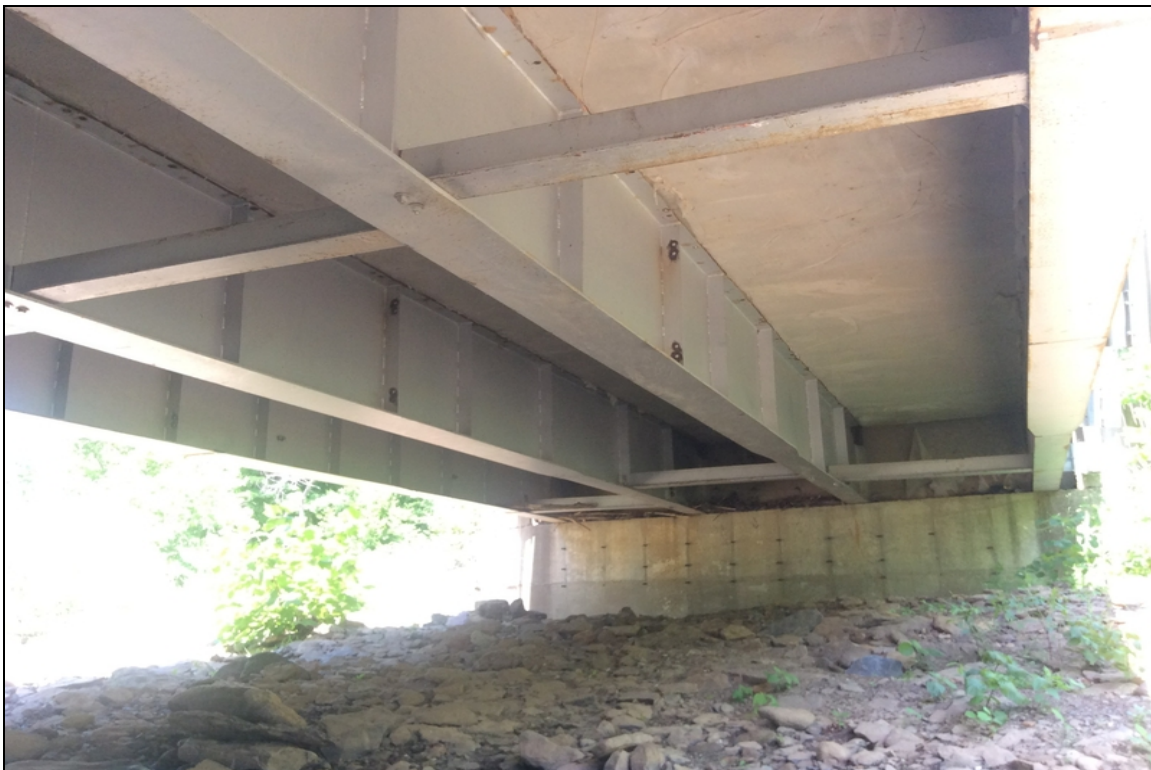
General view of superstructure.

07/19/2018: -The superstructure is constructed with salvaged beams. The paint system is beginning to fail in locations along the top flanges. -The superstructure has drift accumulation over abutment #2.

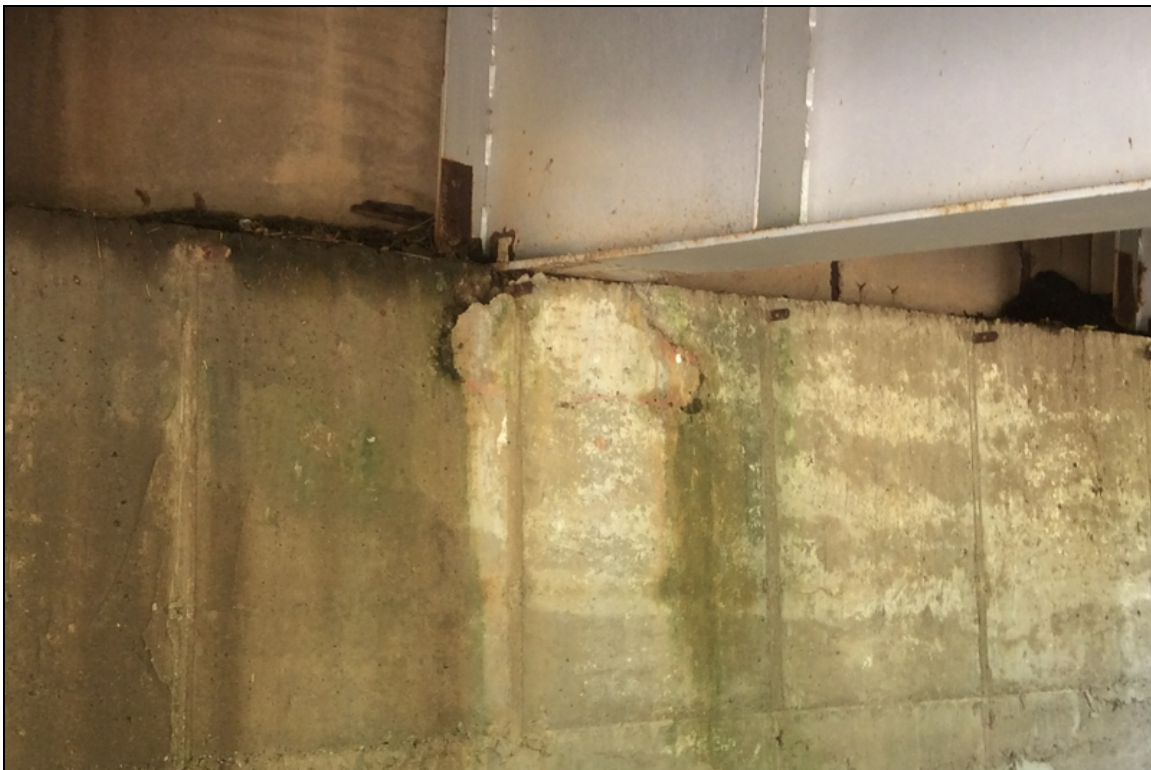
Abutment 1 girder 2 large delaminated area.

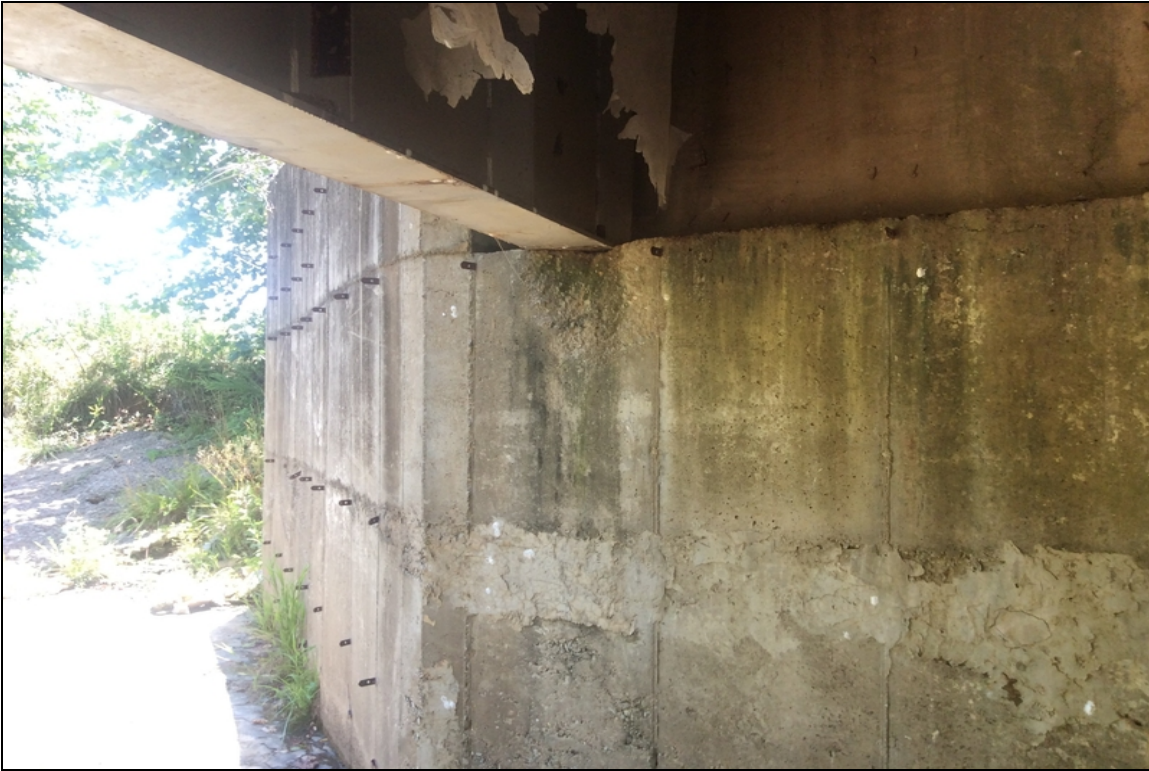
Abutment 1 girder 4 spalling.

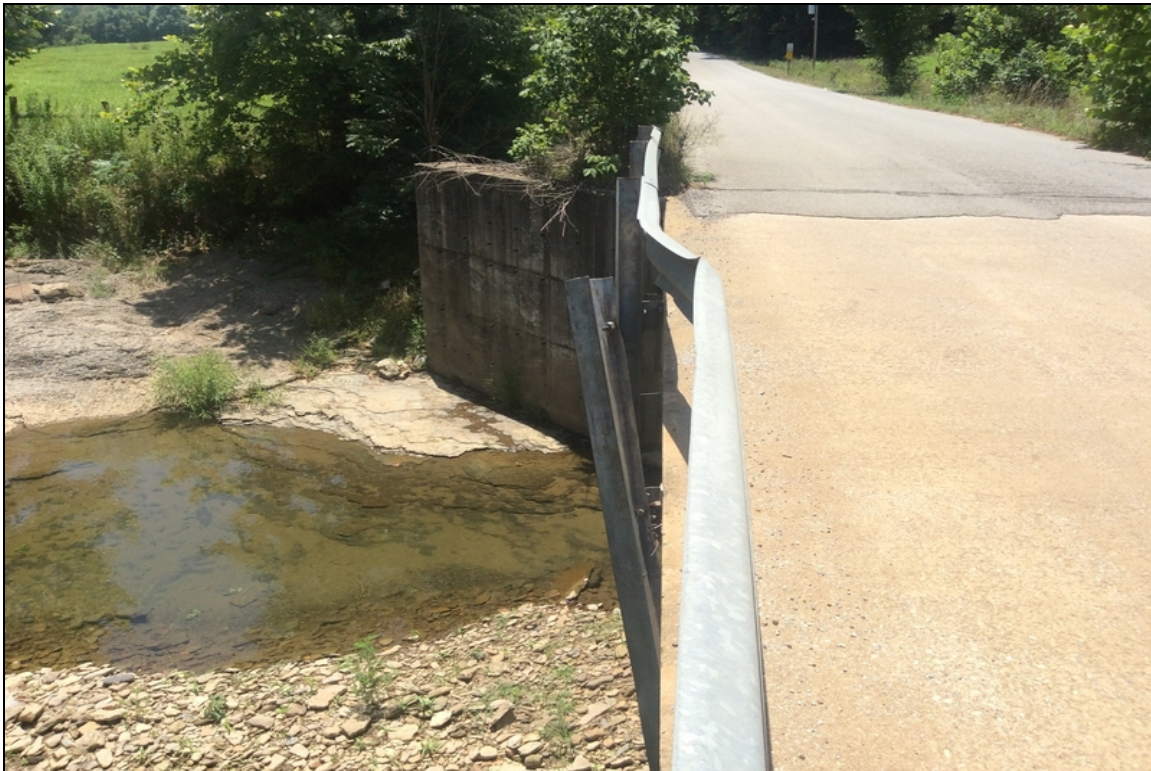
Railing right side collision damage post 4 near mid span.

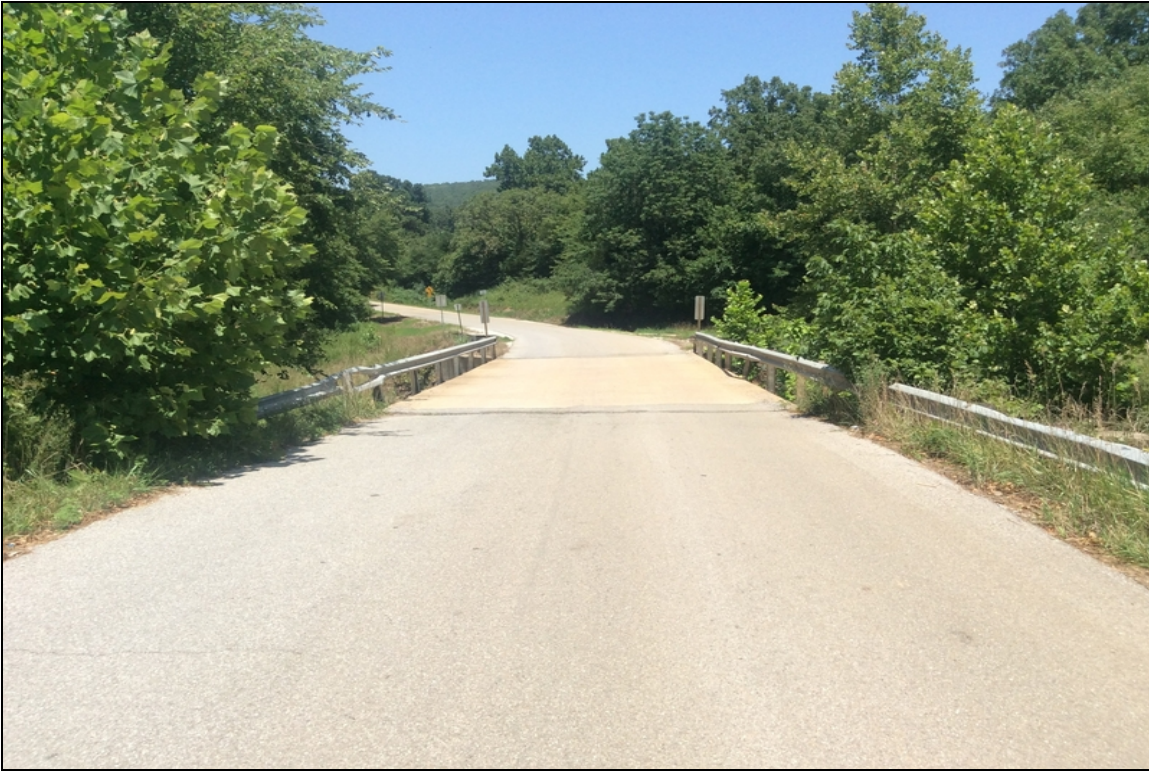
North approach flare boards are missing.
