Bridge #22420(Routine)

CR 180 Madison Co. over DRAKES CREEK

Team Lead: Nathan Rowland Inspection Date: September 12, 2019

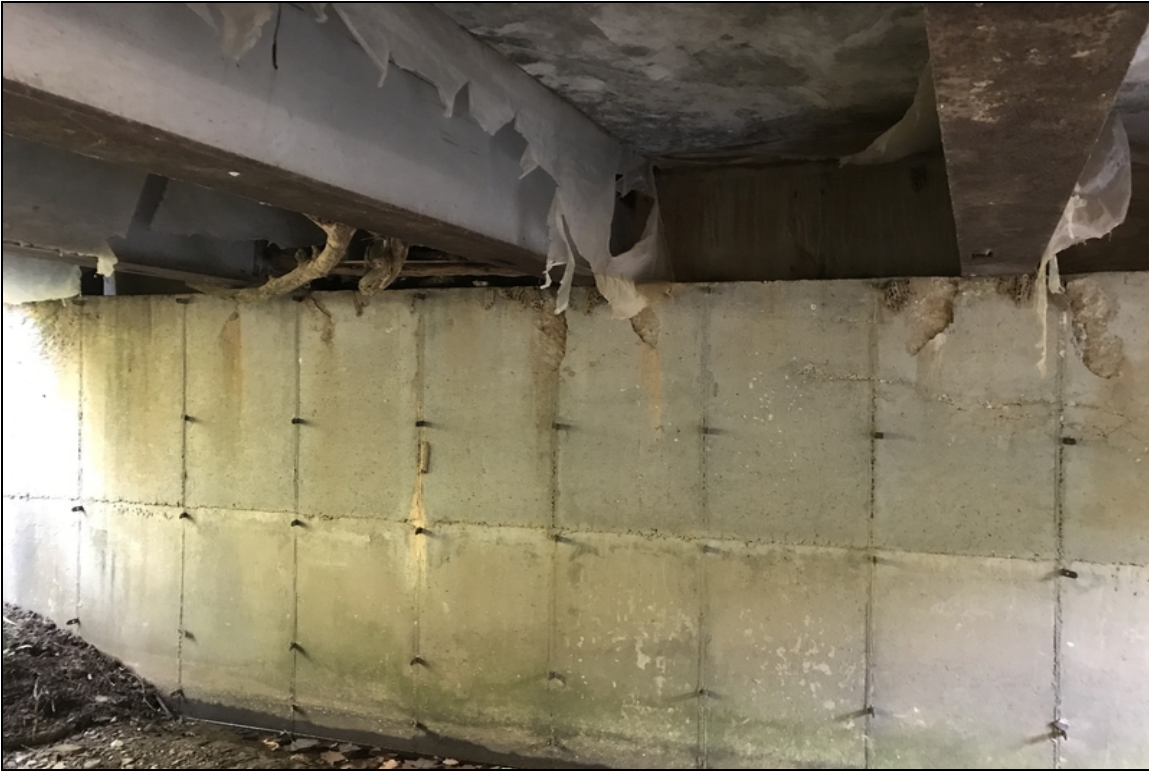
Abutment #1 Typical spalling and delaminated areas under girders.

- Abutment #1 breastwall has a basketball sized spall under beam #2, a 20" spall under beam #6 and large delaminated areas approximately 30" in diameter under beams #3, #4 and #5. The spall under beam #6 has caused approximately 4" of bearing area loss.
- The top of Abutment #1 (North) footing is exposed on left side with a few shallow voids along the edge of footing.
- Abutment #2 breastwall has large spalls that range in size from approximately 8" to 16" in diameter under beams #1, #2, #4, #5 and #6 and a full height vertical crack at centerline. The backwall of abutment #2 has a full height vertical crack in bay #2 and in bay #5.

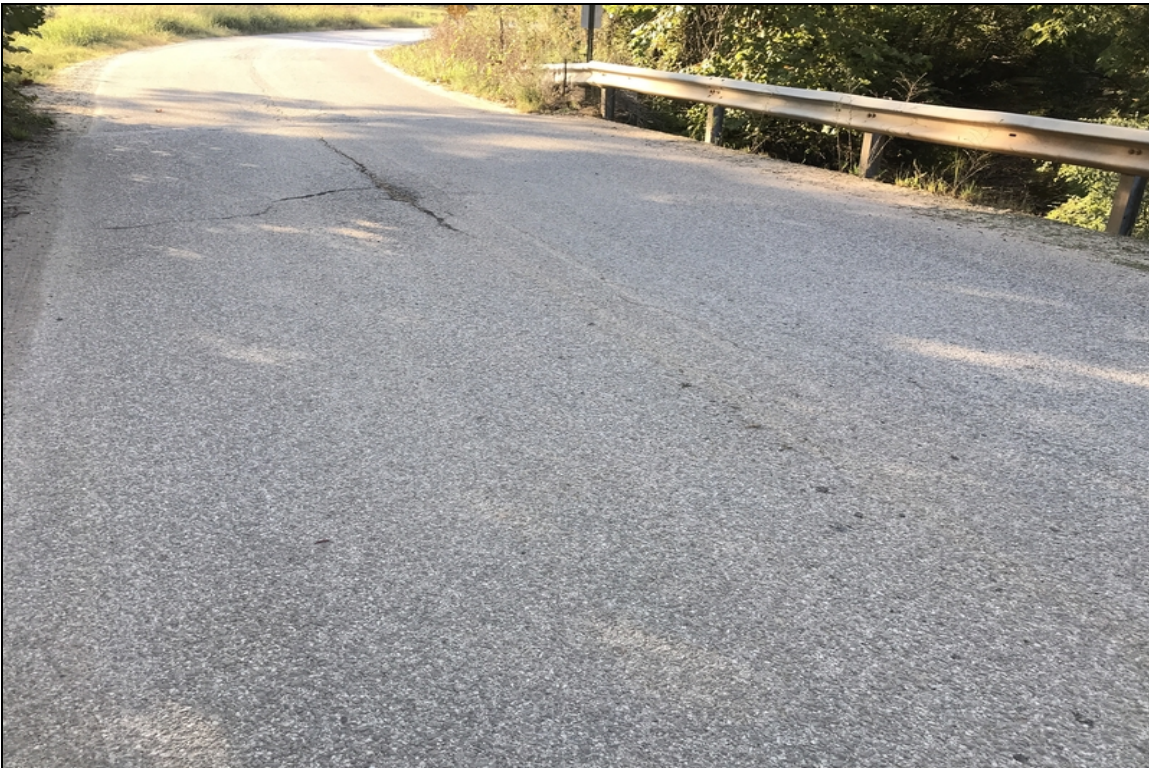
General view of deck.

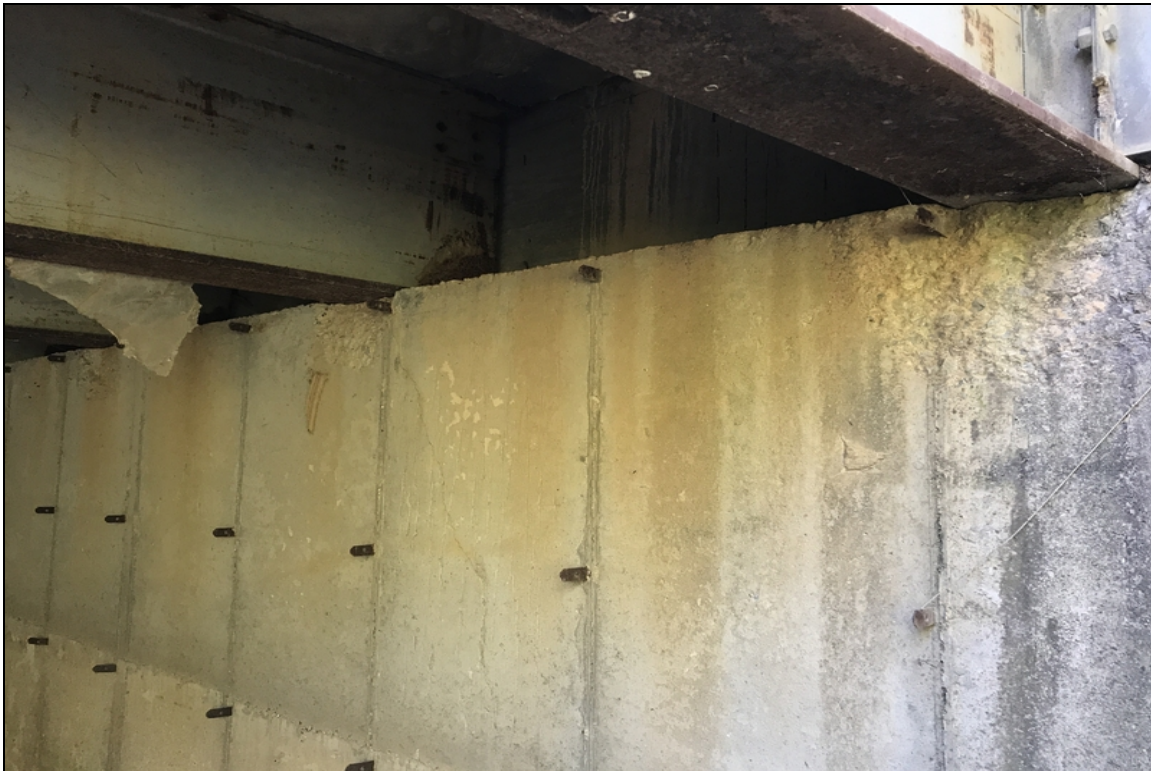
Top of Abutment #2 bearing area under Girders 4 - 6 spalling.

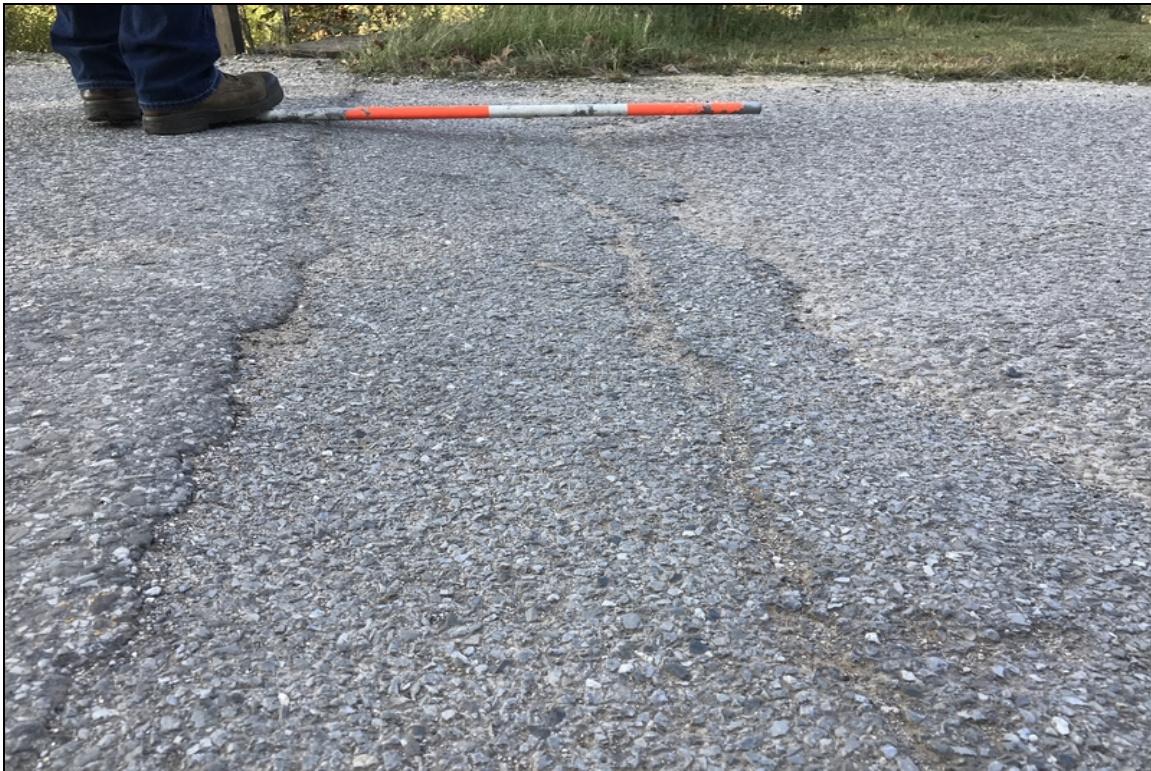
Typical settlement of north approach roadway

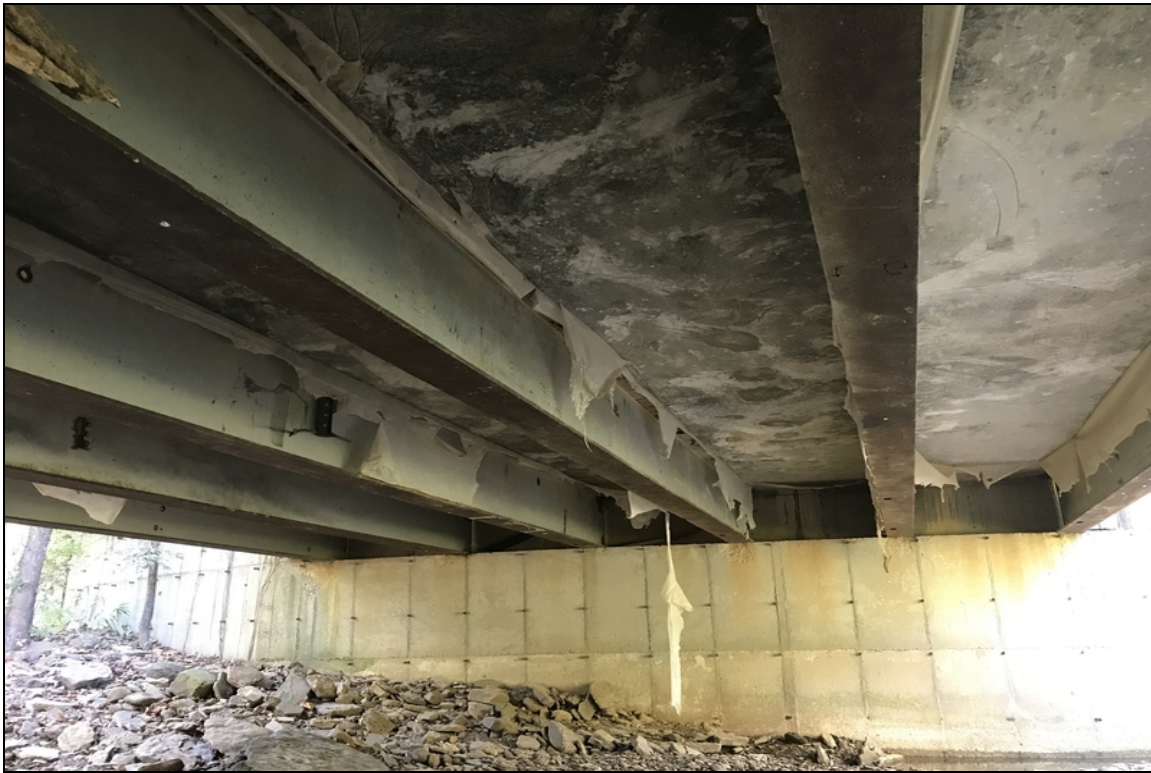
General view of superstructure

09/12/2019 - WNR & DBM:-The superstructure appears to be constructed from salvaged beams with old diaphragm connections left in place and torch cut holes in the bottom flanges of beams in random locations. -The ends of girders over both abutments have old section loss scars with a few small holes in the webs that appears to be from when they were part of a previous structure and are the "as-built" Condition of this structure.-The undersurface of the bottom flanges have a rust coating throughout. The webs and top flanges of beams have rust forming in several locations.-Beam #1 bottom flange has drilled holes throughout.

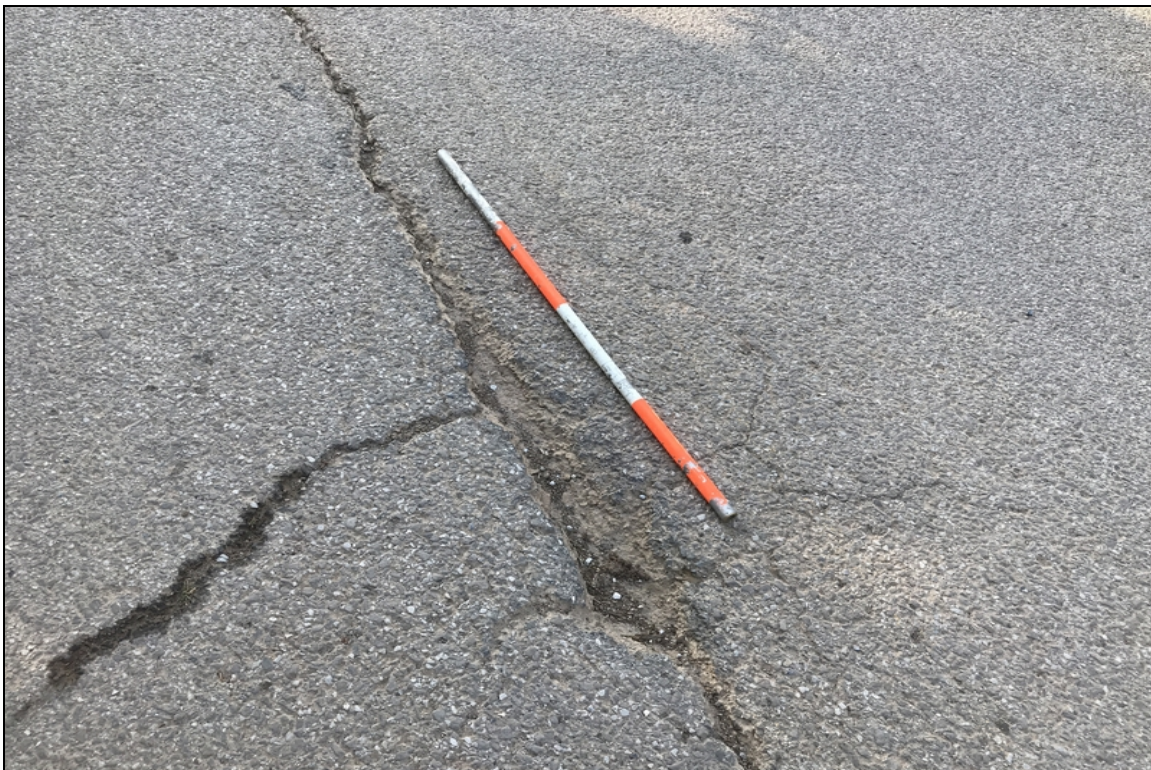
Cracking and spalling of asphalt wearing surface has caused a pothole near centerline of roadway.

- The driving surface of the deck has an ACHM overlay. The driving surface has longitudinal cracking at centerline where a pothole has formed and a transverse crack in the Northbound lane near the South bridge end.
- The undersurface of the deck is partially covered with visqueen. Areas that appear to be superficial mapcracking visible in locations.
- The North and South approach roadways have approximately 2" of settlement at the bridge ends. Maintenance forces have placed asphalt shims at the bridge ends.
