Insp. JEF & HGJ  
Date 09/25/2013  
Dist. 09 Co. 44/Madison

Rt.0180

Sec. 00/F Log 05.250

Br. # 22420

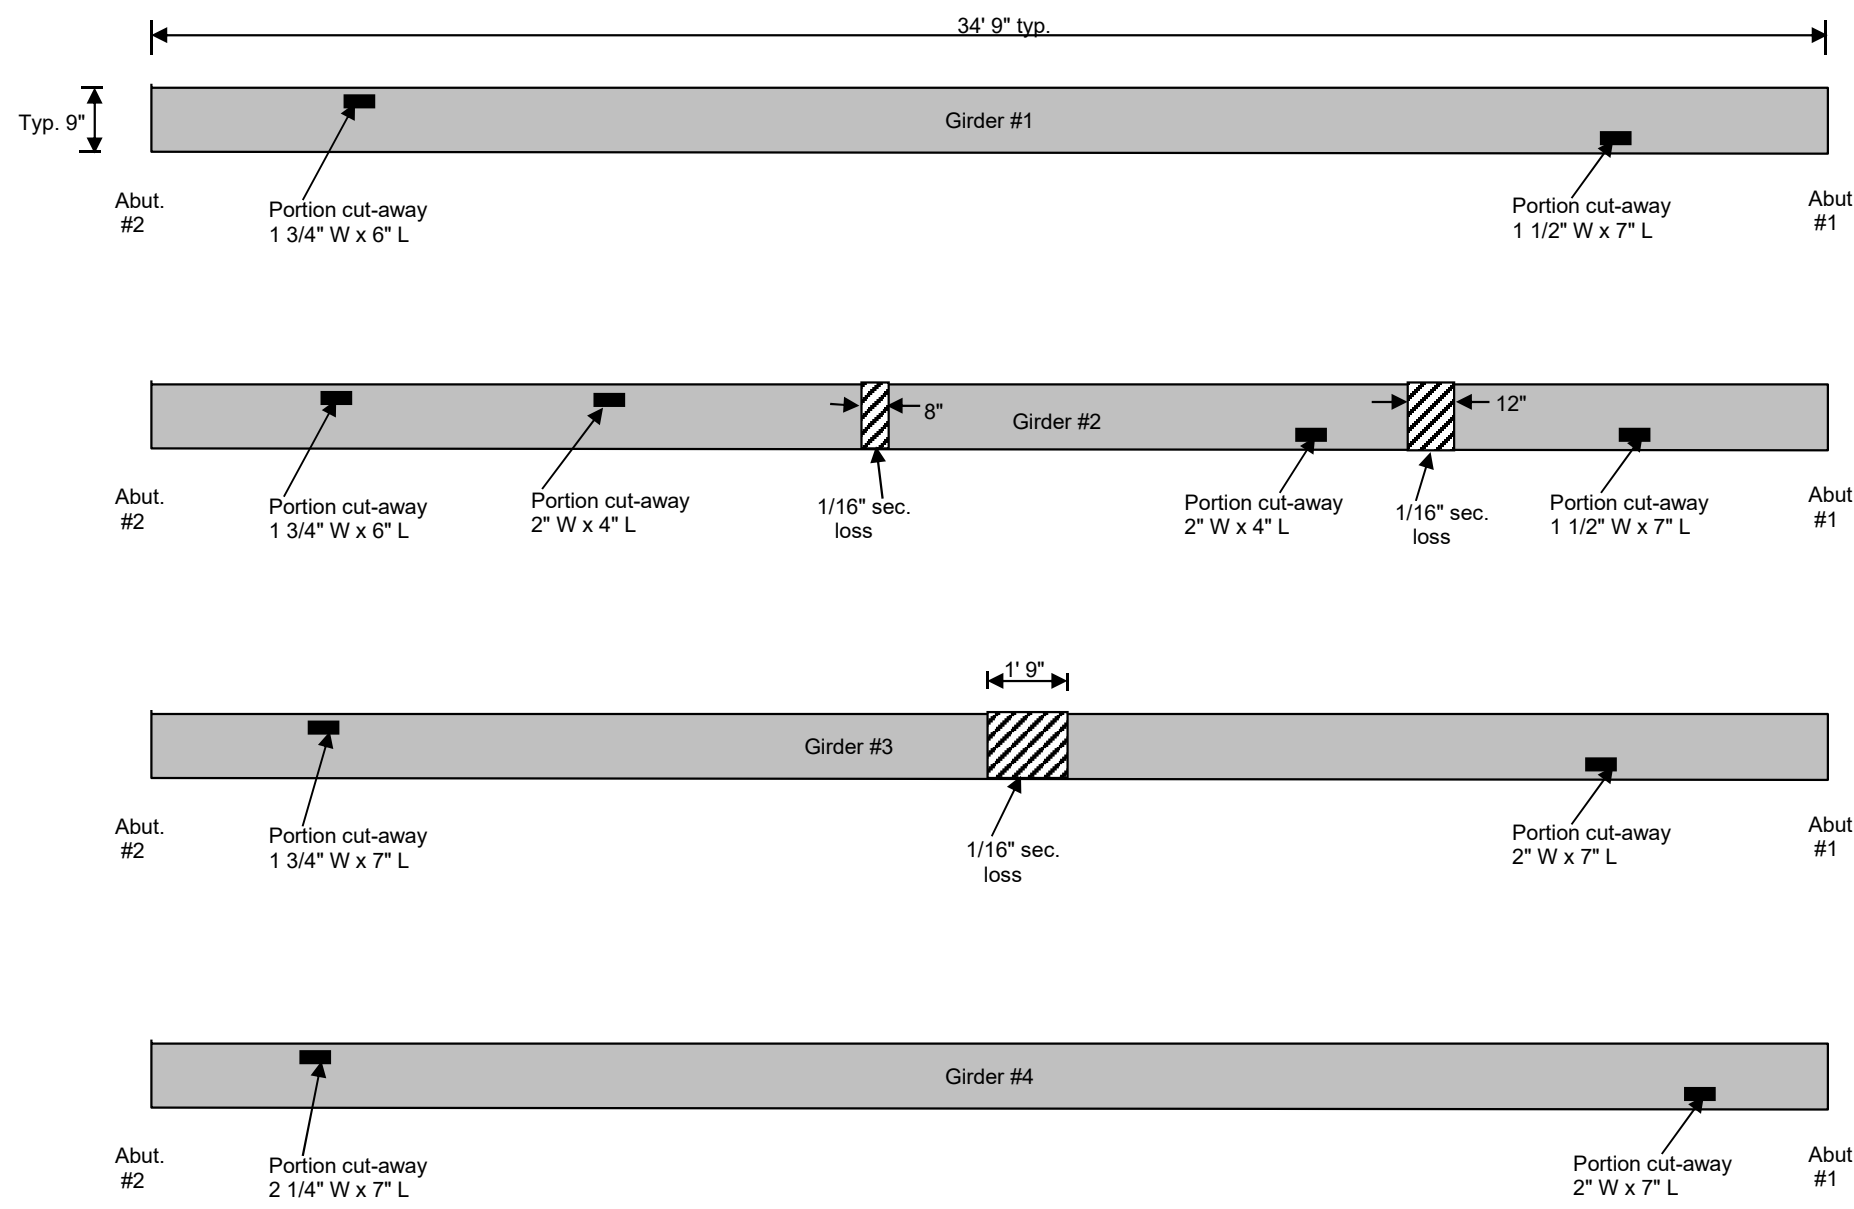
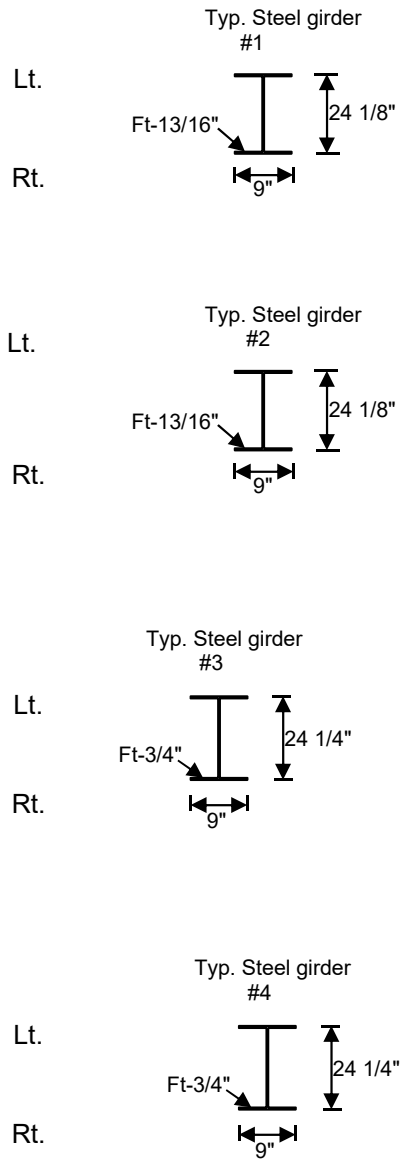
Looking up at Bottom Flange of girders  
showing portions cut-away and section loss  
[ As built condition ]

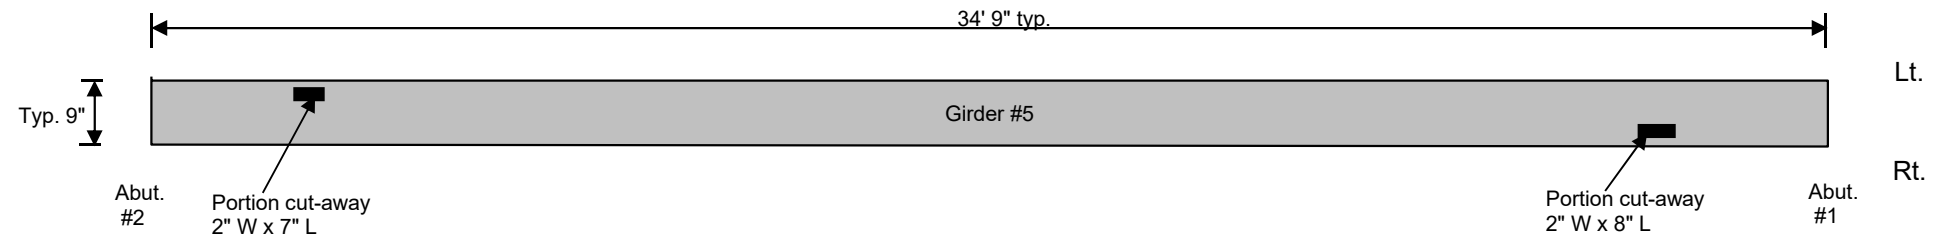
Looking up at Bottom Flange of girders  
showing portions cut-away and section loss  
[ As built condition ]
