Asset #04499(Routine)

CO RD 13 -D- 2.60 over BEECH CREEK

Location: 2.6 MI S JCT SH 196

Team Lead: Jared Kegley, Inspection Date: 08/01/2023

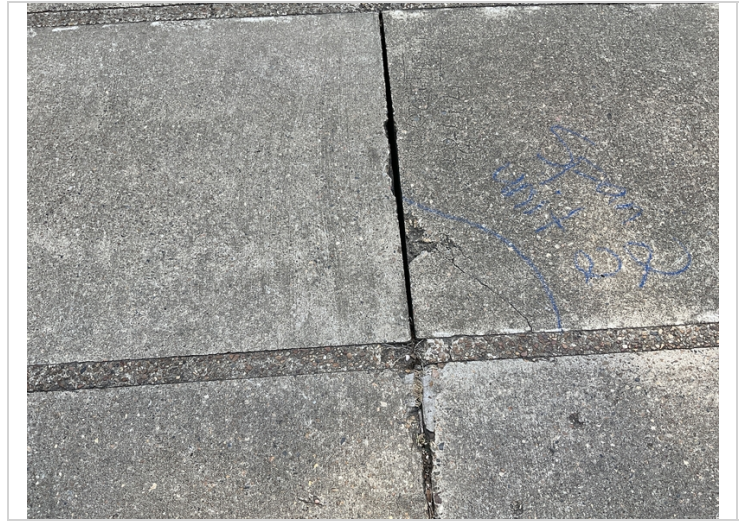
Joints on this bridge need to be cleaned out and poured back, some joints have material completely missing others have lack of seal adhesion.

Joints need to be cleaned out from debris and reported back

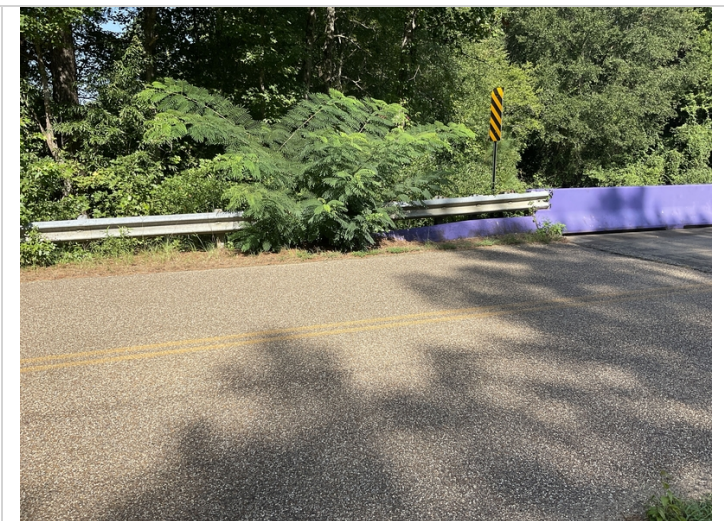
Maintenance need was created on this due to priority code C update because of vegetation encroachment upon bridge on both ends.

Updated brush photo 8/23 brush now on top of bridge

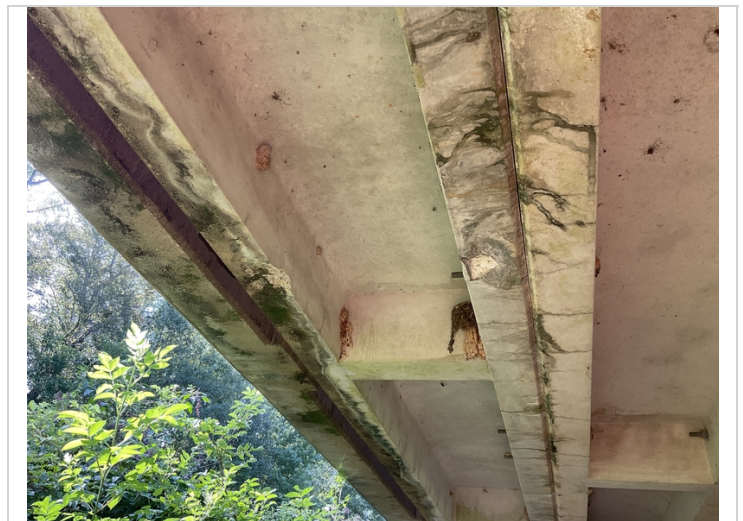
Superstructure is rated a 7 due to minor flexural cracks in stems of all units, 2 spalls in span 5 unit 1 near bent 5.

Span 5 unit 1 has two delams

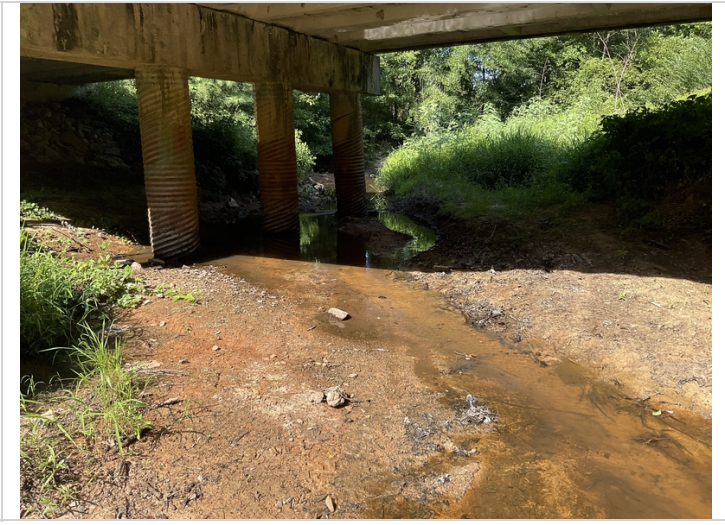
Upstream channel

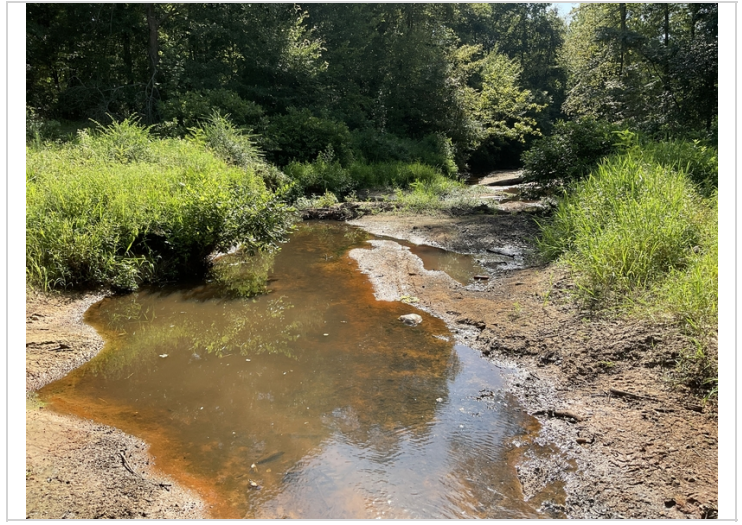
Down stream channel

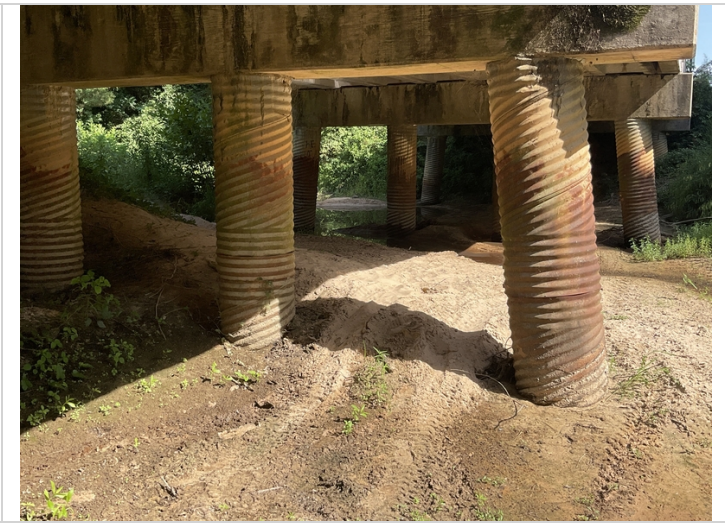
Scour is rated a 6 this inspection due to minor scour hole at beginning of bridge right side, Ground is mostly sugar sand and is eroding in one area and filling in another area as shown in the picture below.

Scour hole is in spans 2 and 3 and around bent 2.

Scour hole beginning of bridge right side

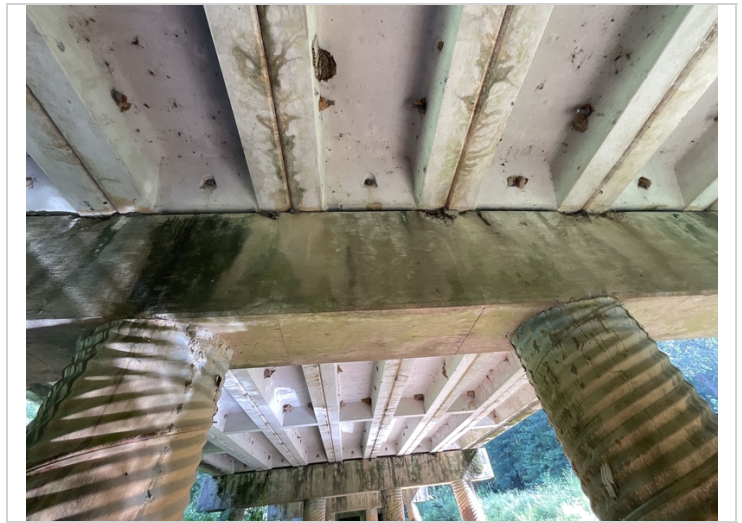
Substructure is rated a 7 this inspection due to spalls on concrete caps at bents 3 and 5. All piling has been encased in metal culvert pipe and showing signs of corrosion on casing.

3 spalls on bent 5 cap south face

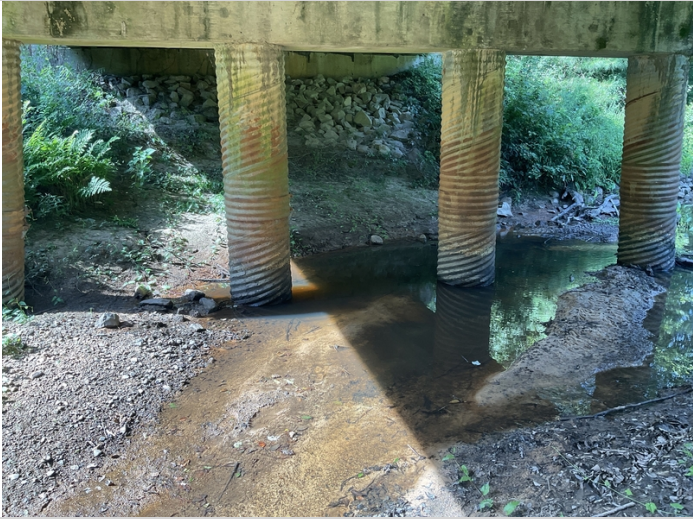
All piling have been encased by steel culvert pipe and beginning to show signs of corrosion

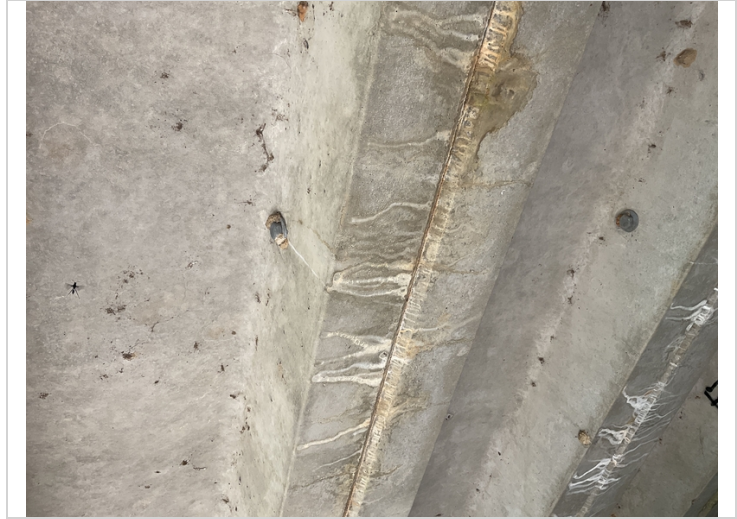
Salt leeching through all joints underside of deck

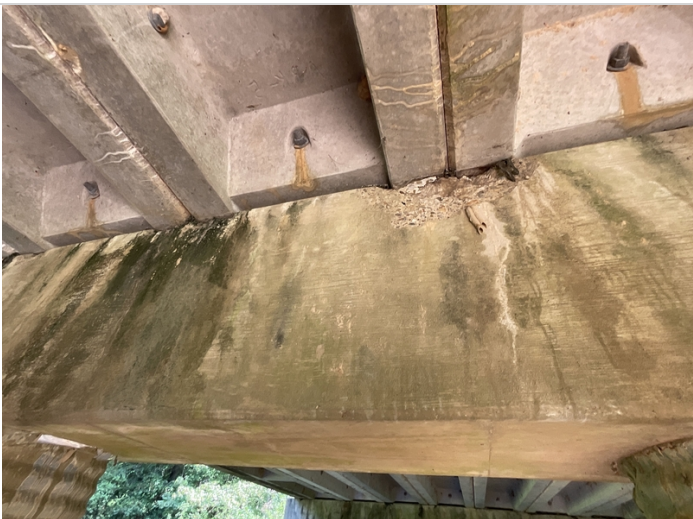
2 spall bent 3 cap south face

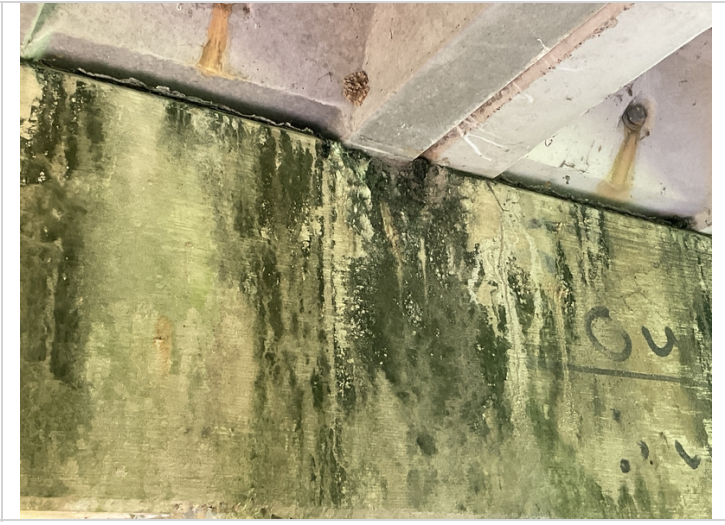
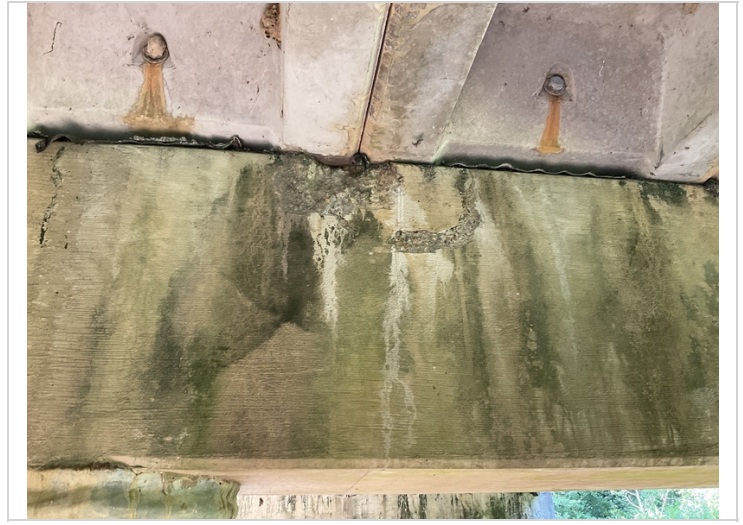
Spall bent 3 north face of cap

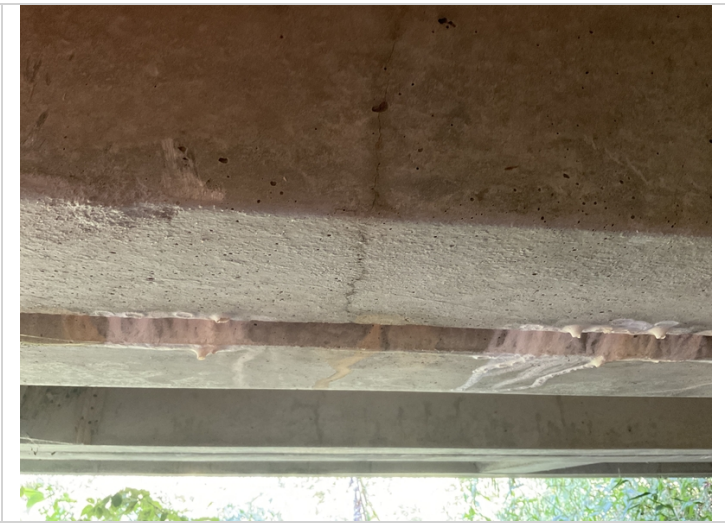
Minor cracking in various locations on underside of precast units

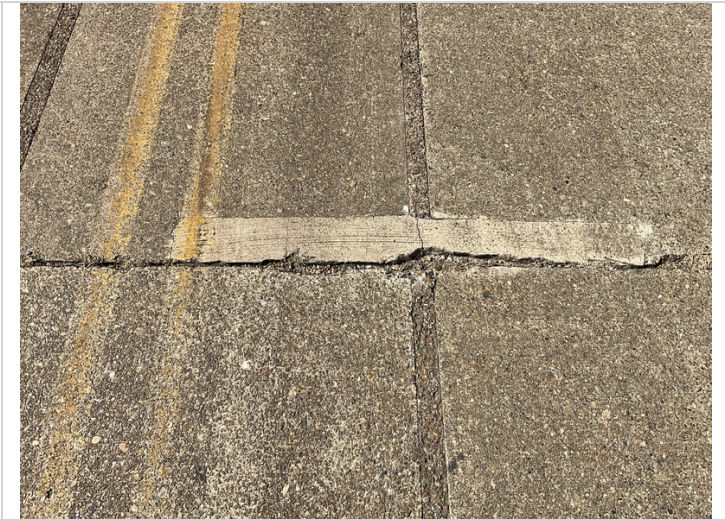
Deck is rated a 7 this inspection due to minor cracking, minor delams, old patch work and abrasion on top flange.

Some small old patch work in various locations

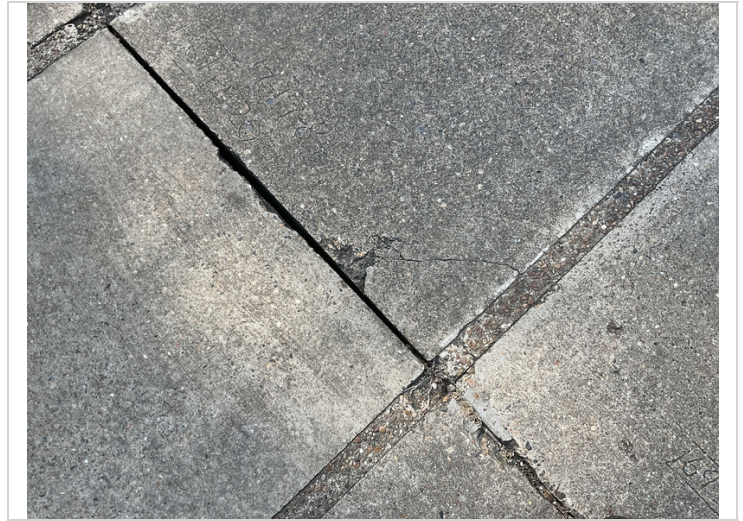
Some cracking in precast units various locations on deck

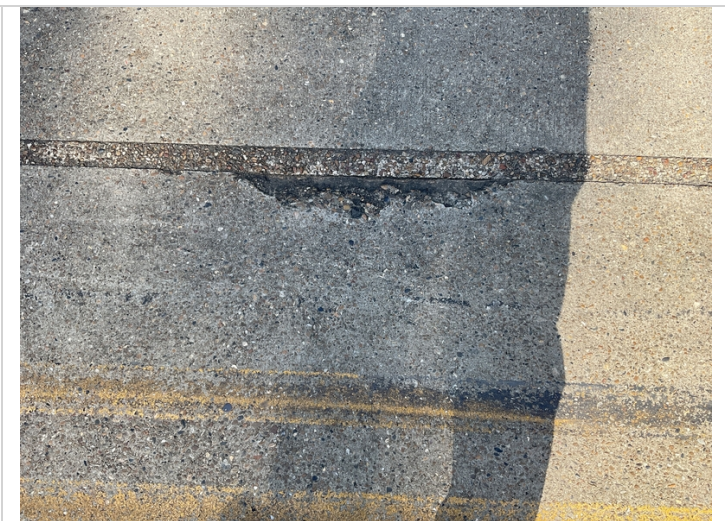
Minor delams in various locations

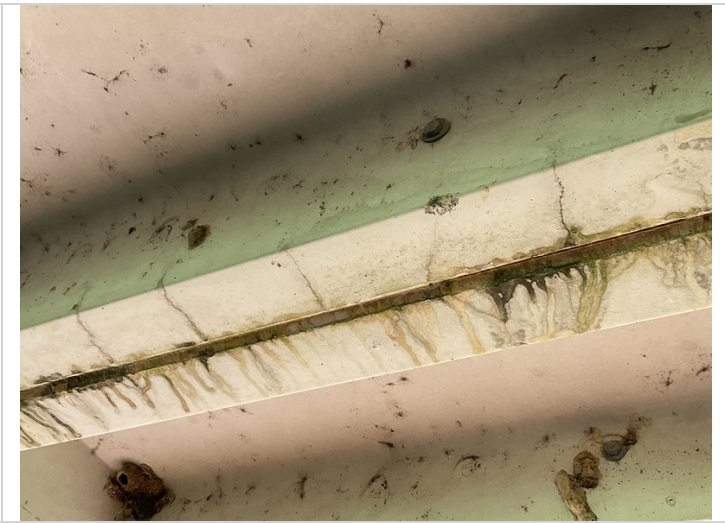
Cracks in bottom of precast units various locations of all spans

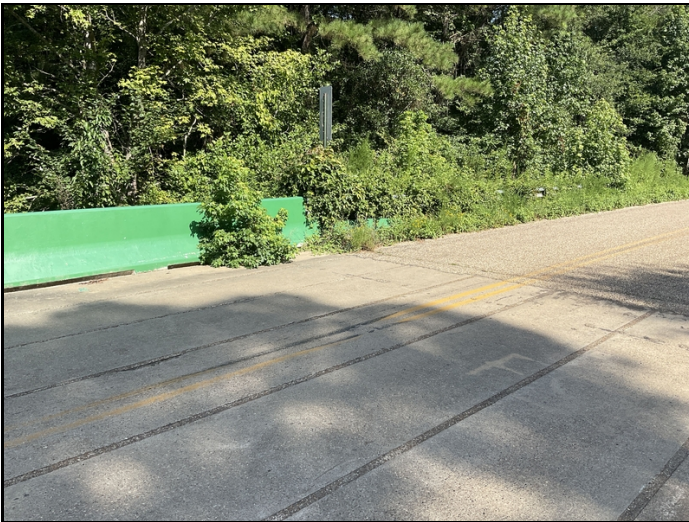
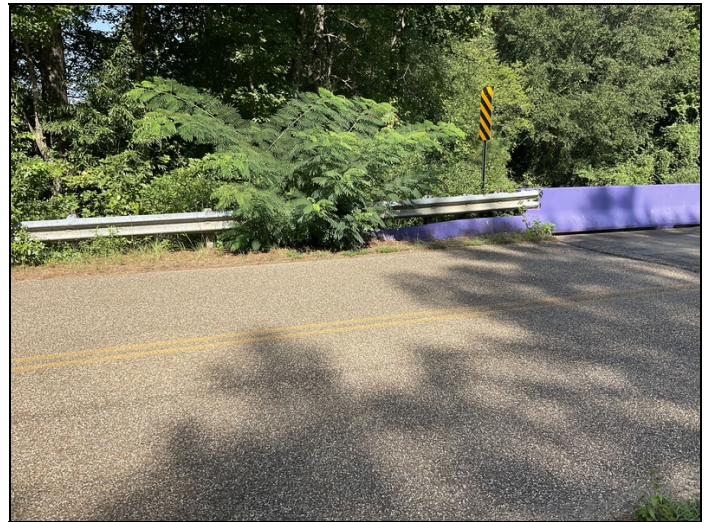
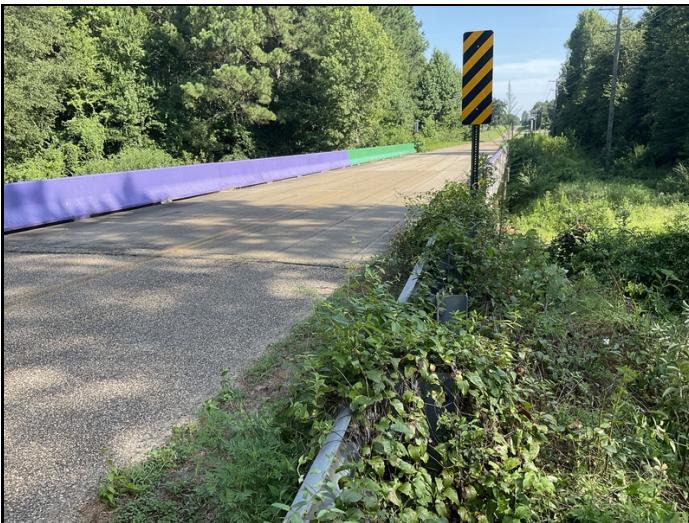
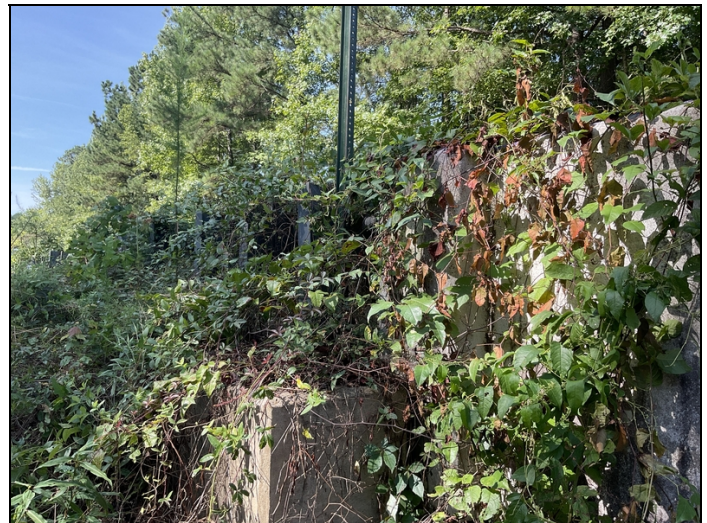
Trees and brush growing along and under bridge.

Updated pictures in 2023 inspection. brought priority code from a D to a C due to the vegetation is now encroaching onto the bridge itself and up around the guard railing. reopened maintenance need to show the change in priority code.

Updated brush photo 8/23 brush now on top of bridge

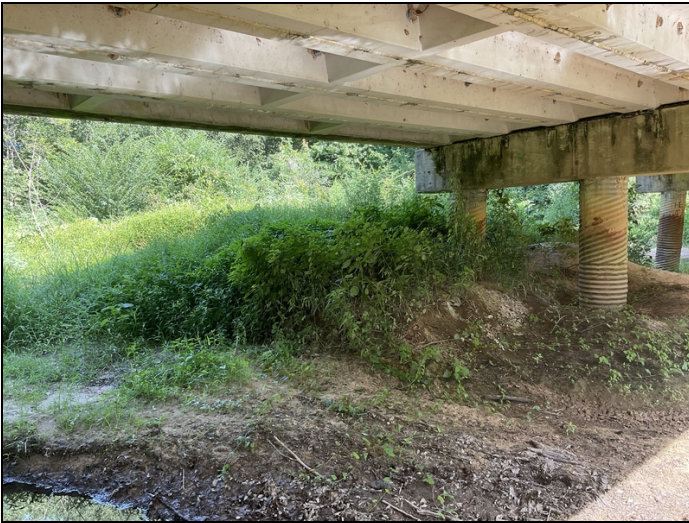
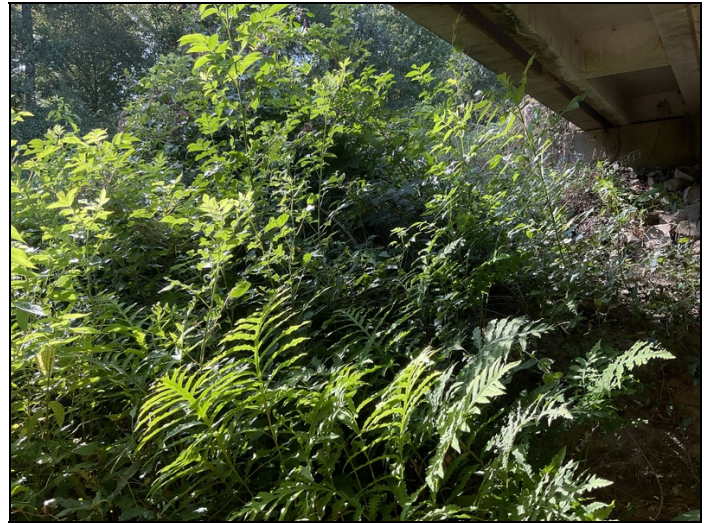
Updated brush photo 8/23

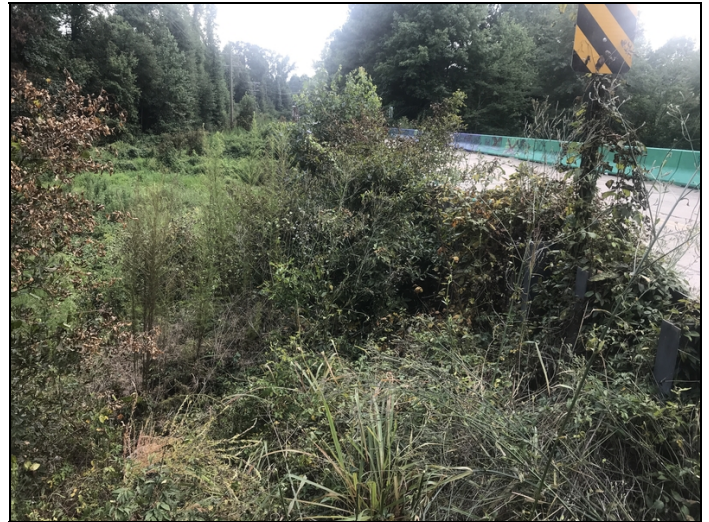
Trees and brush growing along and under bridge.

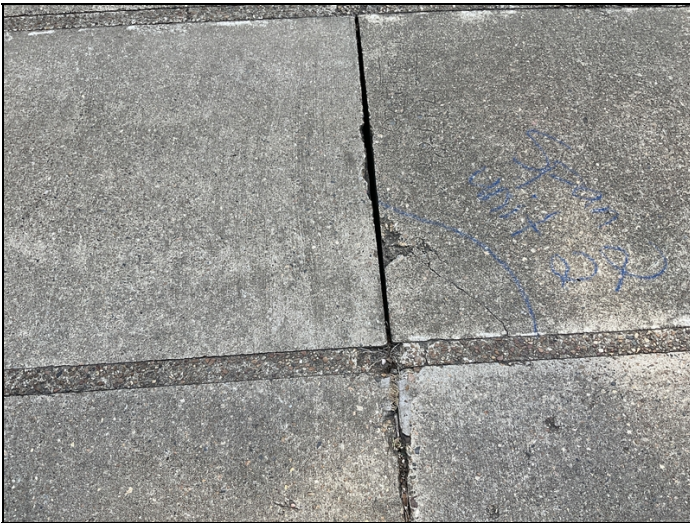
Joints on this bridge need to be cleaned out and poured back, some joints have material completely missing others have lack of seal adhesion.

Joints need to be cleaned out from debris and reported back

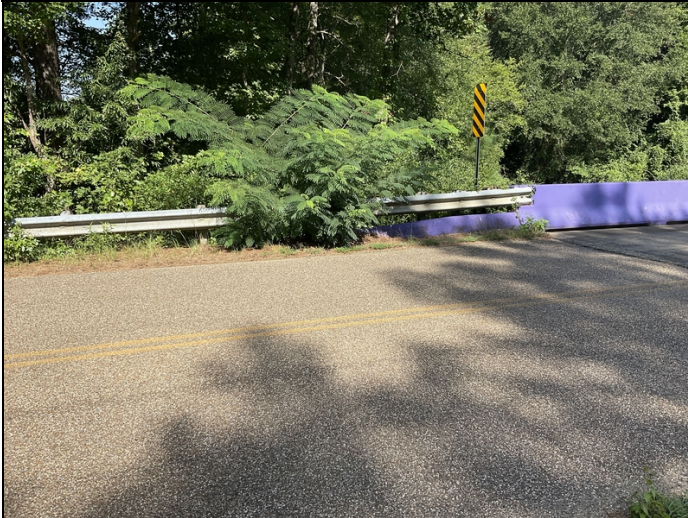
Maintenance need was created on this due to priority code C update because of vegetation encroachment upon bridge on both ends.

Updated brush photo 8/23 brush now on top of bridge
