Asset #06786(Routine)

C.R. 26 ZONE -E over I 49 N.B. & S.B LNS

Location: 5.0 MI. NO. OF FOUKE

Team Lead: John King, Inspection Date: 04/03/2023

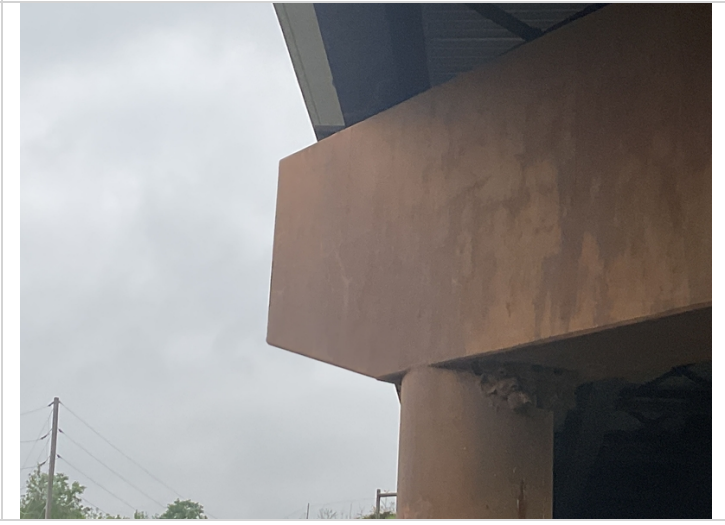
(234) Small hairline Cracking in bent 3 cap Map like hairline cracking in bent 4 cap							
303	Assembly Joint with Seal	LF	95	95	0	0	0
310	Elastomeric Bearing	EA	20	20	0	0	0
331	Reinforced Concrete Bridge Railing	LF	1050	200	800	50	0
1120	Efflorescence/Rust Staining	LF	300	0	300	0	0
1130	Cracking (RC and Other)	LF	550	0	500	50	0

Map like hairline cracking bent 4

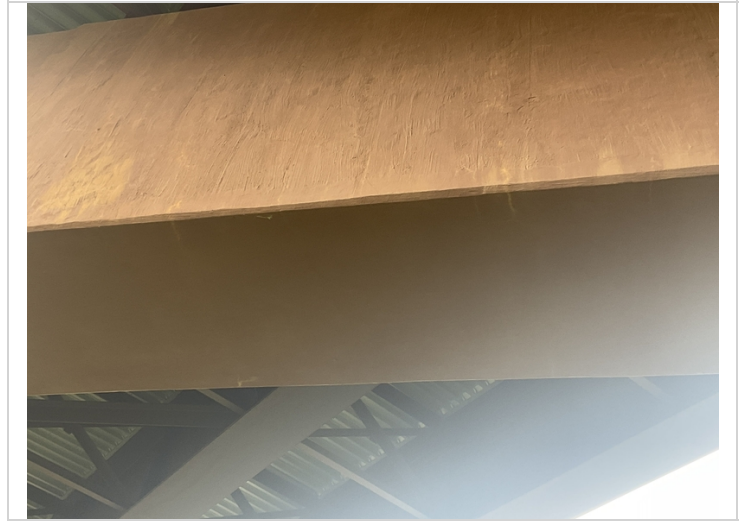
Small hairline cracking bent 3 cap

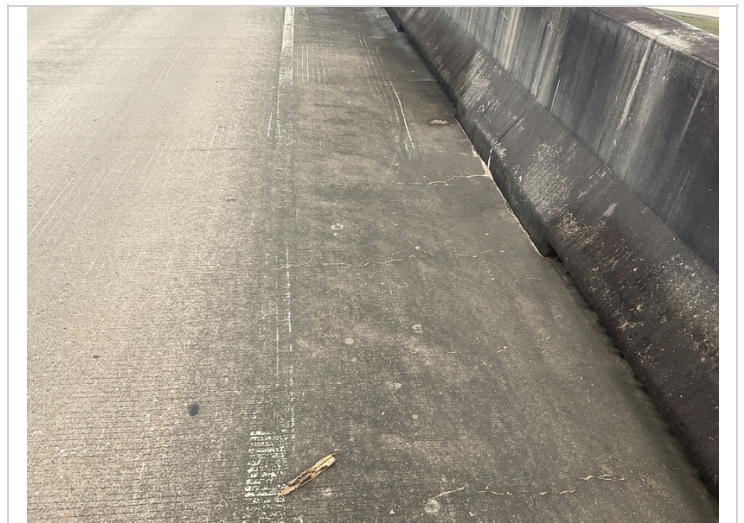
04/2023 bridge deck has crack to top side and deck pans on bottom side. may look at polymer overlay...

Polymer overlay candidate

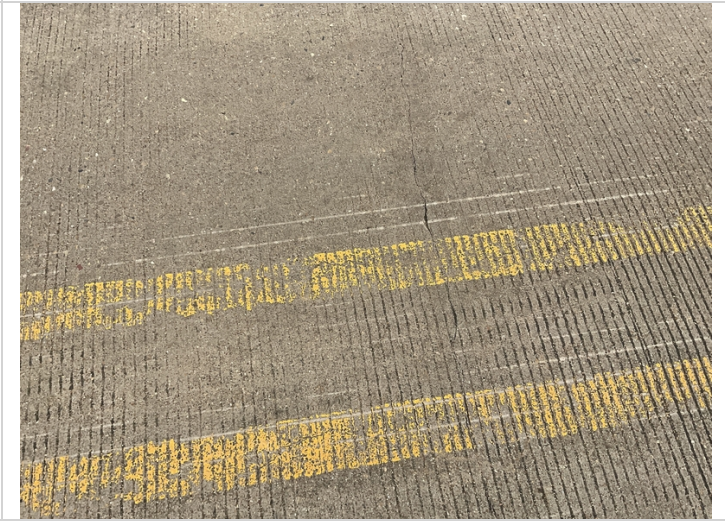
Cracking in deck various locations

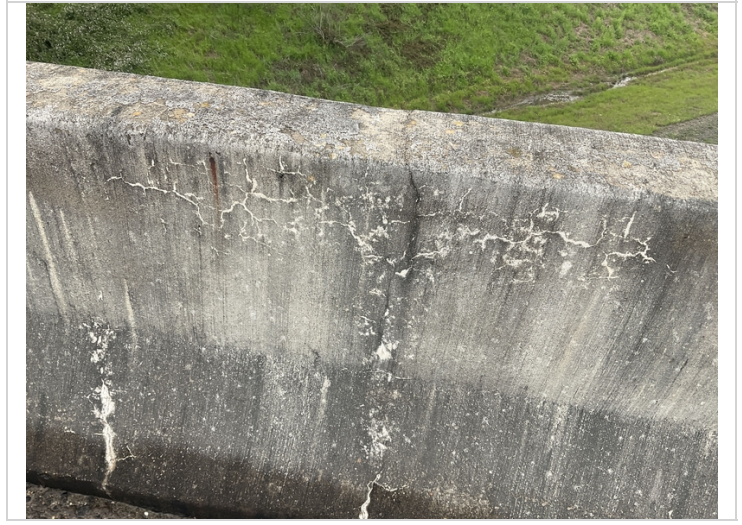
(331) Cracking in concrete bridge railing in various locations Efflorescence in various locations of bridge railing Some efflorescence is maplike across various locations.

Map like efflorescence in concrete bridge railing various locations

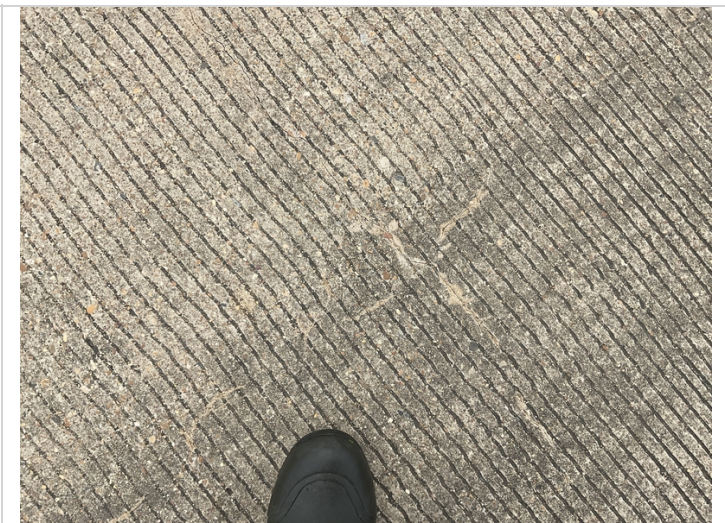
Cracking in deck

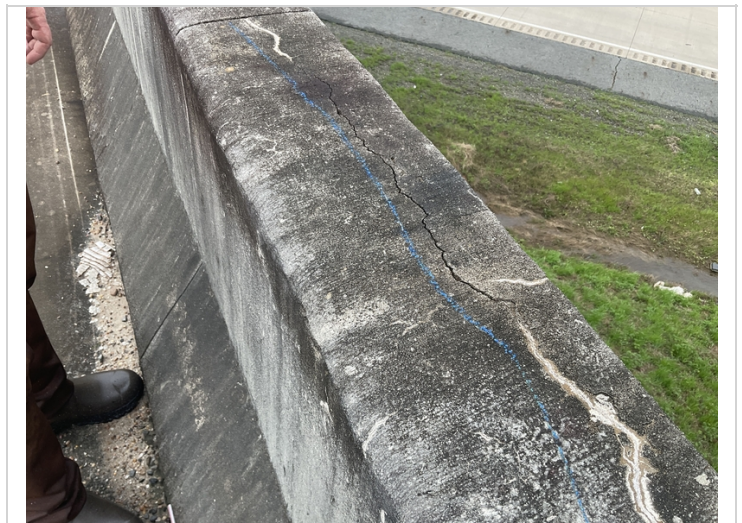
Cracking in concrete bridge railing various locations

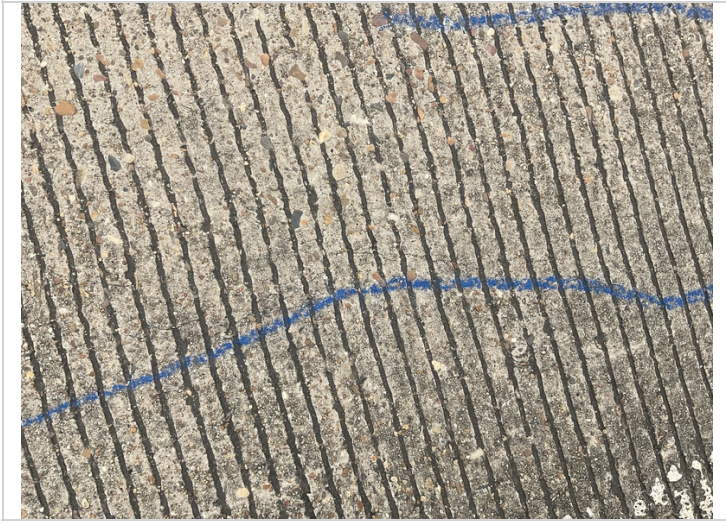
rated a 7 Due to minor cracking in deck, Minor efflorescence and cracking in deck overhang

Minor cracking in deck various locations

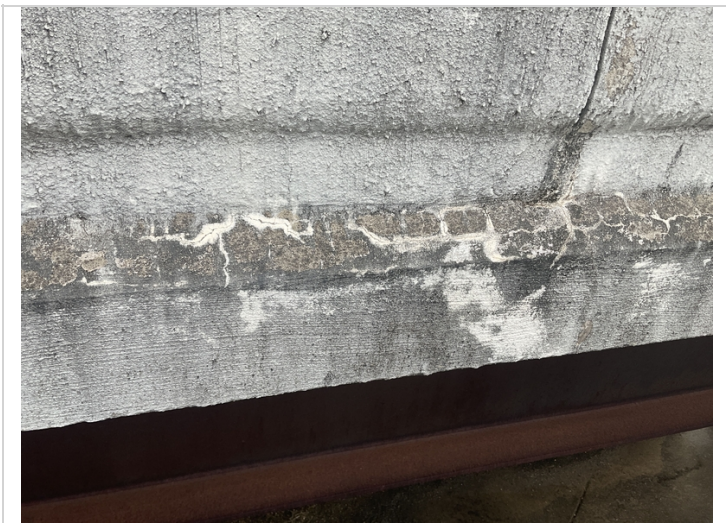
Efflorescence in concrete bridge railing various locations

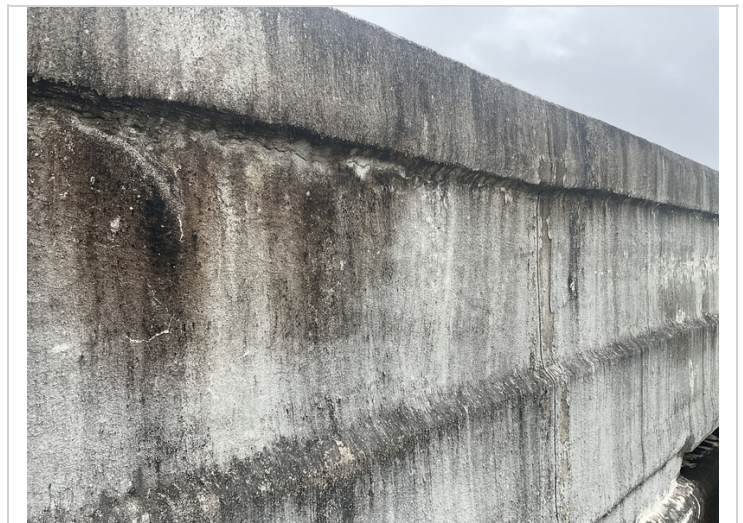
Cracking in bridge concrete railing various locations

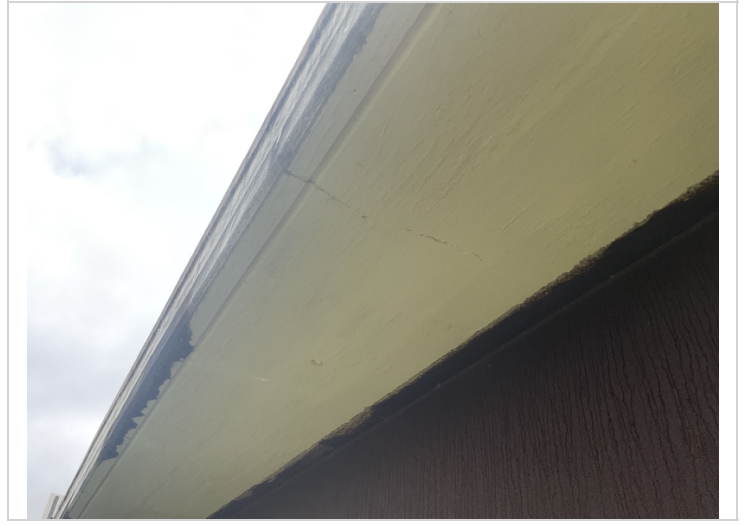
Cracking in deck overhang various locations

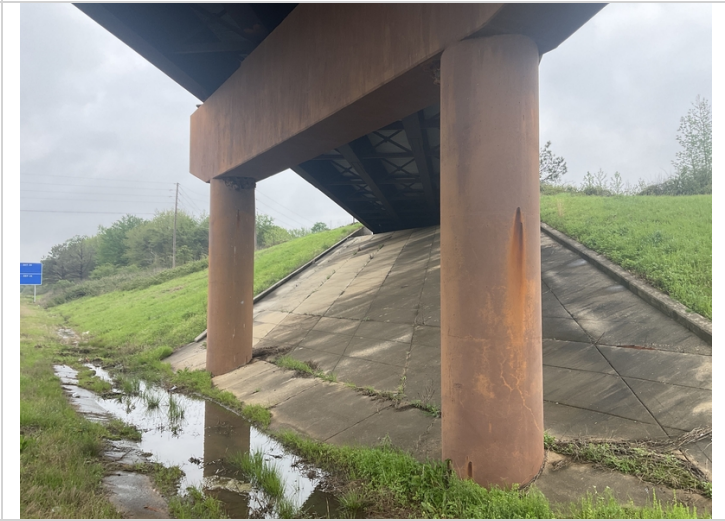
(205) Rust staining on all 6 Columns							
215	Reinforced Concrete Abutment	LF	135	135	0	0	0
234	Reinforced Concrete Pier Cap	LF	205	200	5	0	0
1130	Cracking (RC and Other)	LF	5	0	5	0	0

Rust staining on all 6 Columns

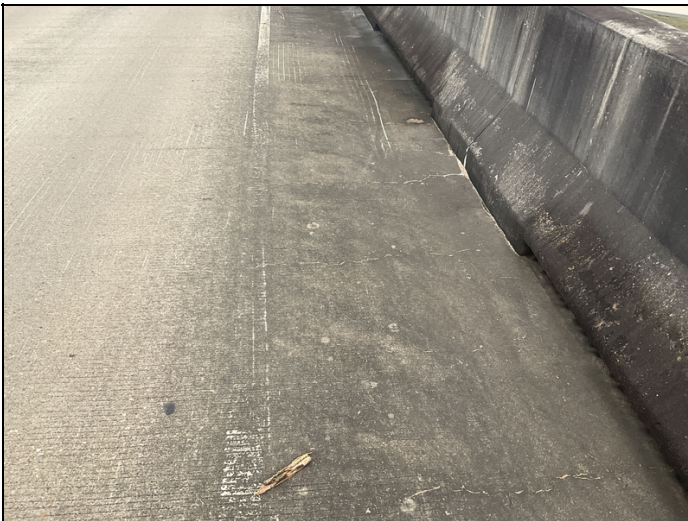
04/2023 bridge deck has crack to top side and deck pans on bottom side. may look at polymer overlay...

Polymer overlay candidate
