Bridge 04819 Inspection Report

Asset #04819(Routine, Underwater type 2)

CR 58 Newton over DRY BRANCH

Team Lead: Nathan Rowland Inspection Date: 01/18/2024

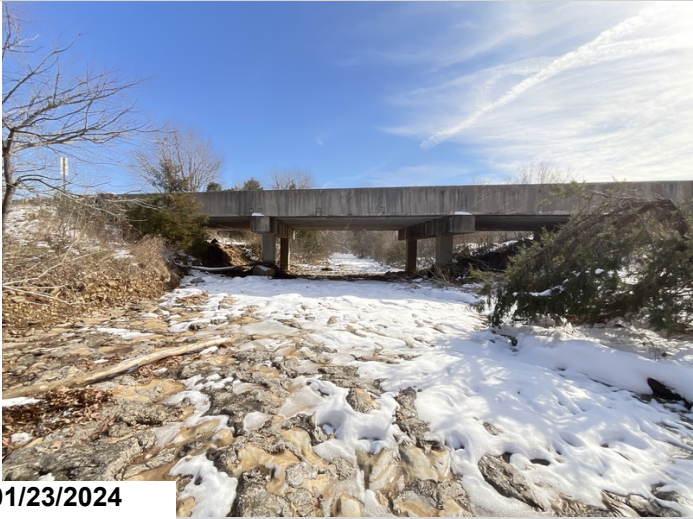
Elevation looking east

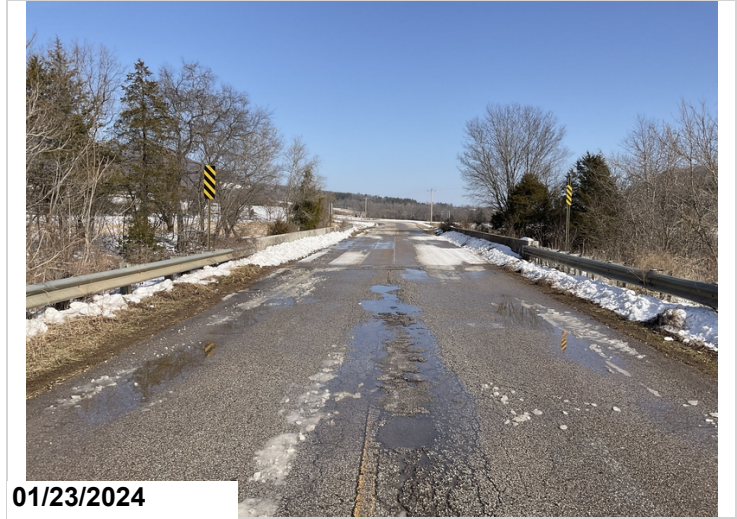
Inventory looking north

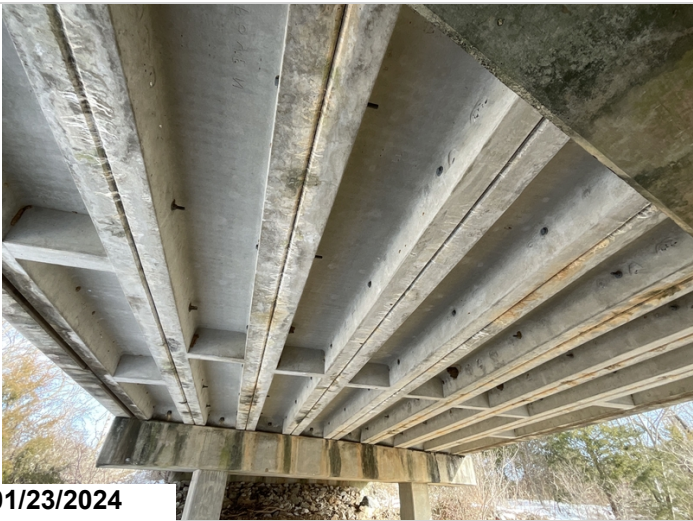
Span #2- Hairline vertical flexure cracking was noted at approximately 12" spacing in the left and right stems of all units. CS2 efflorescence leaching was noted between units #2-8. The under surface of the channel beams (deck) showed no deficiencies.

General view of span #2

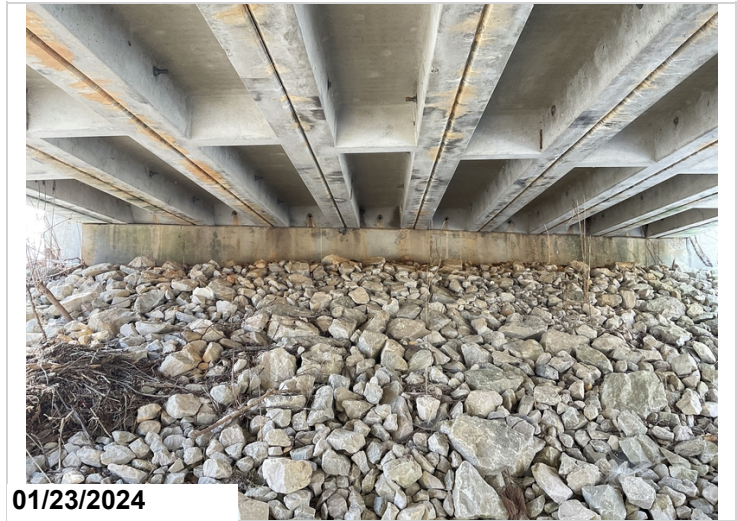
Abutment #1- has 3 vertical hairline cracks. The top edge of the bridge seat has shallow, superficial spalls on the top edge from construction when setting channel beam units onto the bridge seats, no rebar is exposed at these locations. Abutment #1 slope rip rap is in place and functioning as intended.

View of abutment #1

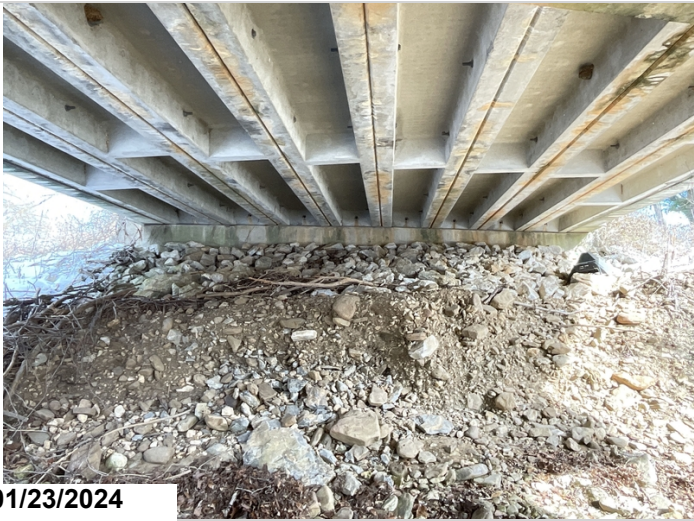
Abutment #2- has 1 vertical hairline crack with shallow superficial spalls on the top edge from the construction process. Embankment erosion has occurred at the abutment #2 slope where it is not armored with rip rap. The edge of the erosion measures 15' 3" from under unit #5 at the abutment #2 face, this condition has not worsened since the last inspection.

View of abutment #2

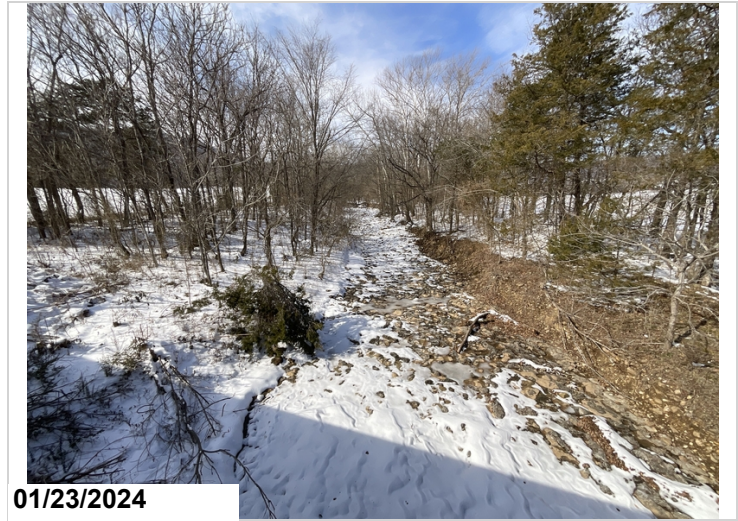
Upstream view

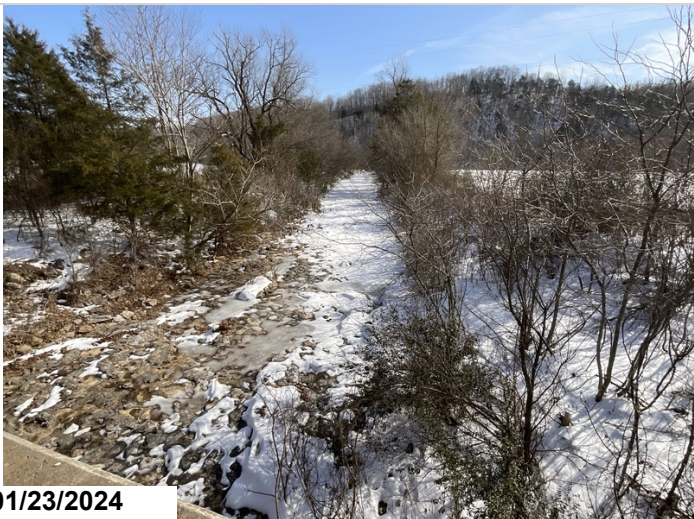
Downstream view

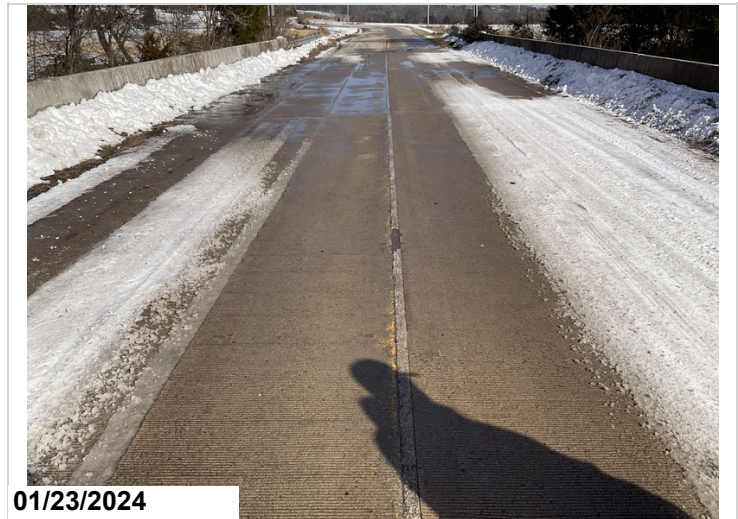
Driving surface- The driving surface of the deck has a tined finish that is showing minor wear. Span #1 and Span #3 have minor debris accumulation in the left and right gutter lines. The top of the keyway grout is partially spalled between some of the channel beam units, especially at the end and the beginning of the spans. No cracking was noted in the driving surface.

General view of deck
