Route:15 Section:00 Log:0.9

Arnold Road ID:55xSTRAWBERRYRDx3xA, Arnold Log mile:4.145

District 03, 109 - Pike County

IDENTIFICATION	
(1) State Names	5 - Arkansas
(8) Structure Number	23145
(5) Inventory Route	1
(2) Highway Agency District	03 - District 03
(3) County Code	109 - Pike County

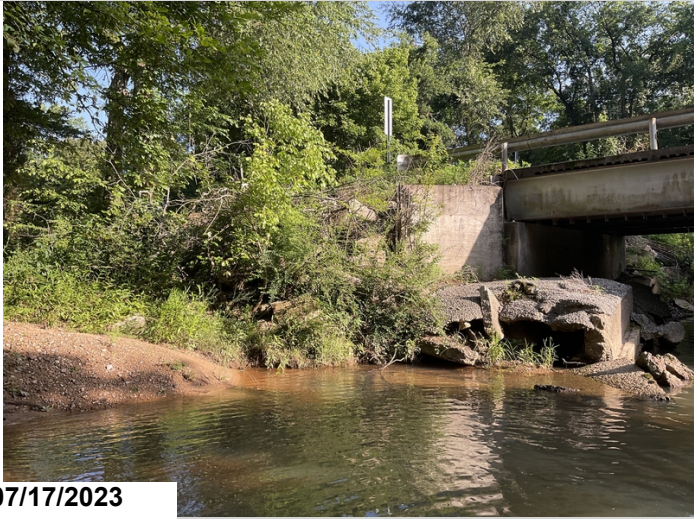
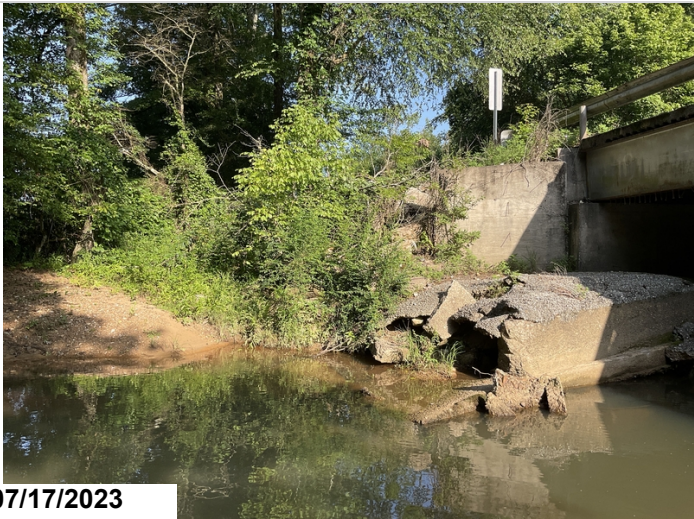
Vegetation needs removed in various locations on both right and left sides of bridge.

Rt side of bridge vegetation

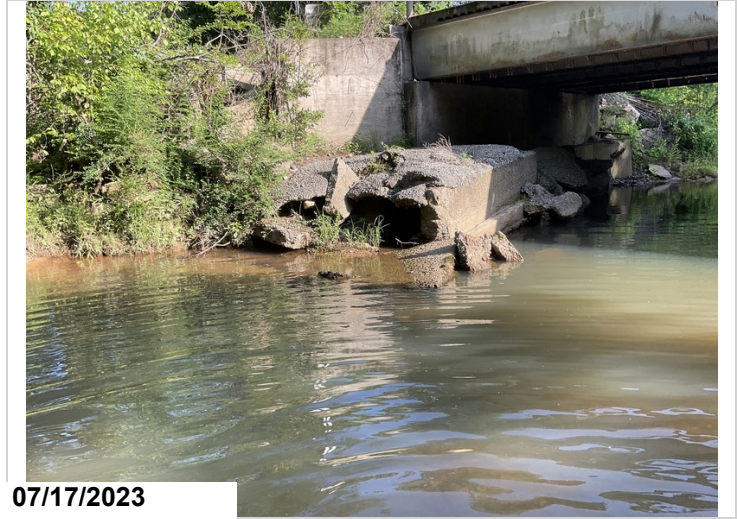
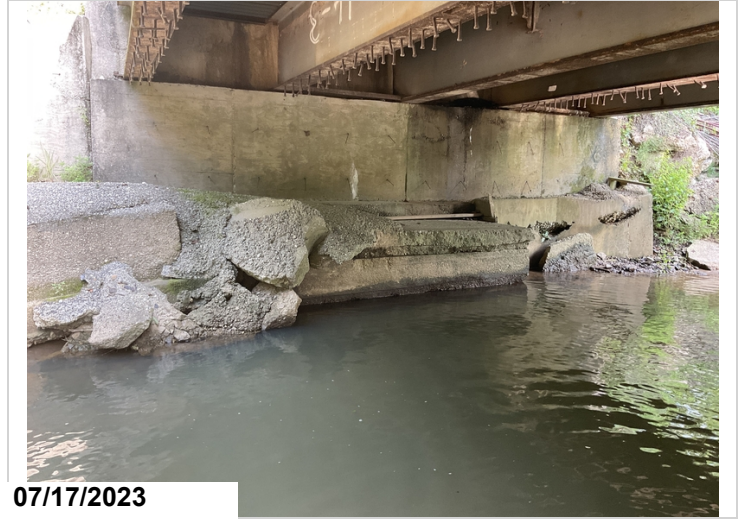
Scour rating is a 6 this inspection due to isolated scour around Bent 1 abutment.

Bent 1 isolated scour

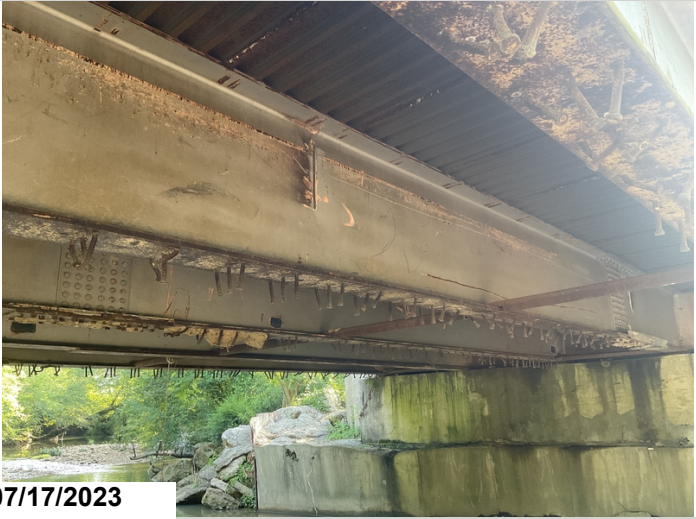
Dropped superstructure rating to a 6 this inspection due to corrosion on all beams around bottom flanges. Old state beams were used, beams were flipped over with shear studs down.

Shear studs on bottom of beams

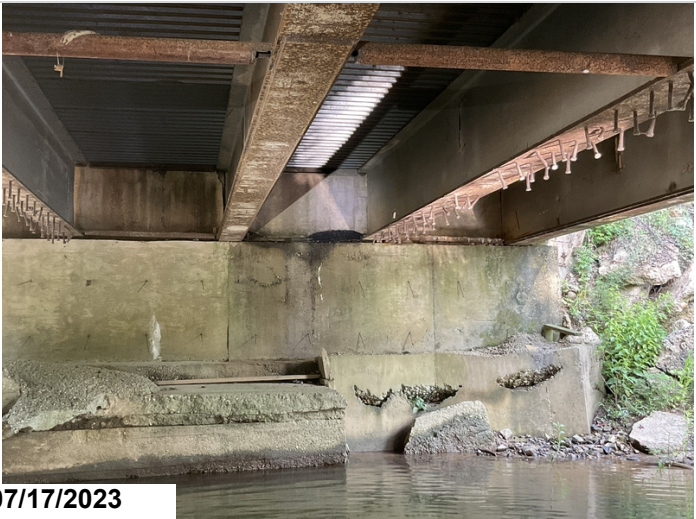
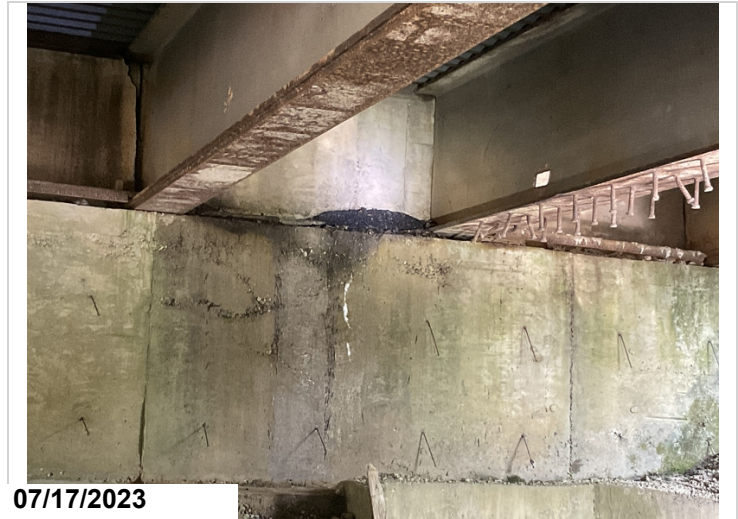
Asphalt needs cleaned off of abutment 1 cap.

Asphalt on abutment 1 cap

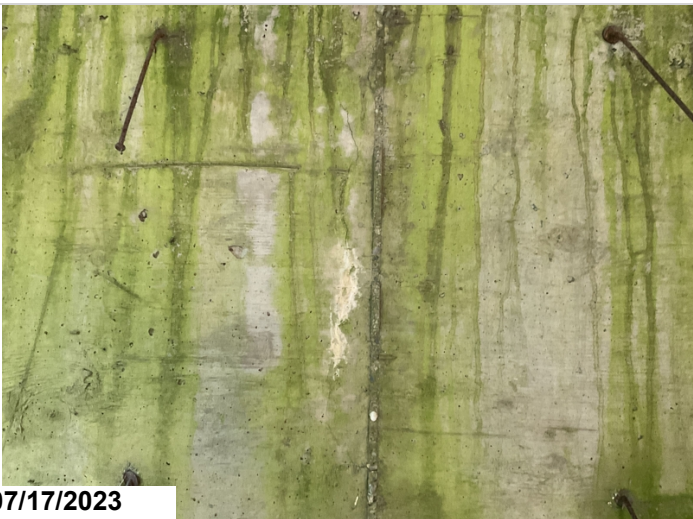
Substructure rating is a 6 this inspection due to various locations of cracking with efflorescence, and abrasion in various locations of abutments 1 & 2.

Cracking with efflorescence

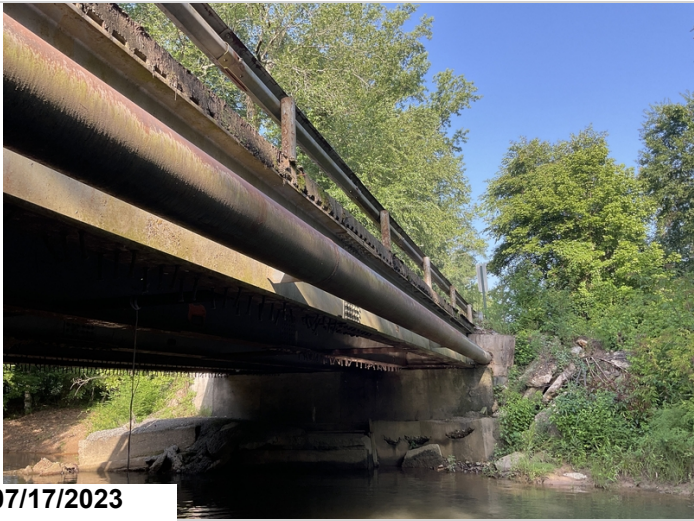
Utility pipe attached to steel beams. LT side of bridge

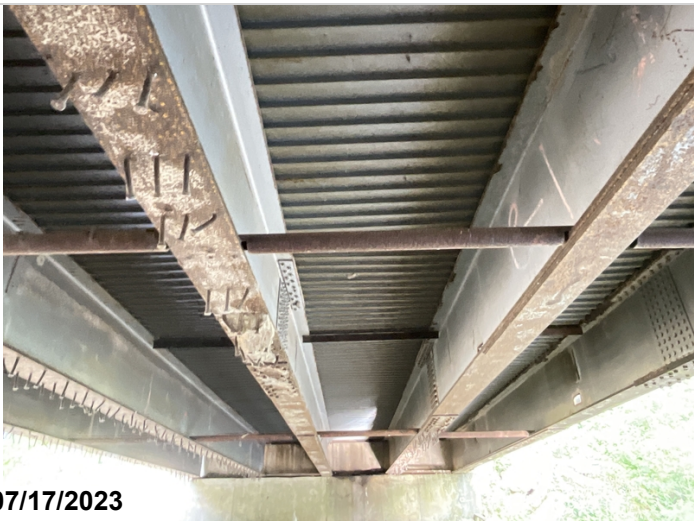
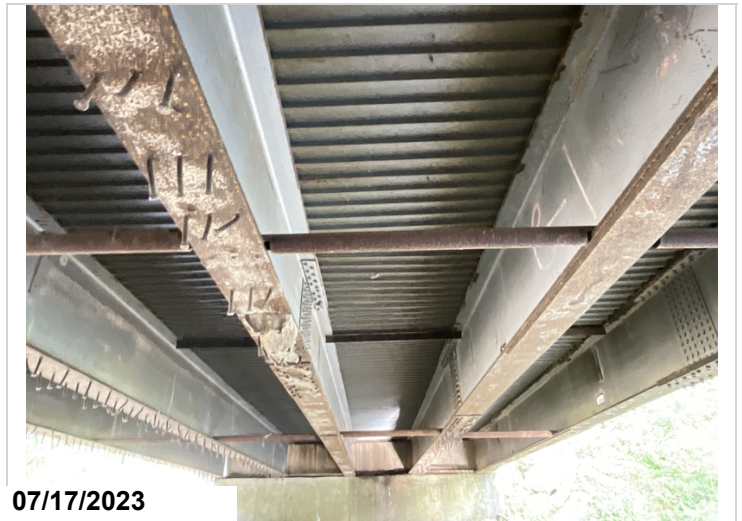
Deck rating is a 7 this inspection due to various locations of cracking throughout all spans. Underside of concrete deck has stay in place forms.

Underside of deck with stay in place forms

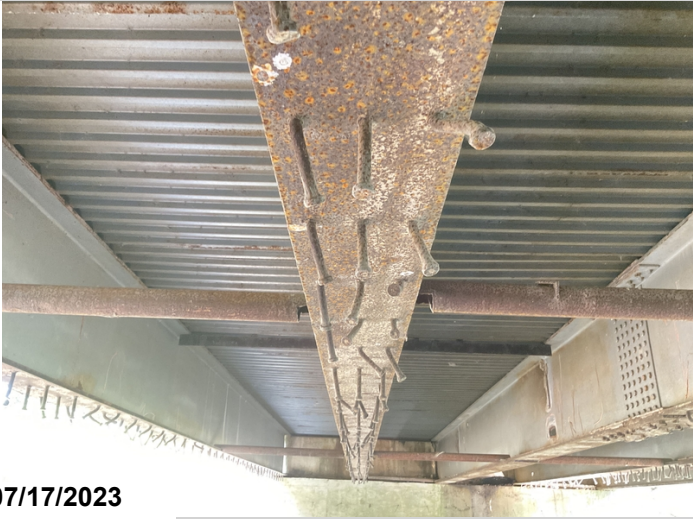
Corrosion to beams.

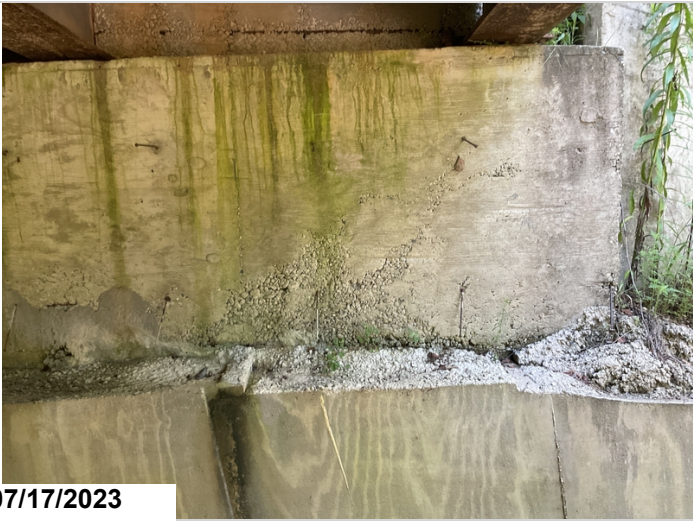
Abrasion on abutment 2

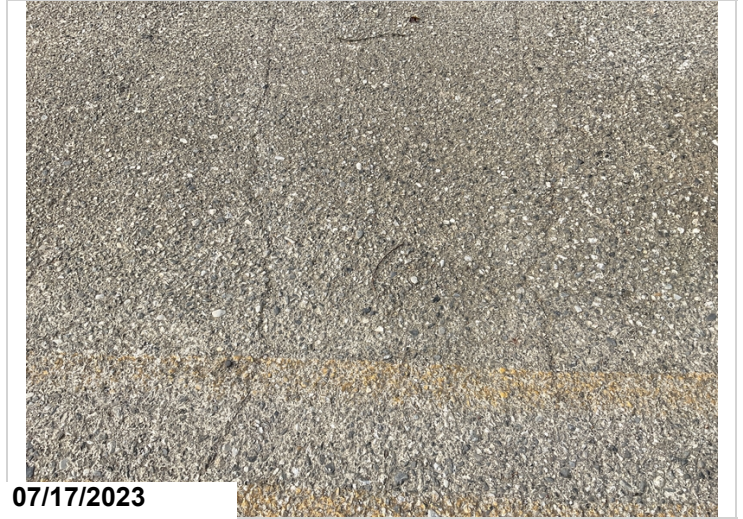
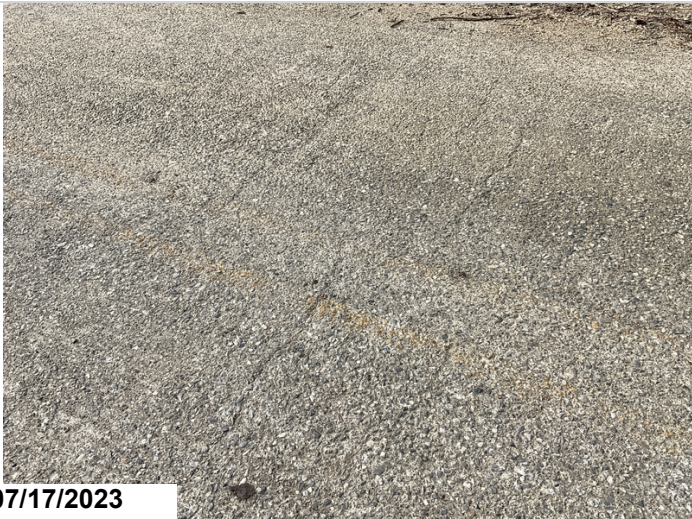
Deck cracking

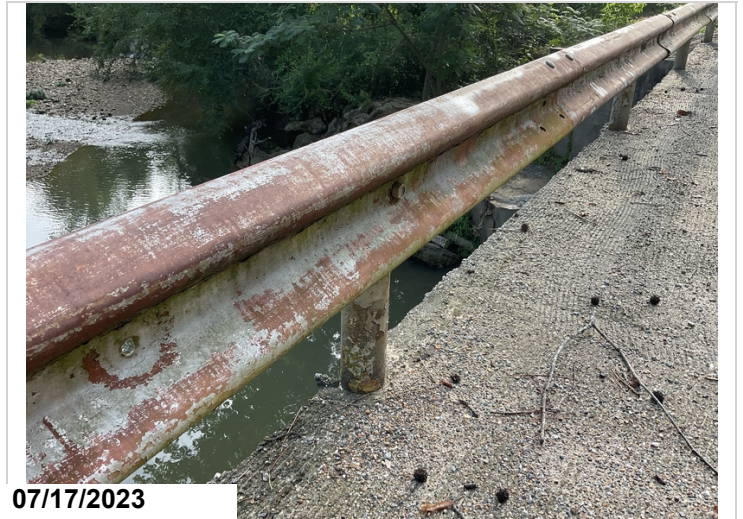
Corrosion on guardrail

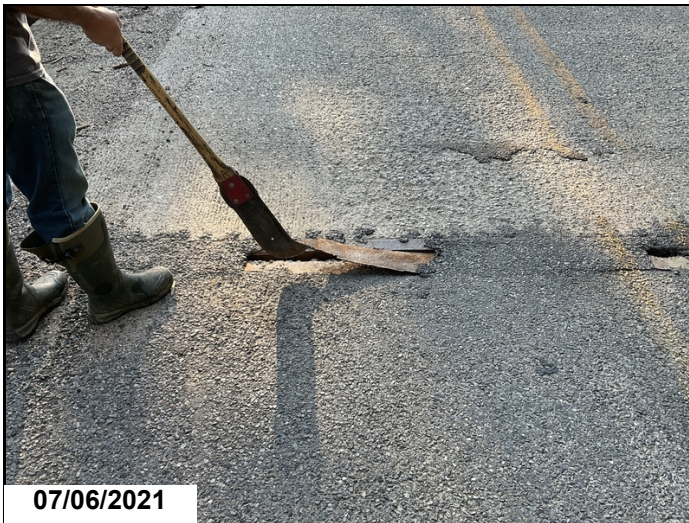
Metal plate at joint needs cut out and repaired

Metal plate at joint needs cut out and repaired At
beginning of bridge

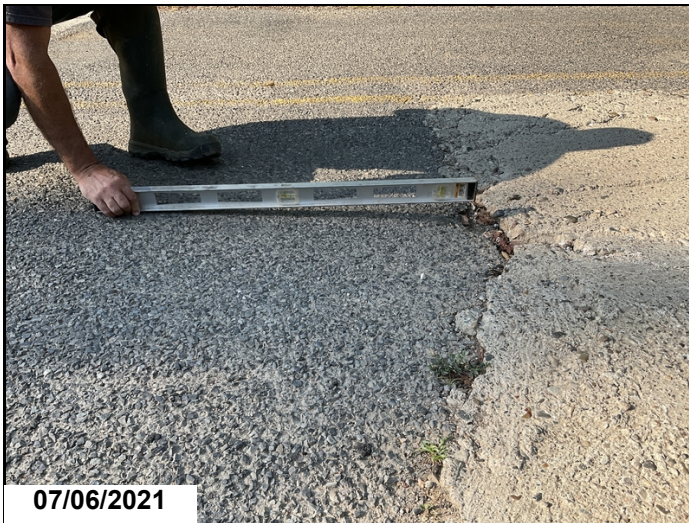
Approach roadway has settlement needs leveling

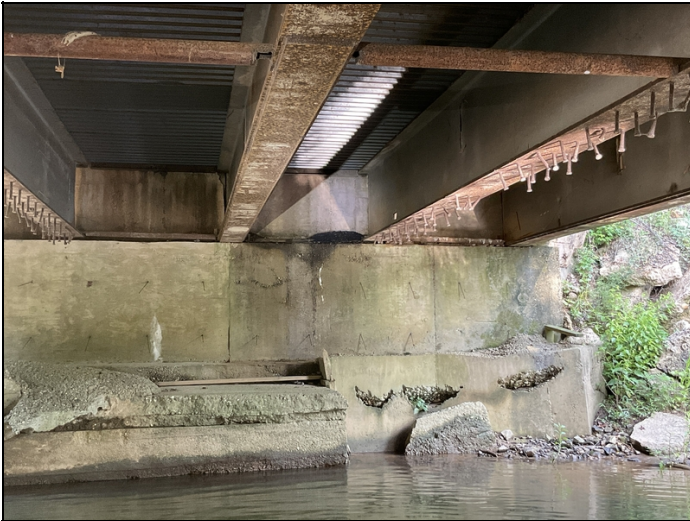
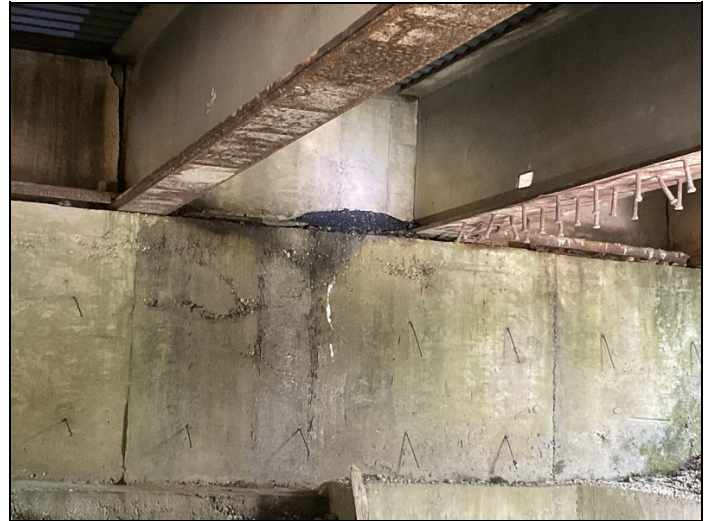
Asphalt on abutment 1 cap

A-58 - Cap Cleaning/Flushing Needed (Yes)
Asphalt needs cleaned off of abutment 1 cap.

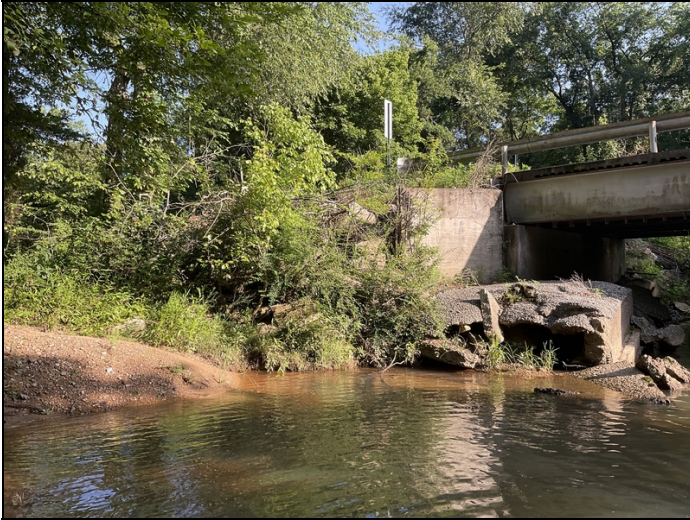
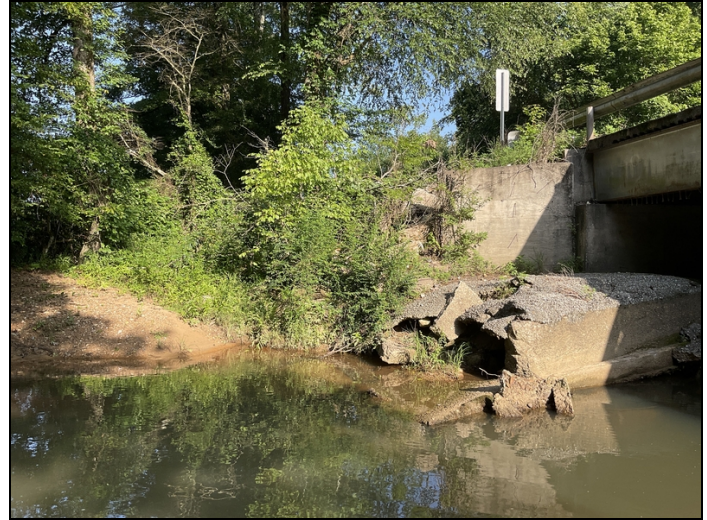
Rt side of bridge vegetation

Vegetation needs removed in various locations on both right and left sides of bridge.
