Asset #23415(Routine, Underwater type 2)

CR 11-B-HEAD ROAD over SALINE CREEK

Location: 2.75 MI S. PIKE CITY

Team Lead: John King Inspection Date: 03/19/2024

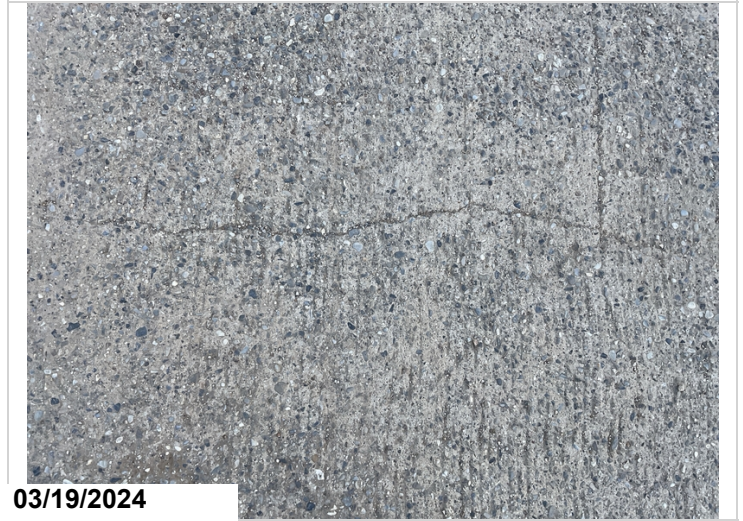
Sealable deck cracking is present in various locations on the driving surface of the bridge deck.

Sealable deck cracking

Sealable deck cracking is present in various locations on the driving surface of the bridge deck.

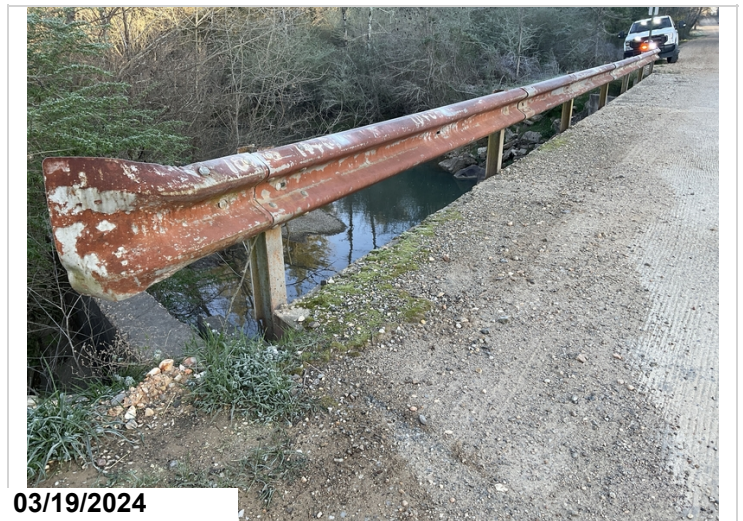
The deck rating is a 7 this inspection due to minor deck cracking in various locations of the driving surface as well as both right and left sides of the metal bridge railing having minor corrosion.

Metal bridge railing photo rusting

Lt side metal bridge railing, Minor corrosion, Typical of both right and left sides

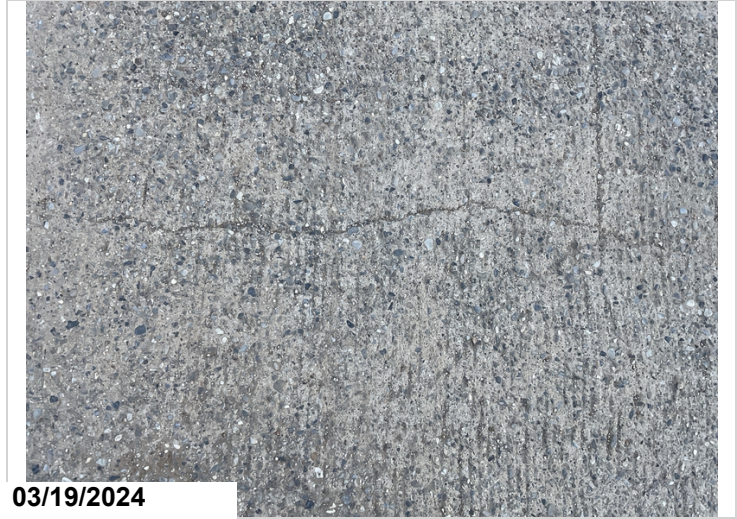
Lt side of bridge deck, Deck cracking, Typical in various locations.

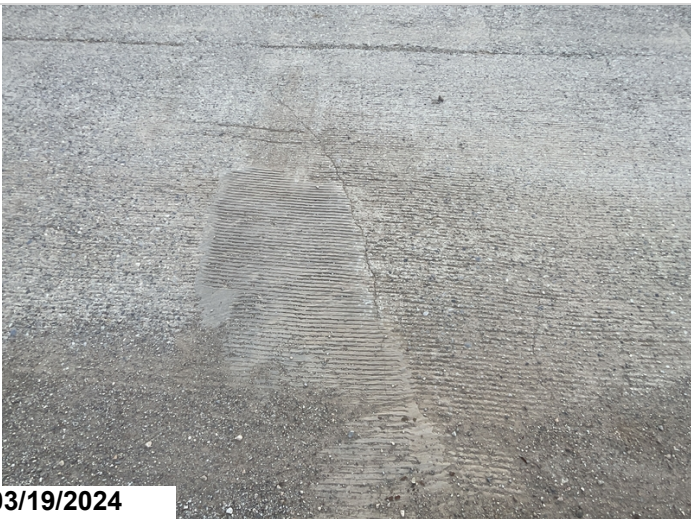
Rt side of bridge deck, Deck cracking, Typical in various locations.

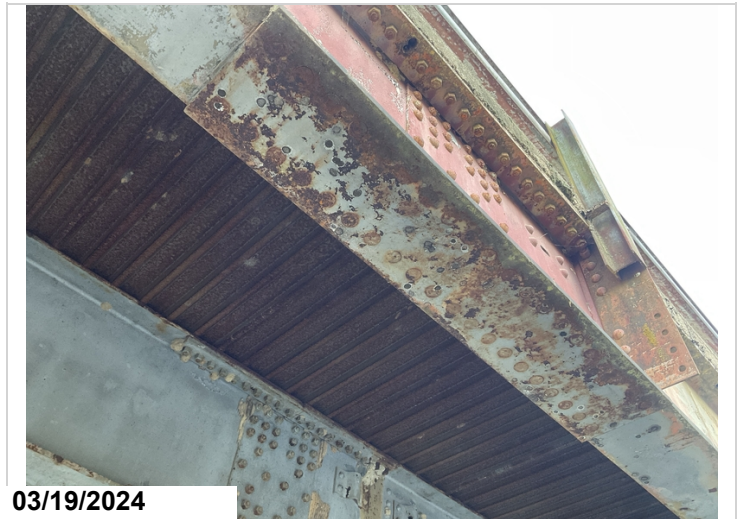
Superstructure rating is a 7 this inspection due to very minor corrosion to the bottom flanges of all the painted steel beams. Beam 5, Minor corrosion, Typical throughout all beams

Beam 5, Minor corrosion, Typical throughout all beams

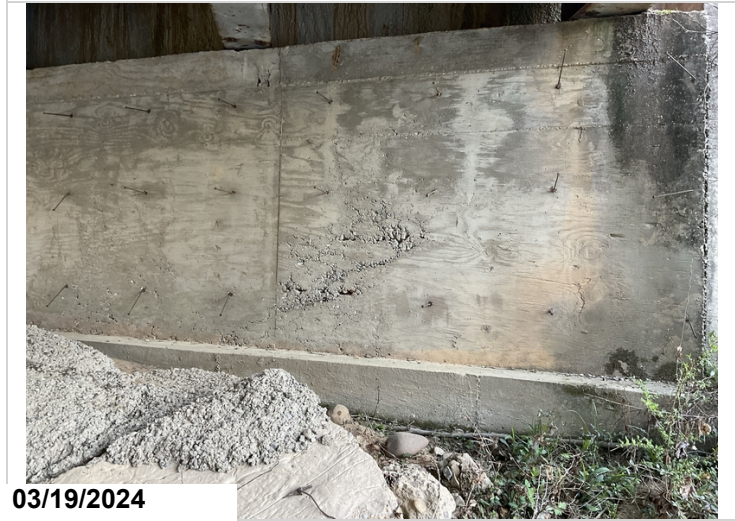
The substructure rating is a 7 this inspection due to minor honeycombing areas and abrasion to both abutments 1 & 2. Abutment 2, Rt side, Honeycomb area, Typical in various locations of both abutments

Abutment 2, Rt side, Honeycomb area, Typical in various locations of both abutments

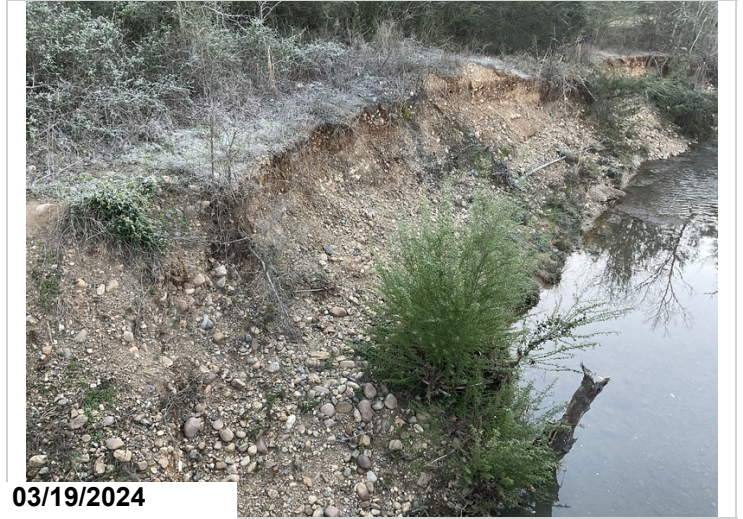
Channel rating is a 7 this inspection due to minor embankment damage to the downstream side of the bridge.

Downstream embankment damage

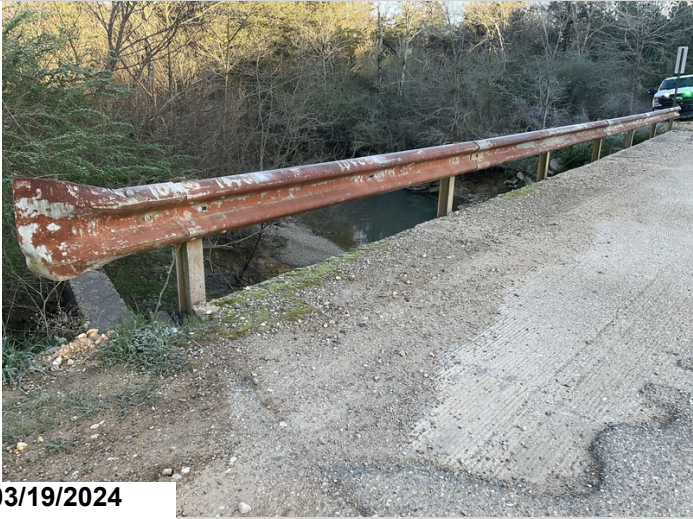
Metal bridge railing photo
