Bridge 23833 Inspection Report

Asset #23833(Routine, Underwater type 2)

CR 28 Palestine Rd over Little Bear Creek

Team Lead: Jared Kegley Inspection Date: 11/05/2025

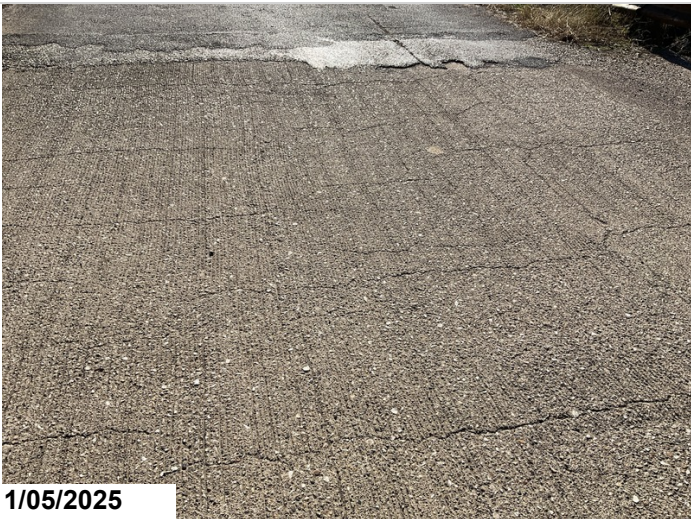
The deck is rated a 6 in this inspection due to the topside of the deck having cracking in various locations.

The topside of the deck has cracking in various locations,
CS2

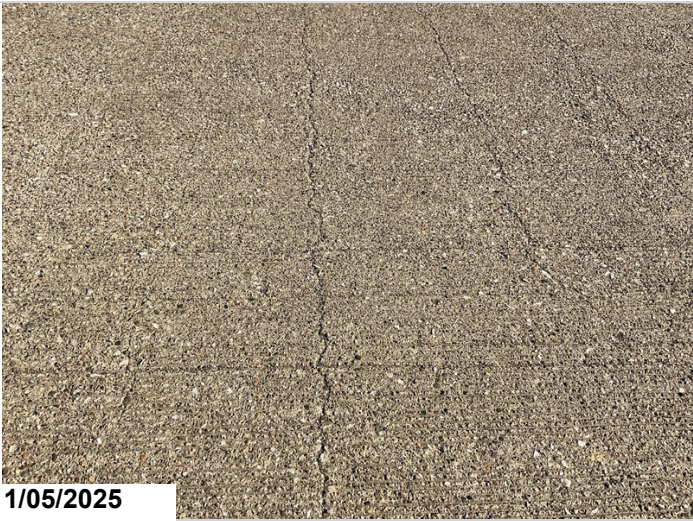
The topside of the deck has cracking in various locations, CS2

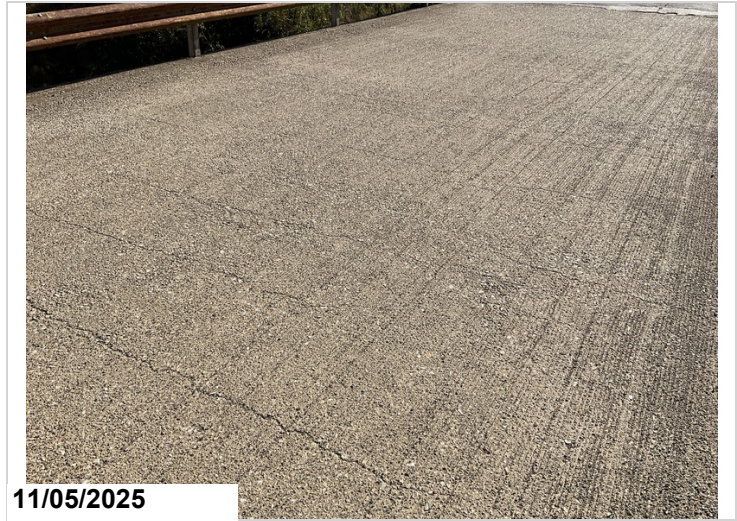
The topside of the deck has cracking in various locations, CS2

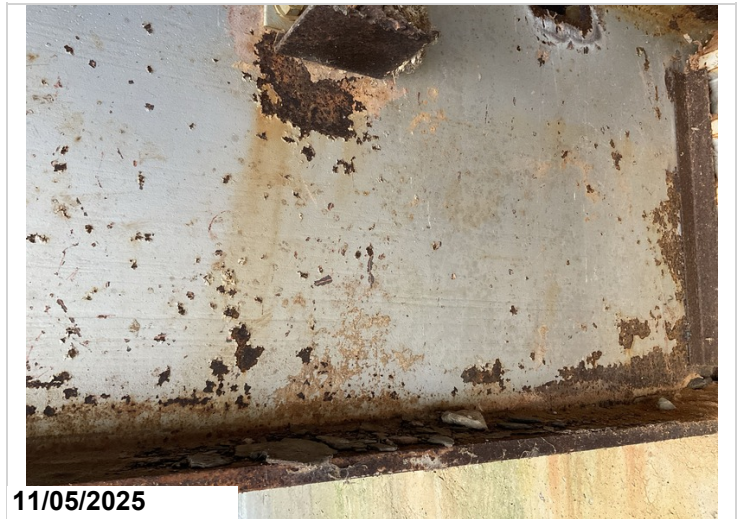
The superstructure is rated a 6 in this inspection due to all the steel beams having corrosion with minor pitting and paint loss in various locations.

All steel beams have widespread minor corrosion in various locations, CS2.

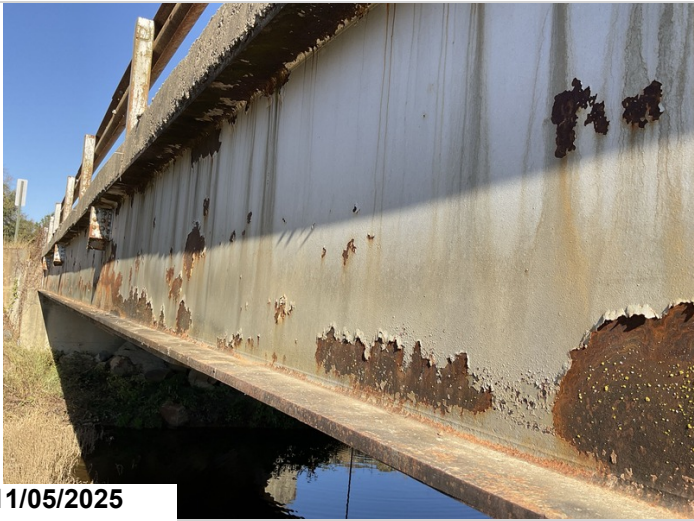
All steel beams have paint loss in various locations, CS2.

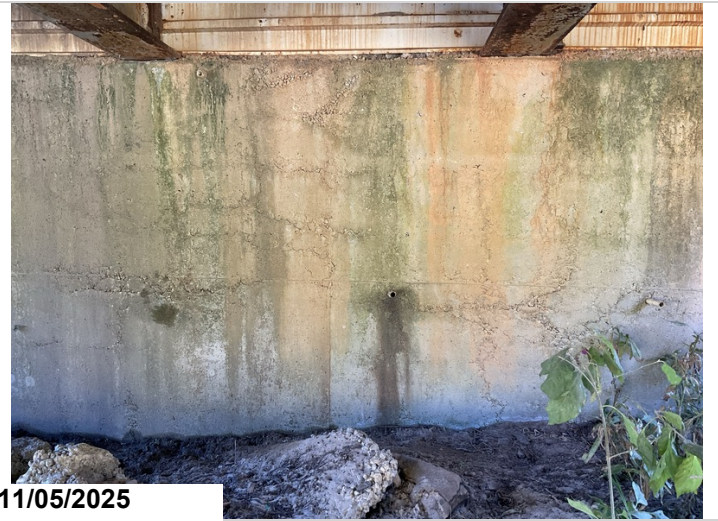
The substructure is rated a 7 in this inspection due to bents 1 and 2 having abrasion in various locations.

Bents 1 and 2 have honeycombs in various locations, CS2.

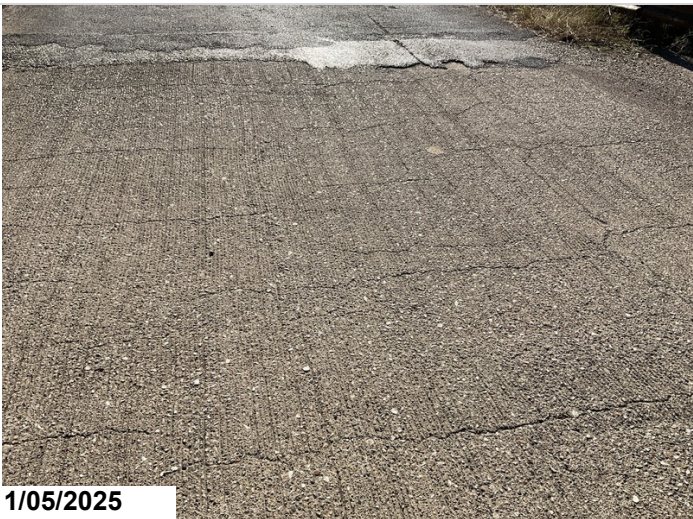
The topside of the deck has excessive amounts of cracking in various locations.

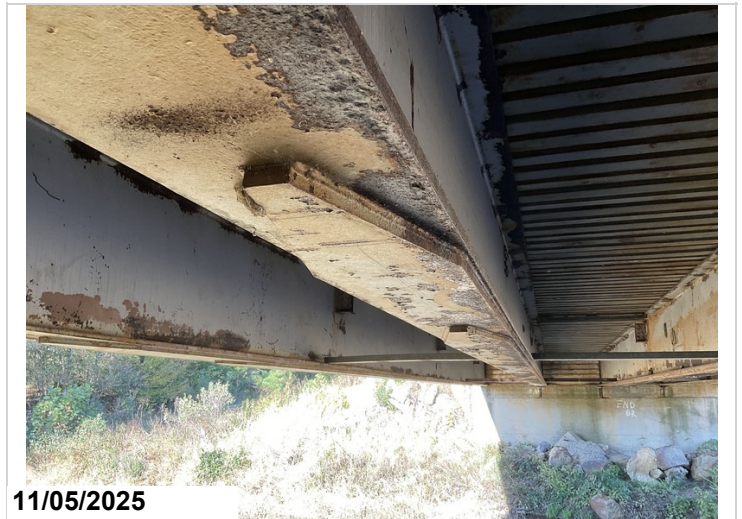
Cover plates are welded to the bottom flanges.

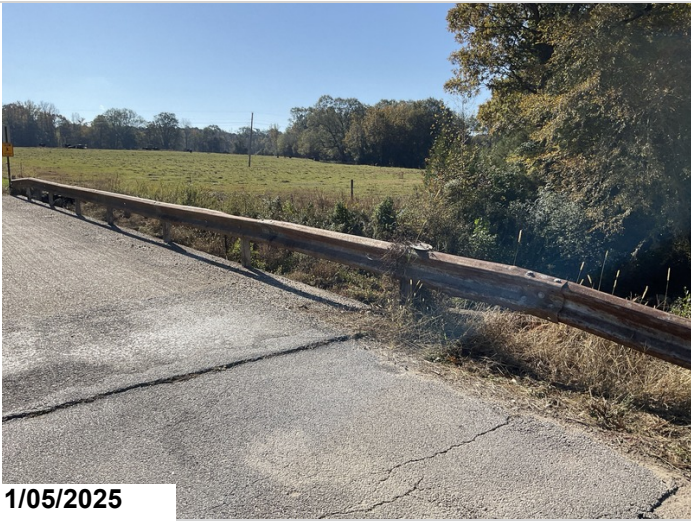
The bridge railing is rated a 6 in this inspection due to the left and right sides having minor corrosion and paint loss in various locations.

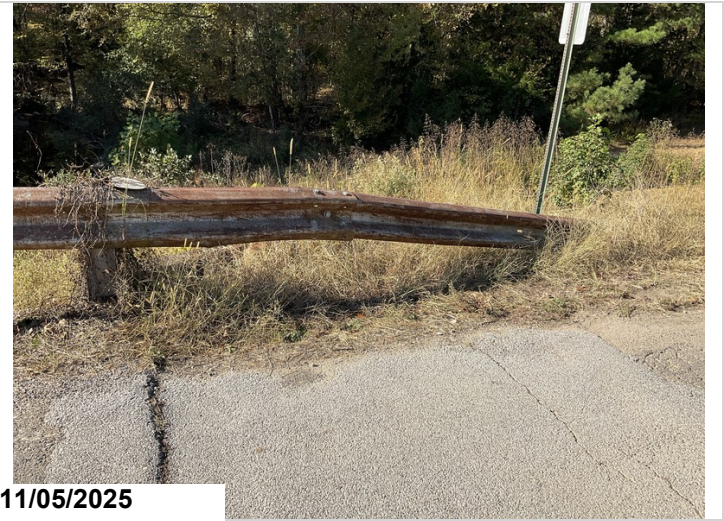
The bridge railing is rated a 6 in this inspection due to there being minor corrosion and paint loss in various locations.

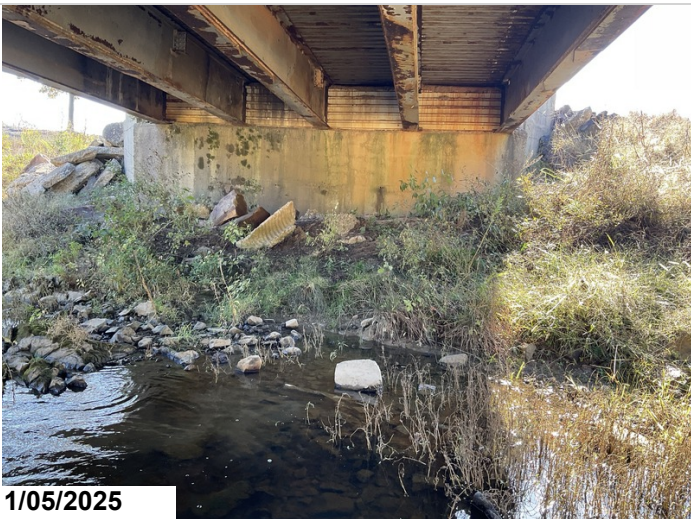
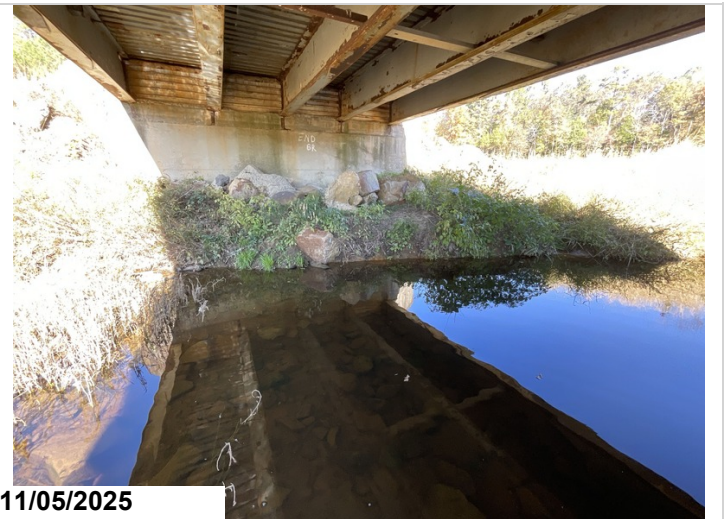
The rating of the scour was dropped to a 7 this inspection due to bents 1 and 2 having minor scour in various locations.

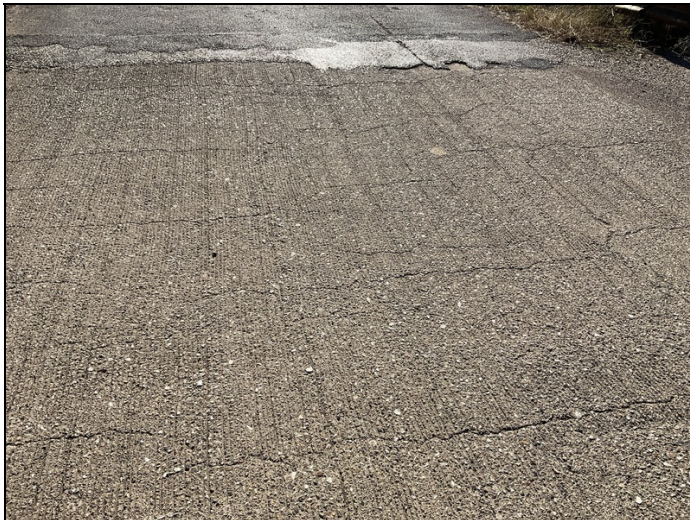
The topside of the deck has excessive amounts of cracking in various locations.

A-54 - Sealable Deck Cracks (Yes)
