Bridge 24438 Inspection Report

Asset #24438(Initial, Routine, NSTM, Underwater type 2)

CR15 Strawberry Rd over Wolf Creek

Team Lead: John King Inspection Date: 12/08/2025

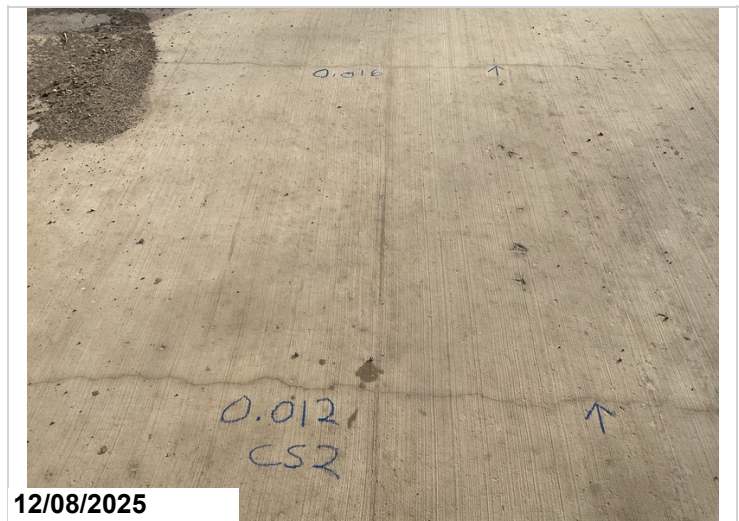
The concrete deck is a 7 good in this inspection because there are small cracks on the surface in different spots.

There are 360 square feet of these minor cracks.

The cracks were measured and are only 0.012 inches wide.

The topside of the deck has 360 SF of minor cracking in various locations, CS2.

Since they are just hairline cracks, no sealing is necessary at this time. bridge

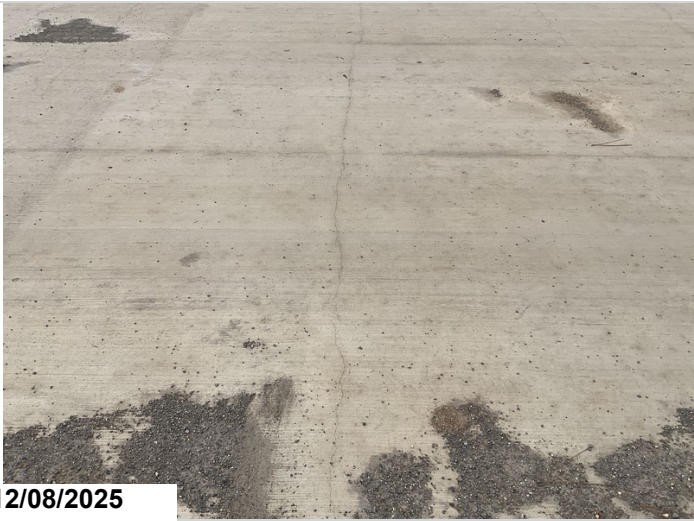
The topside of the deck has 360 SF of minor cracking in various locations, CS2.

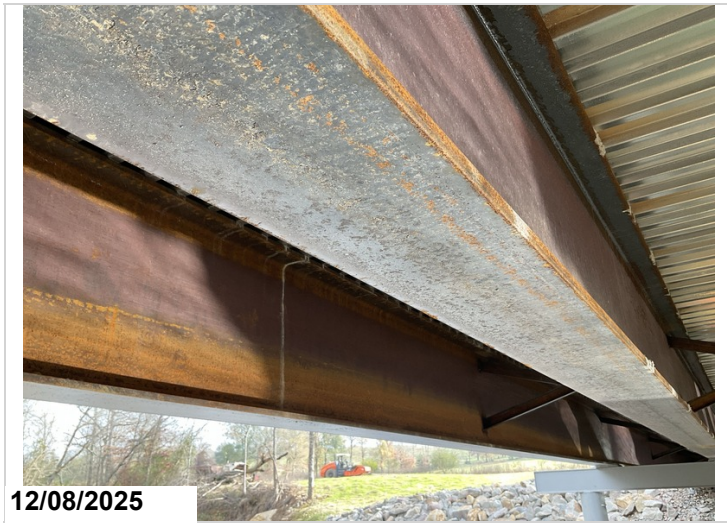
All steel beams speckled rust in various locations.

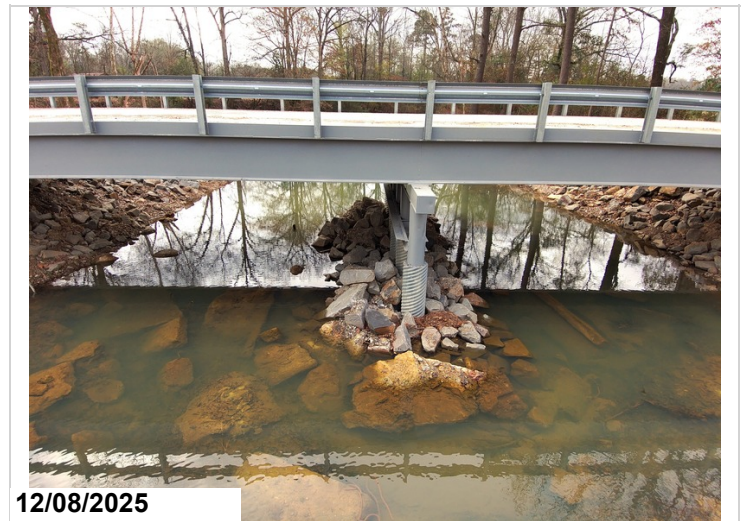
Added Channel protection around bent 2.

Channel protection around bent 2.

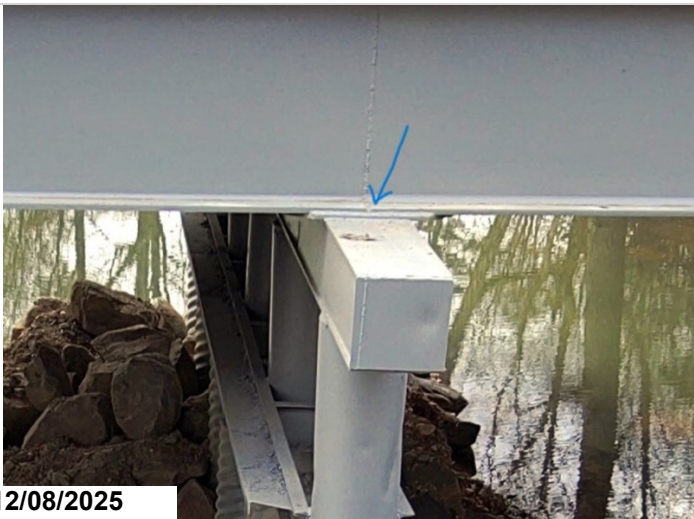
Cover plate welded to bottom flange at bent 2.

Photo shows cover plate and bearing area welded to bottom flange at center bent.

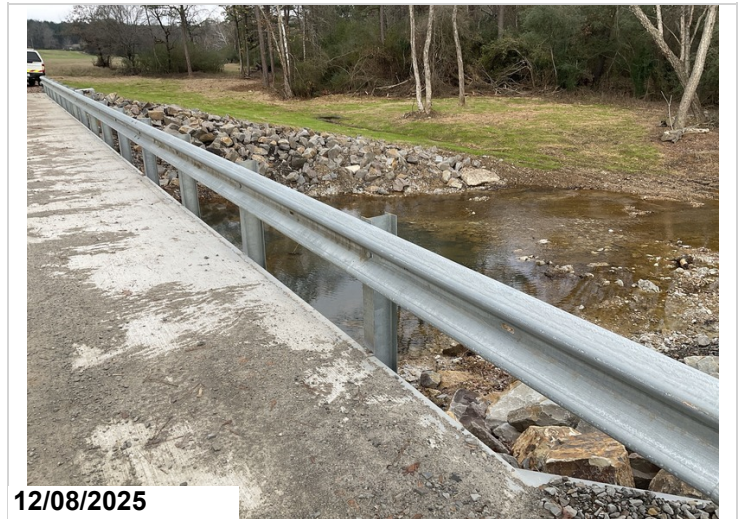
The bridge railing is rated a 9 this inspection due to no problems being noted.

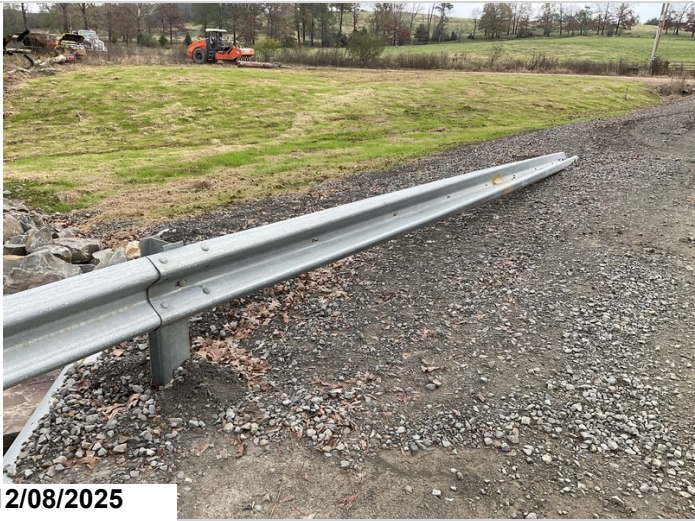
The bridge railing transitions are rated a 9 in this inspection due to no problems being noted.

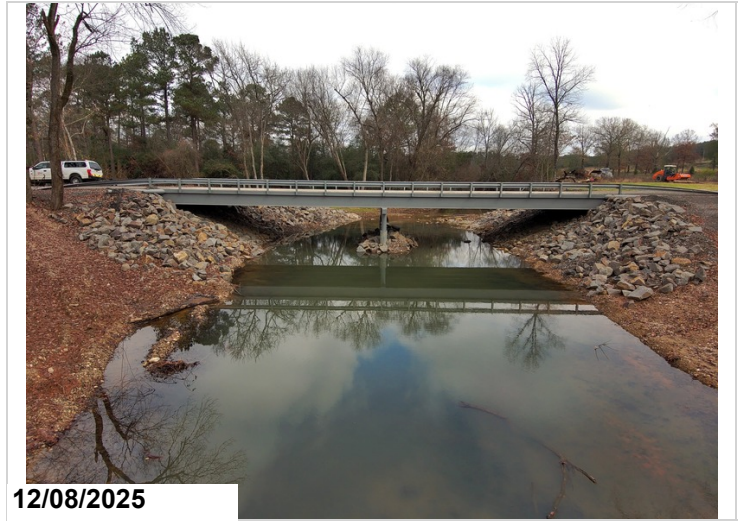
The channel protection is rated a 9 in this inspection due to riprap being placed around both sides of the streambank.

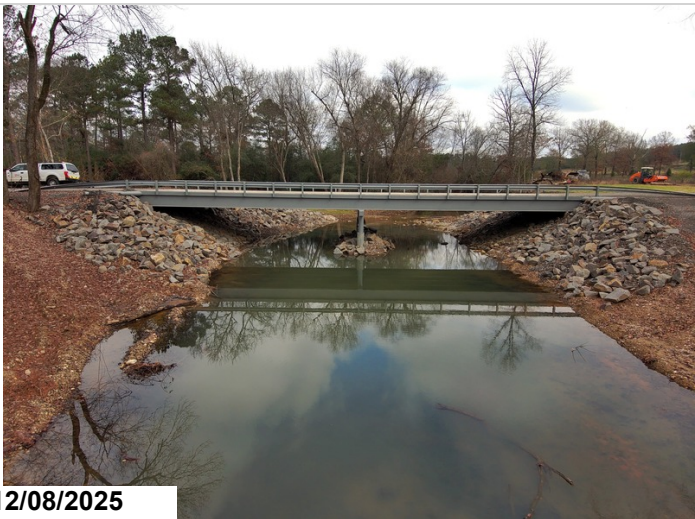
The scour is rated an 8 in this inspection due to riprap being placed around both ends of the streambank.

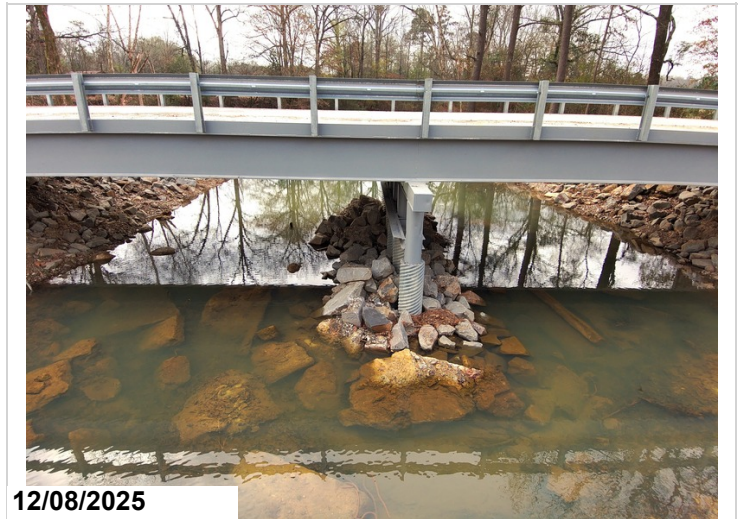
Channel protection around bent 2.

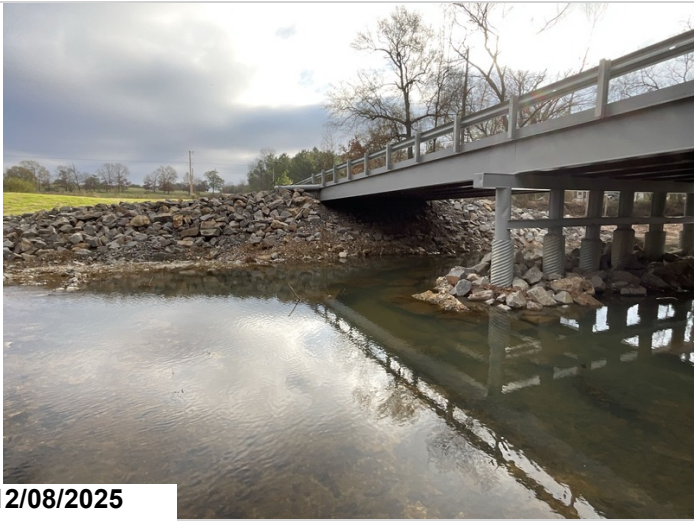
The scour is rated an 8 in this inspection due to riprap being placed around both ends of the streambank.

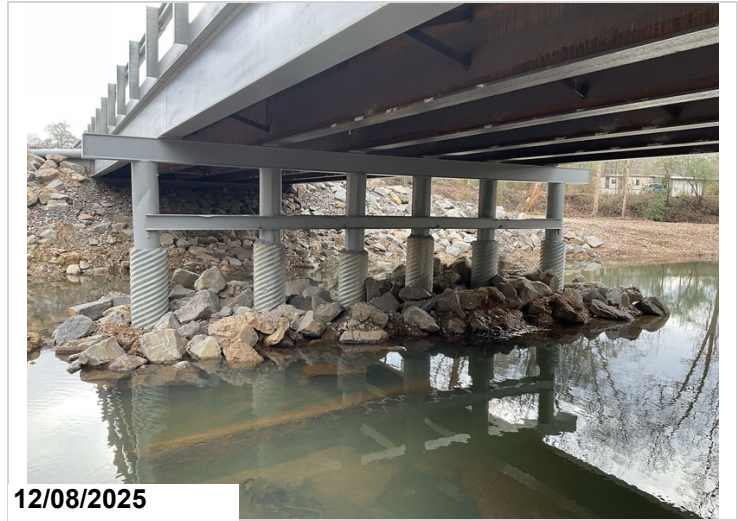
The scour is rated an 8 in this inspection due to riprap being placed around both ends of the streambank.

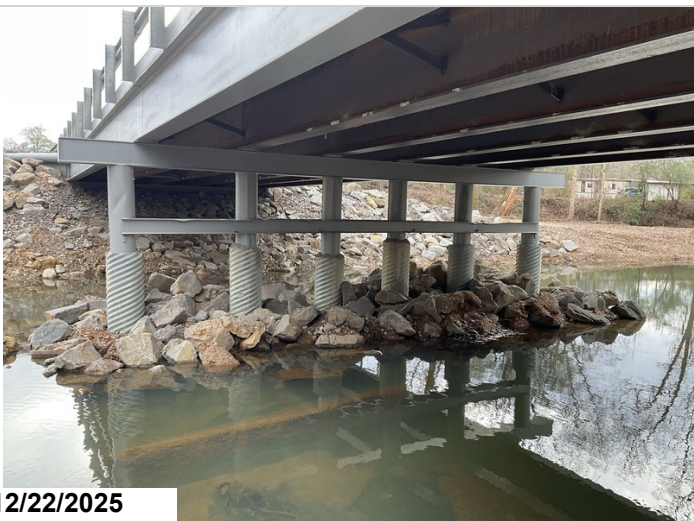
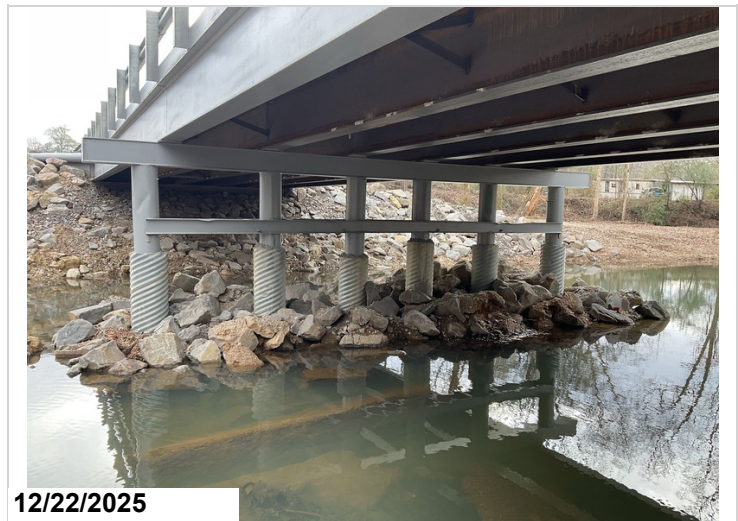
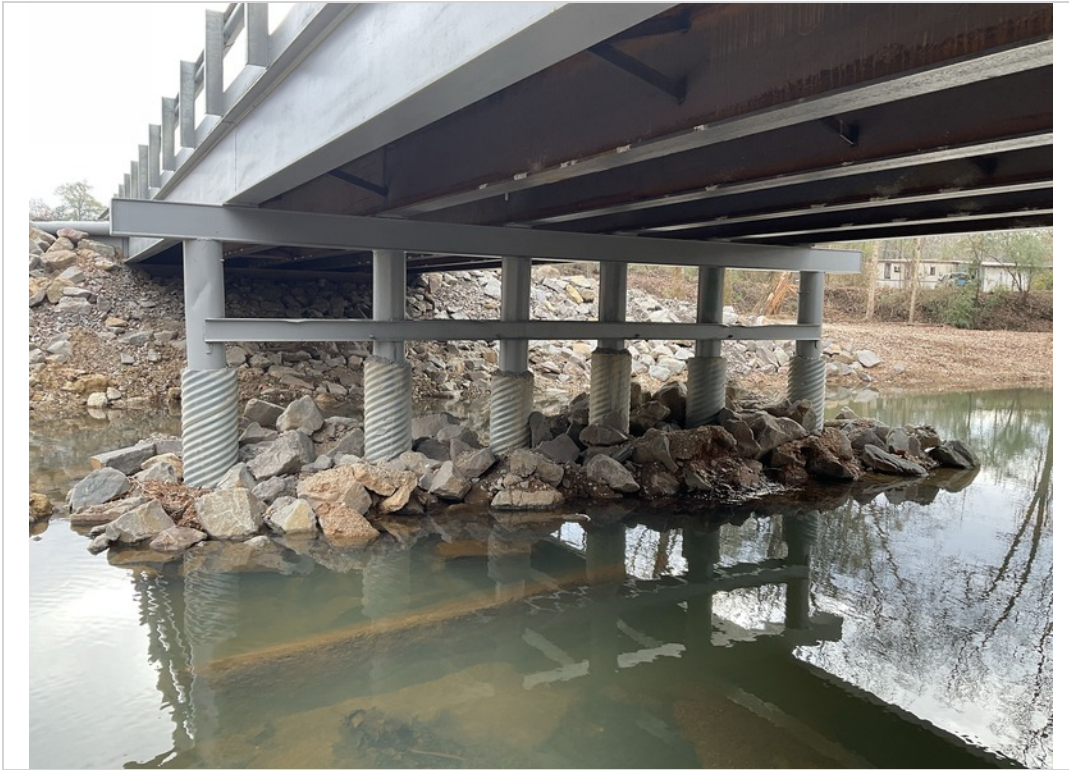
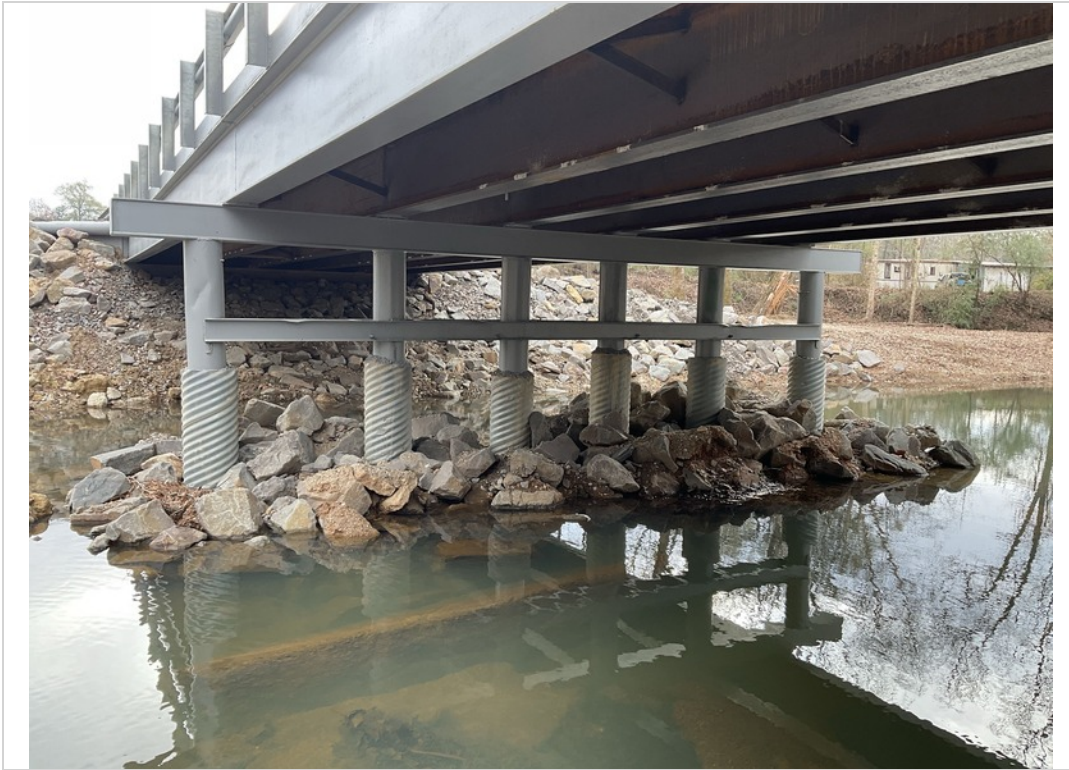
Bent 2 steel cap NSTM member

A-128 - Description of Structure (The bridge has two 50'-00" spans, and the middle support has a steel cap. The NSTM Member is a steel cap that is an IBeam with steel plates welded to its sides and ends, forming a box shape. The steel piles underneath the cap are also welded to it. It's important to closely check this area for any cracks " A risk-based NSTM evaluation was performed by Bridge Operations Engineers in December of 2025 for this structure. Due to this being a new condition structure and the load path from the girders going nearly directly to a pile under the NSTM member and each girder, the frequency of inspection is set at 24 months for the NSTM inspection.")
Steel cap NSTM in very good condition. no noted problems

Bridge #24438 NSTM Member Inspection Log			
Member or Element (NSTM)	Access Equipment	Condition Rating	General Condition Notes
Bent 2 Steel cap.	Inspection will require ladder, hip boots or chest waders. Structure can not be inspected during swift current.	8	Bridge was built in 12/2025 and the cap at bent 2 is in very good condition. the cap was painted when bridge was built. Welds show no sign of cracking.

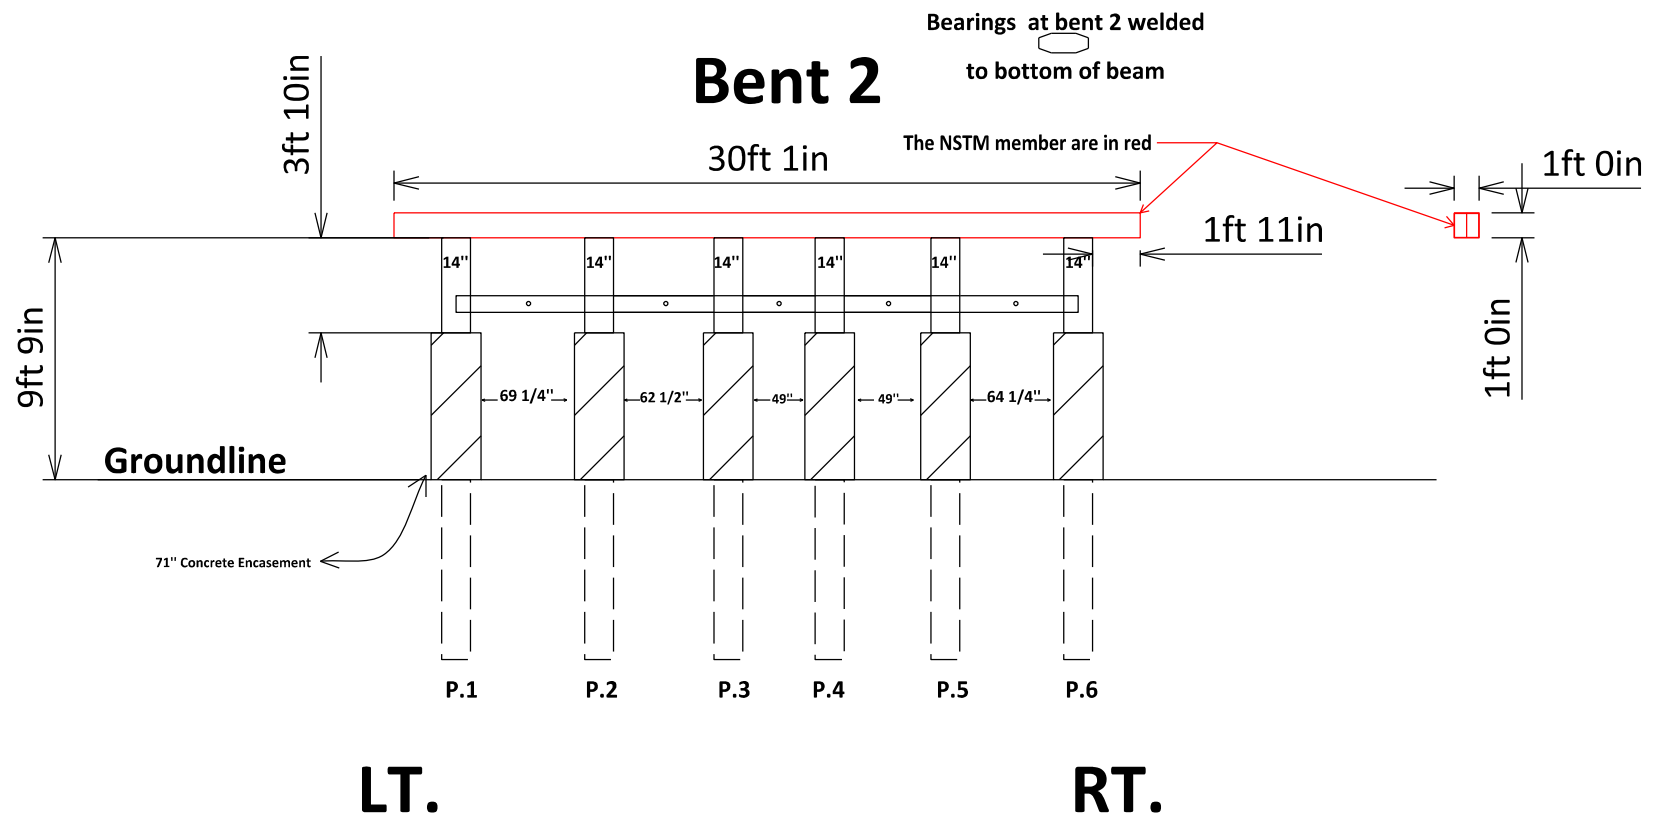
<p>NSTM member is the steel cap at bent 2 the NSTM member are in red</p>	<p>Scale: 1"=5'</p> <p>0' 5' 10'</p>	<p>BRIDGE NO.</p> <p>24438</p>
