Bridge Inspection Report

16233
County Road 288
over
Buffalo Creek - Polk Co.

Structure Number: 16233

Facility Carried: County Road 288

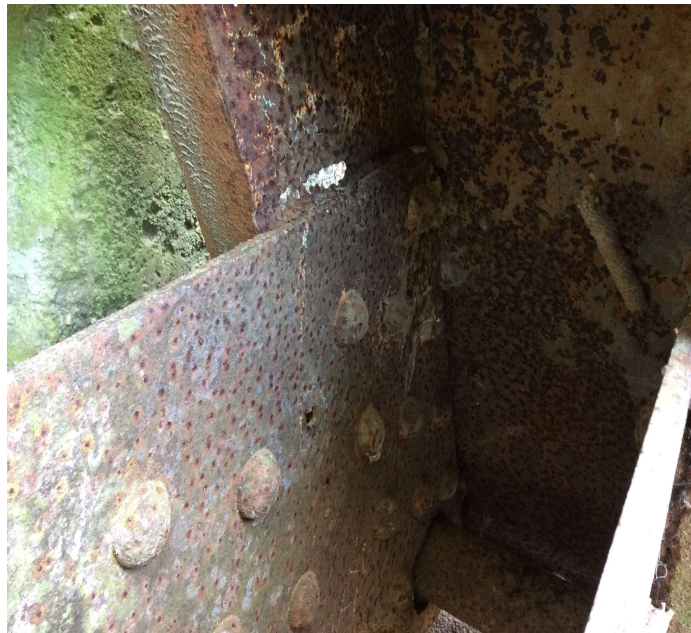
Pack rust, active corrosion, and holes rusted through the lower connection plates. The bottom flanges of floorbeams have heavy pitting with knife edge section loss in locations. Holes rusted through the webs of the channels at the base of the end posts. Lower chords have section loss in numerous locations.

PHOTO 1 Description L0. Left hole rusted through the interior end post at the gusset connection

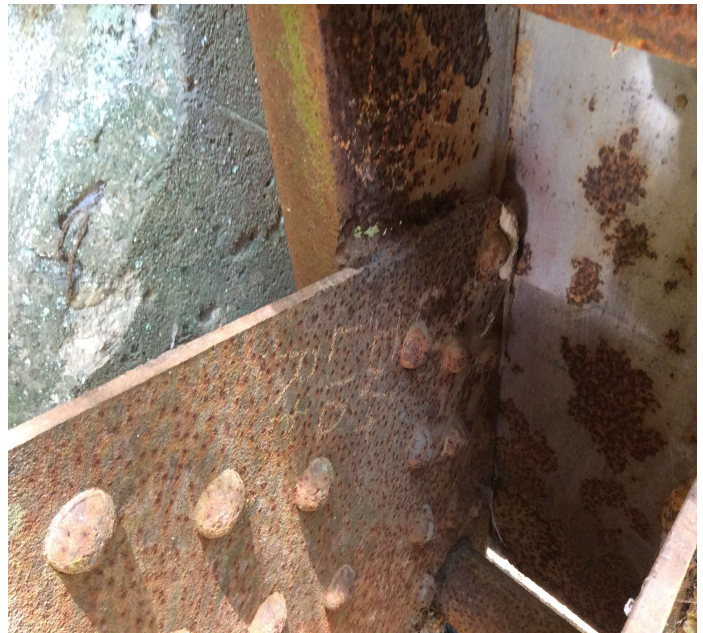
PHOTO 5 Description L10. Right. Hole rusted through the interior channel of the end post.

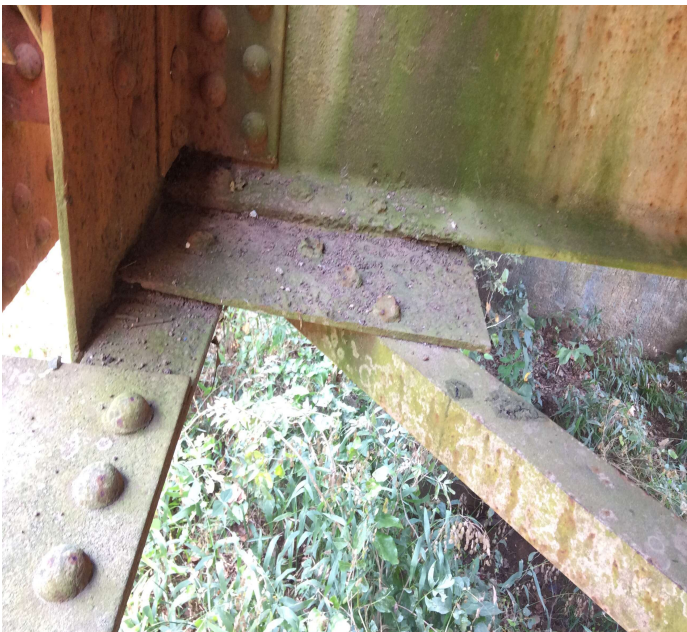
PHOTO 4 Description L2. Right. Lower lateral gusset connection

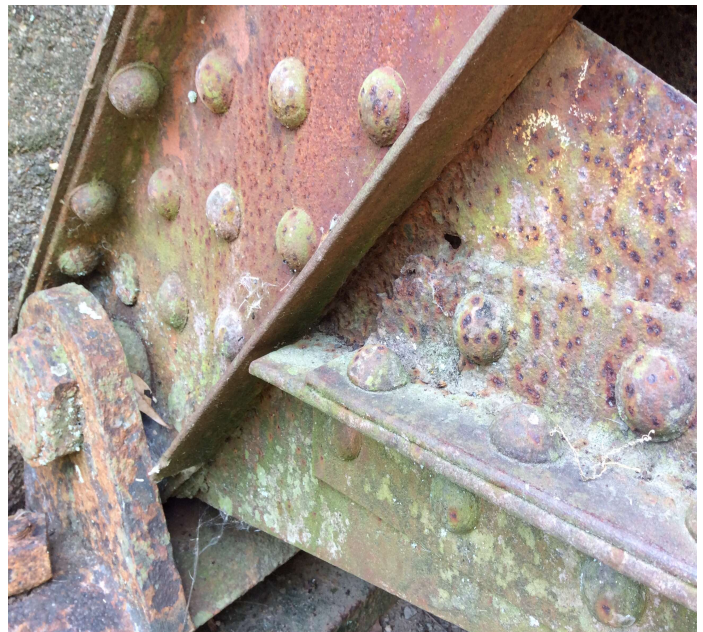
PHOTO 6 Description L0. Right. Exterior connection plate with 1/4" hole.

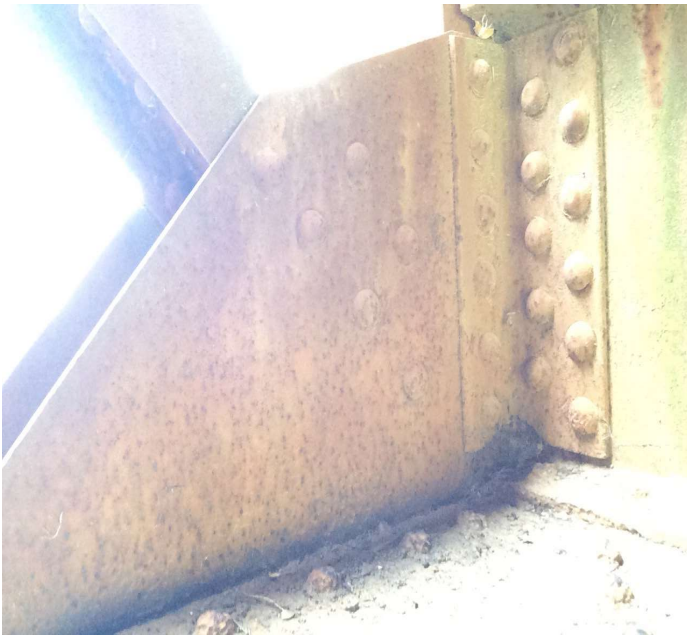
PHOTO 7 Description L4 Left Interior gusset at the Floor beam connection.

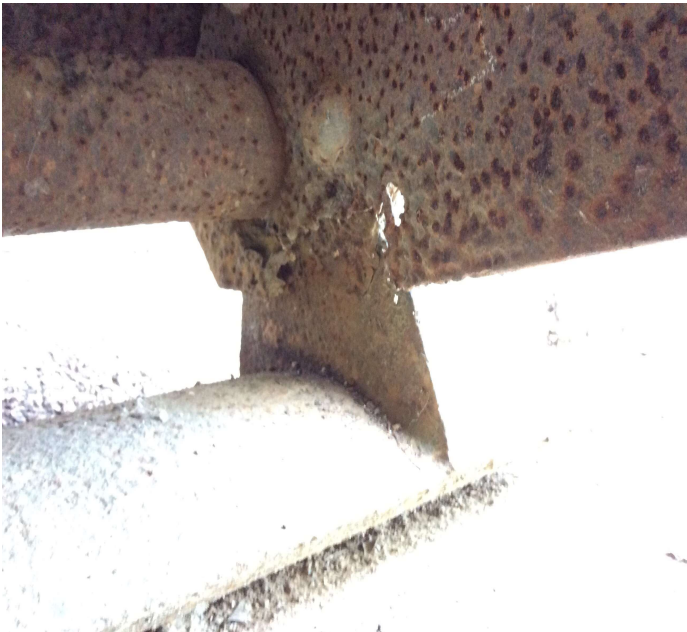
PHOTO 8 Description L0. Left. Exterior connection plate.

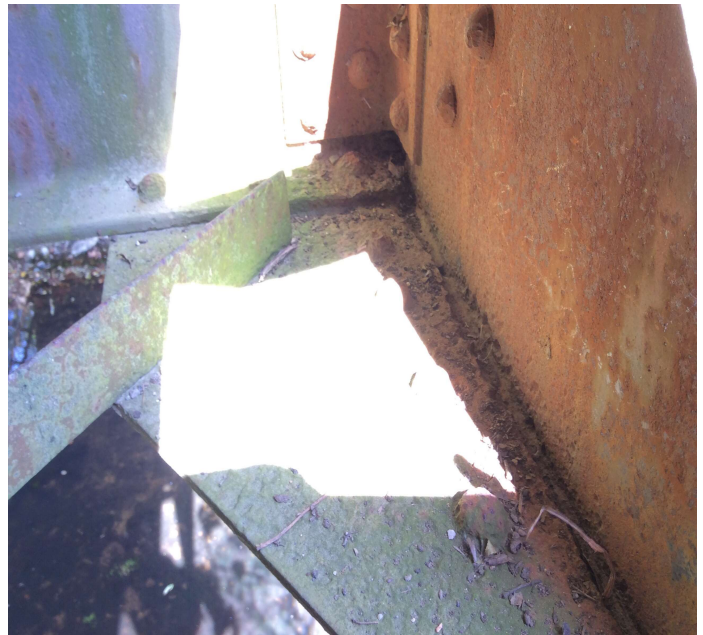
PHOTO 9 Description L4. Right. Interior. Lower gusset connection

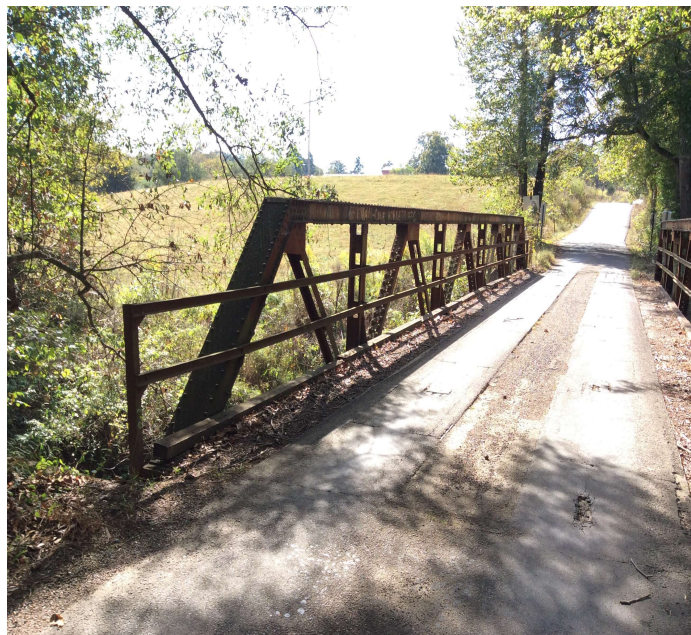
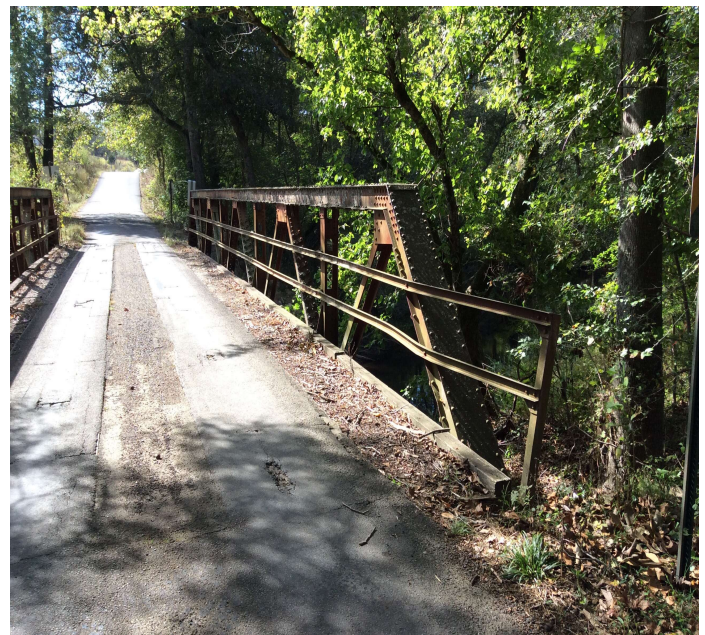
Upper chord connections -
Upper chord connection plates appear to have out of plane bending.

PHOTO 1 Description Right Truss. Typical

PHOTO 2 Description Left Truss. Typical

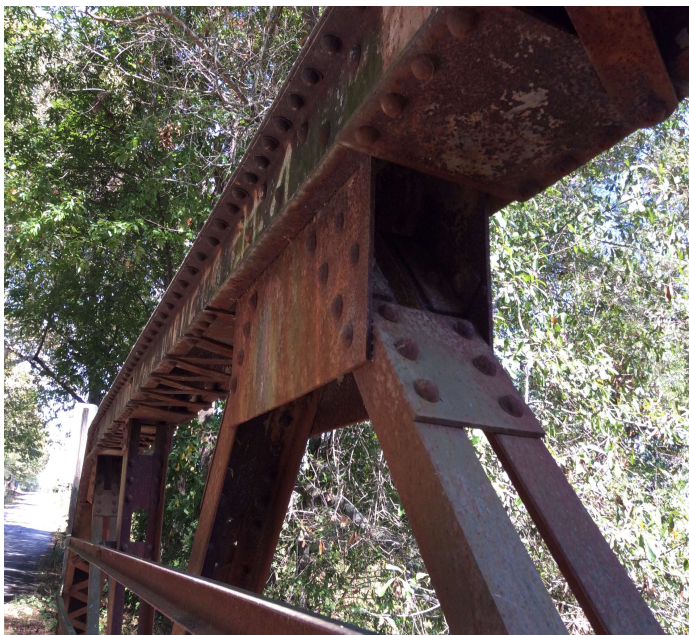
PHOTO 3 Description U7 connection plate.

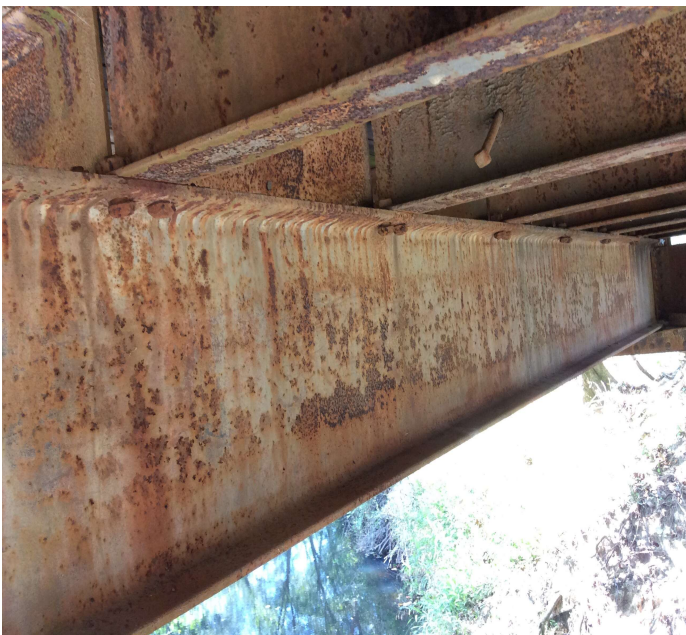
Stringer connections -
Stringers have loose bolted connections.

PHOTO 1 Description L8 Right. Stringer / Floor beam connections

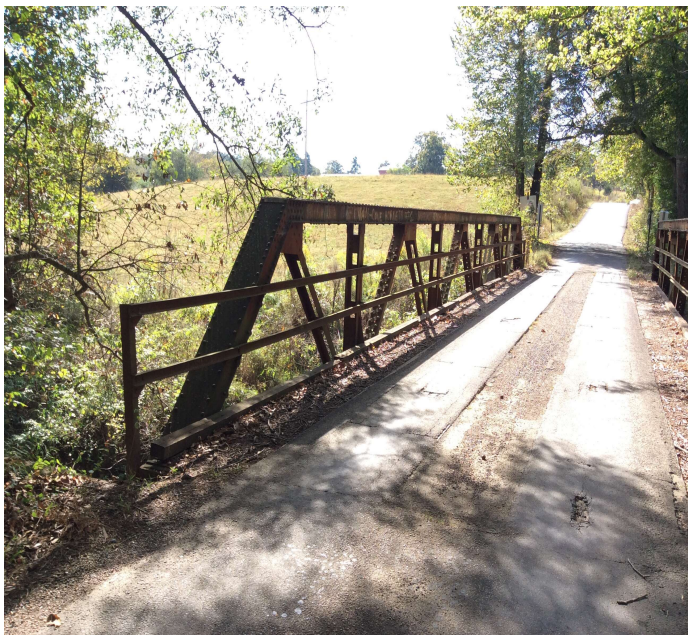
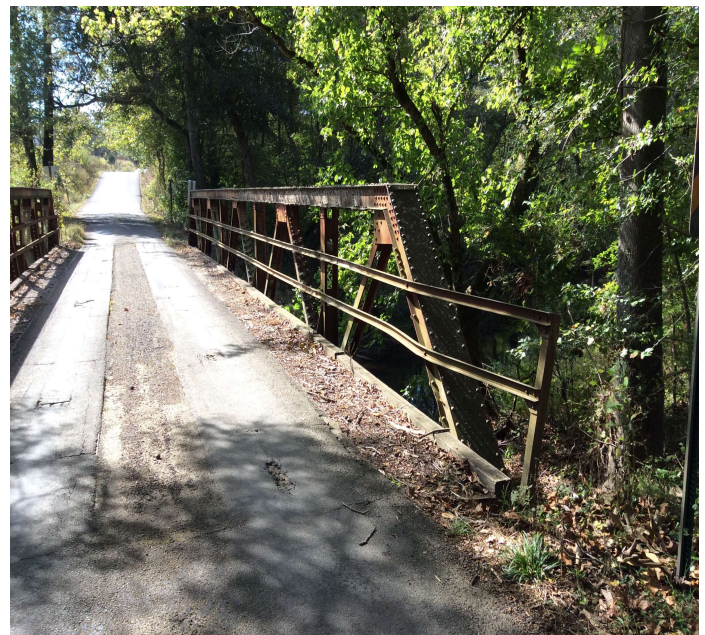
Steel Pony Truss -
Superstructure has no paint system with numerous areas of active corrosion.

PHOTO 1 Description Right Truss. Typical

PHOTO 2 Description Left Truss. Typical

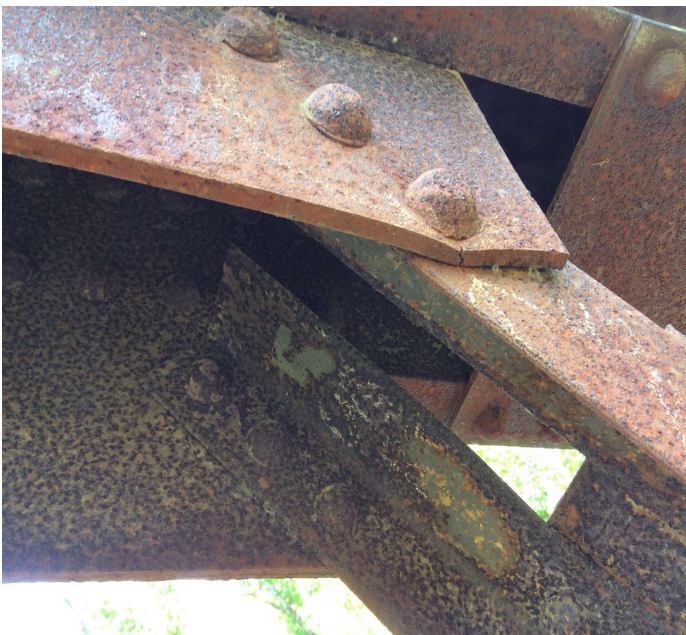
U5 Right exterior connection plate -
U5 right has a short duration crack in the exterior connection plate.

PHOTO 1 Description U5-L6 at U5. Right. 1/8" crack with out of plane bending. No change.

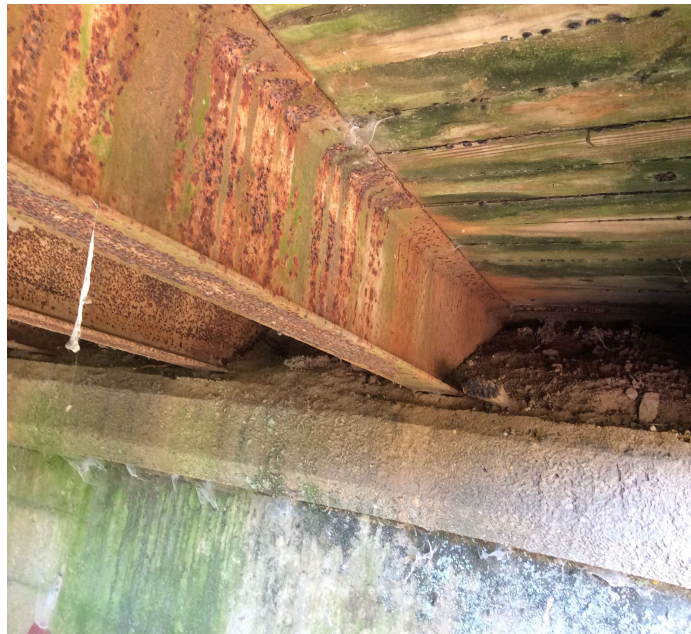
The north and south abutments have dirt and debris on the bridge seats that has accumulated against the steel stringer beams promoting corrosion.

PHOTO 1 Description Bent 2. Dirt on cap.

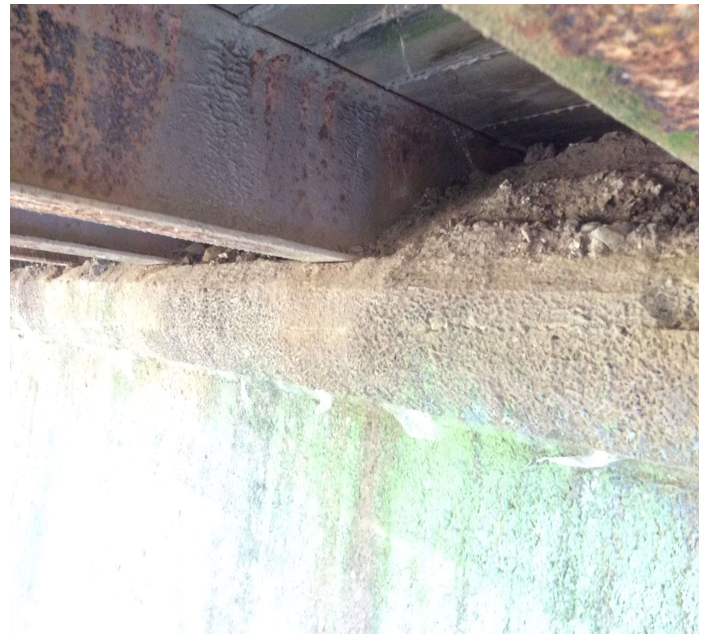
PHOTO 2 Description Bent 1 cap. Dirt on stringers.

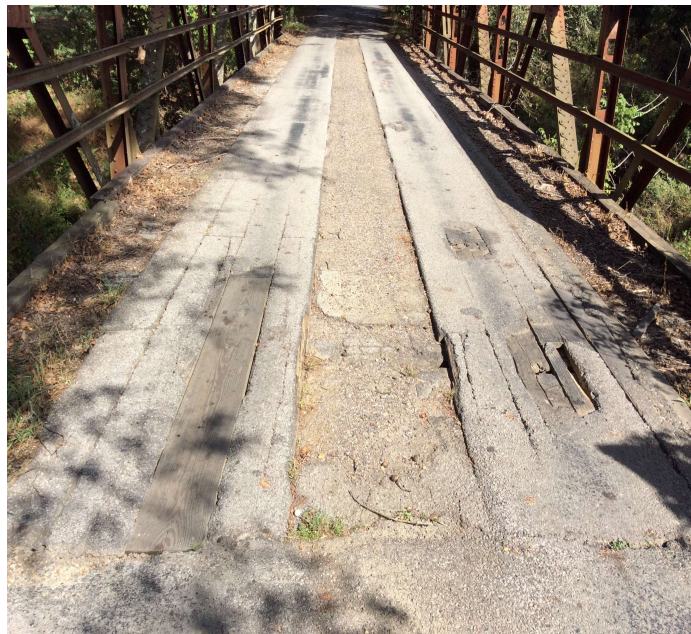
Deck - The deck has a Missing portion of timber 4X4 approximately 4' long between steel stringers # 5 and # 7 near the South abutment. Timber runners are fractured over the fractured deck plank and are loose in other locations.

PHOTO 1 Description Deck. Typical

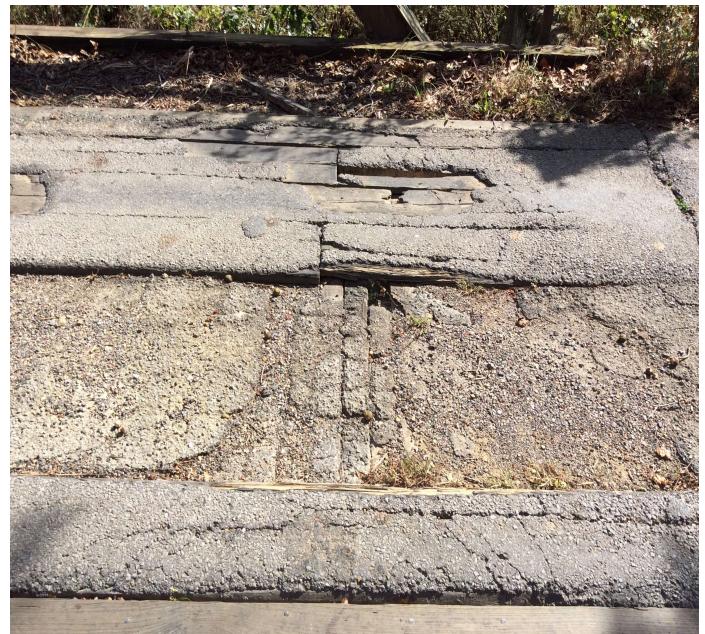
PHOTO 2 Description Deck. Right wheel path. Bay 1.

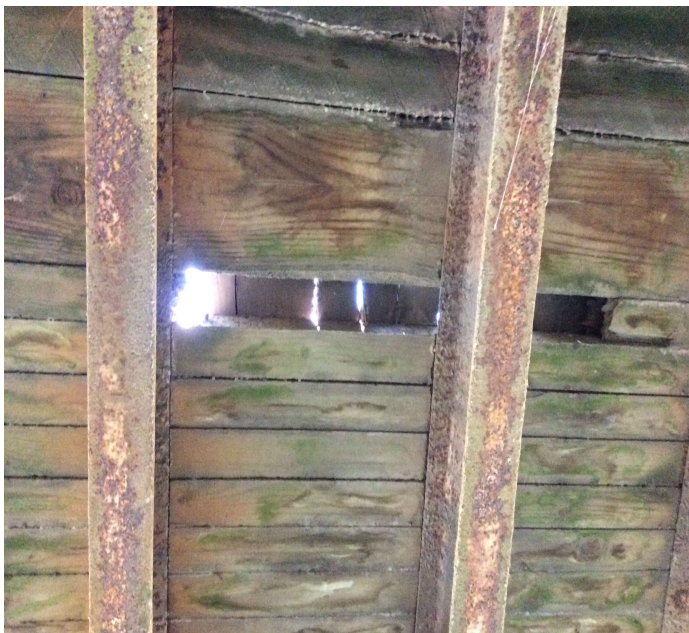
PHOTO 3 Description Deck soffit. Bay 1. Right wheel path.
