Asset #04340(Routine, Underwater type 2)

CR11-Center Point over BARNES CREEK

Location: .40 M W SH 249

Team Lead: Bryan Saunders Inspection Date: 06/12/2023

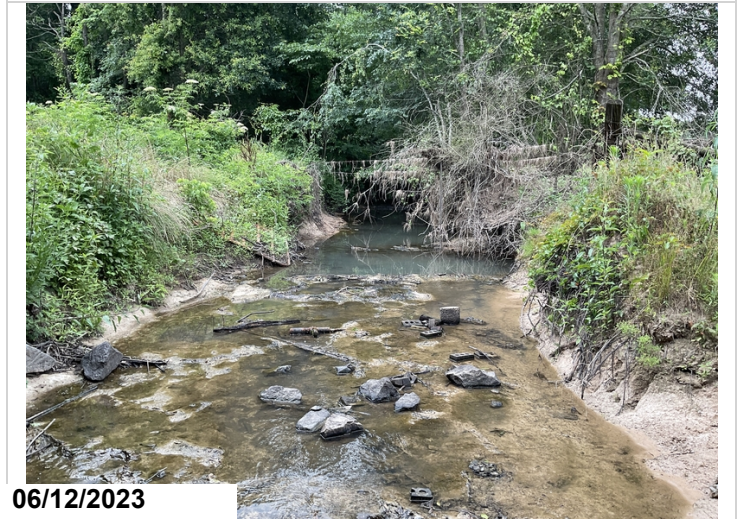
Upstream

61 - Channel/Channel Protection (6 - Bank is beginning to slump. River control devices and embankment protection have widespread minor damage. There is minor stream bed movement evident. Debris is restricting the channel slightly.)

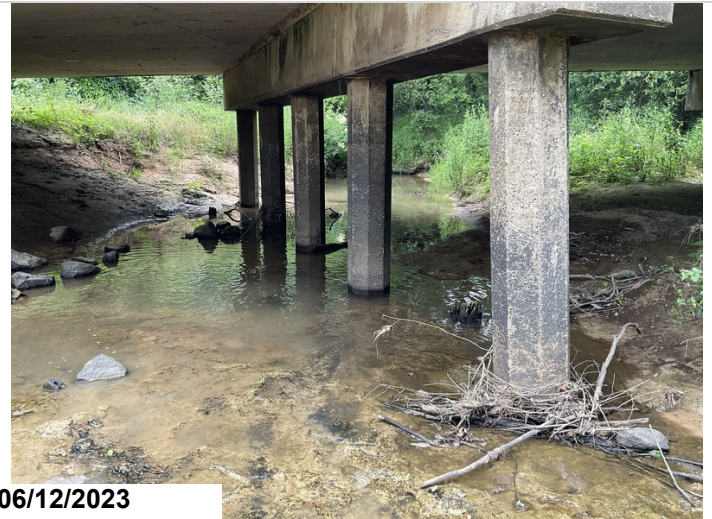
60 - Substructure (7 - GOOD CONDITION - some minor problems.)

All piles have light abrasion

Bent 3 abrasion to piles
