Asset #04761 (Routine, Underwater type 2)
CR 26 (LAWSON RD) over FOURCHE CREEK

Location: 1.0 M E SALINE CO.LINE

Team Lead: Bryan Saunders, Inspection Date: 04/12/2022

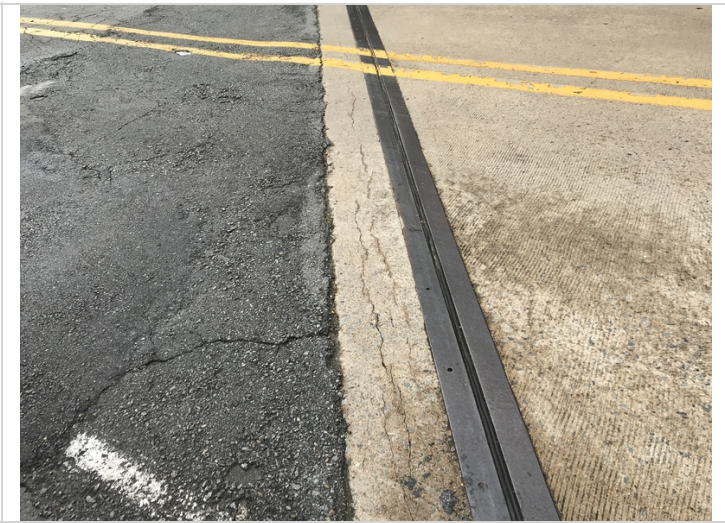
Bt. 1, vertical cracks with efflorescence in the backwall, both abutments have cracks along the top of the backwall.

Bent 1 has cracking in backwall

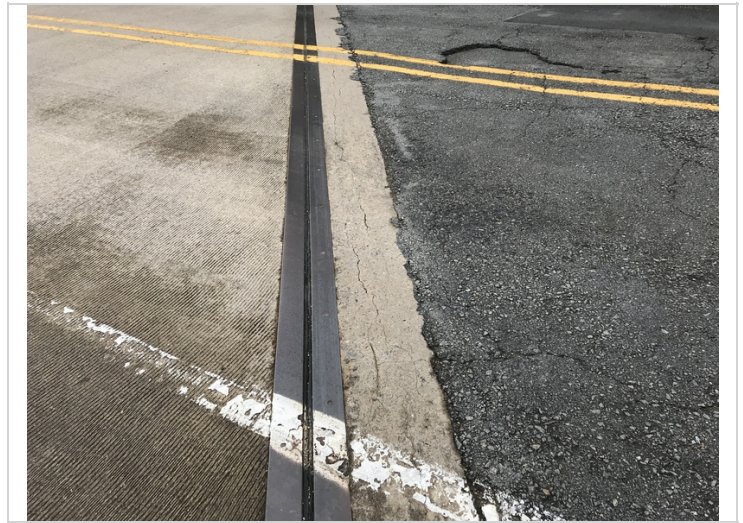
Bt. 4 vertical cracking with efflorescence

Bent 4 has cracking in backwall

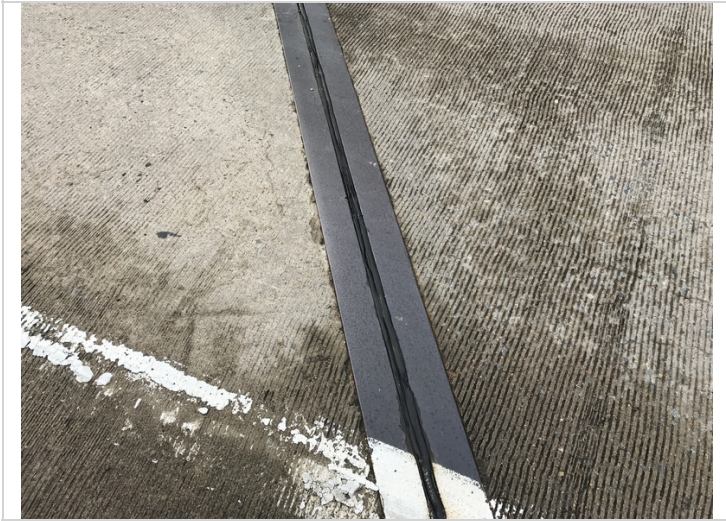
Joints are torn and leaking

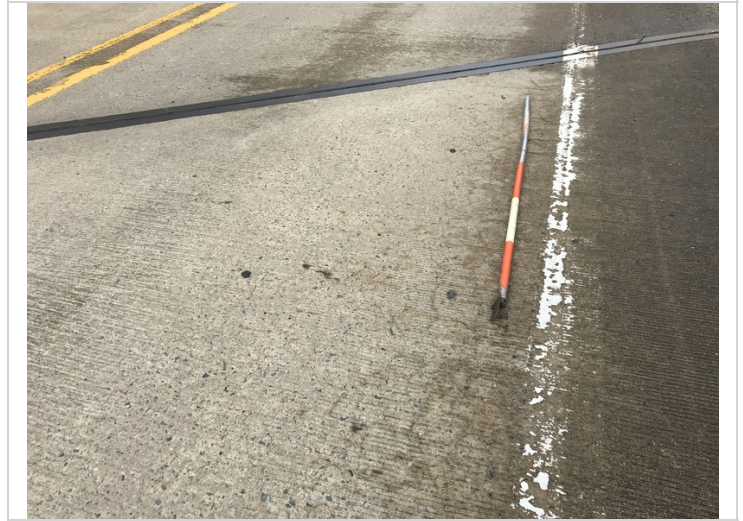
deck has unsealed map cracks

Deck has map cracking

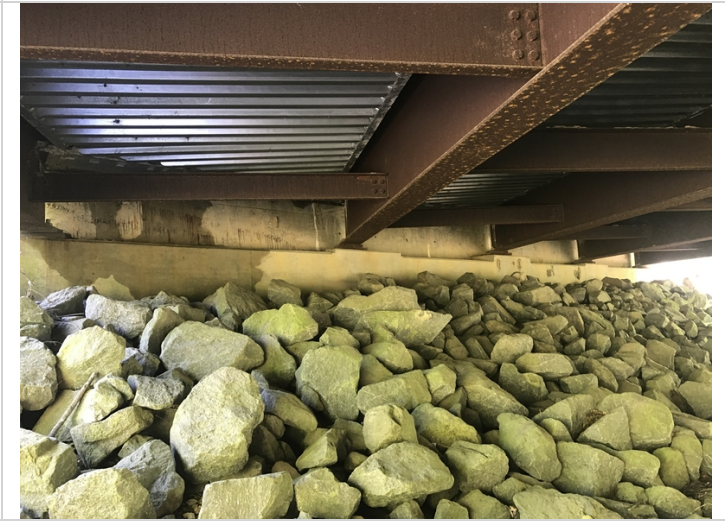
Comment: Bt. 1, vertical cracks with efflorescence in the backwall, both abutments have cracks along the top of the backwall.

Bent 1 cracks with efflorescence.

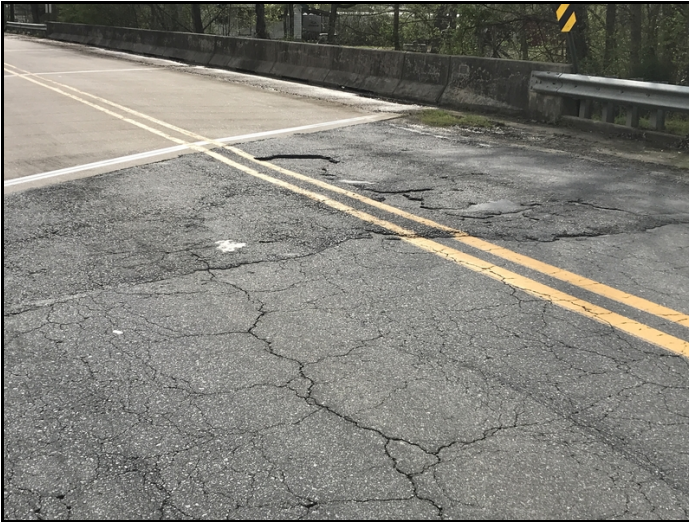
East bound approach , roadway has potholes in the asphalt.

Pothole at bent 4 in the eastbound lane
