Bridge Inspection Report

04695

CO RT 45 / KANIS R

NO. FORK SALINE RIVER

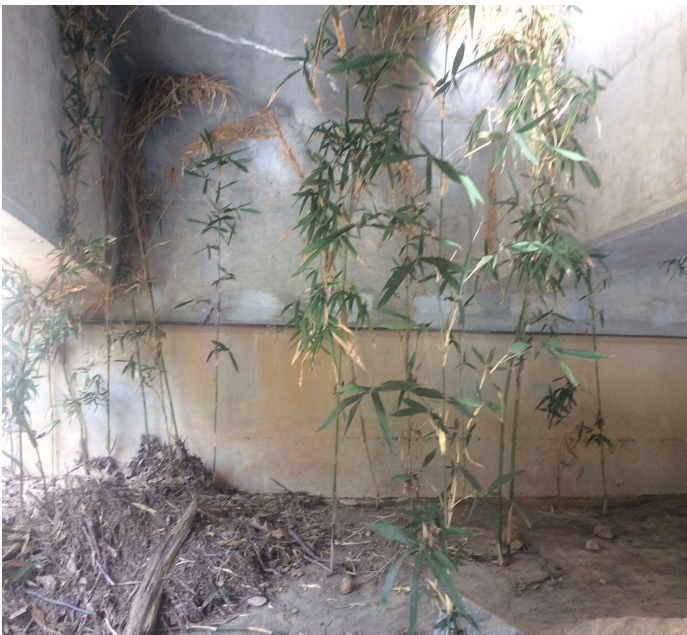
Vegetation under bridge at bent 6 bays 1 and 2. (West end of bridge).

PHOTO 1 Description Bent 6 west end of bridge canes growing under bridge.
