# Bridge Inspection Report

**04269**  
**CR 9-Scott Co.**  
**over**  
**Denton Creek**

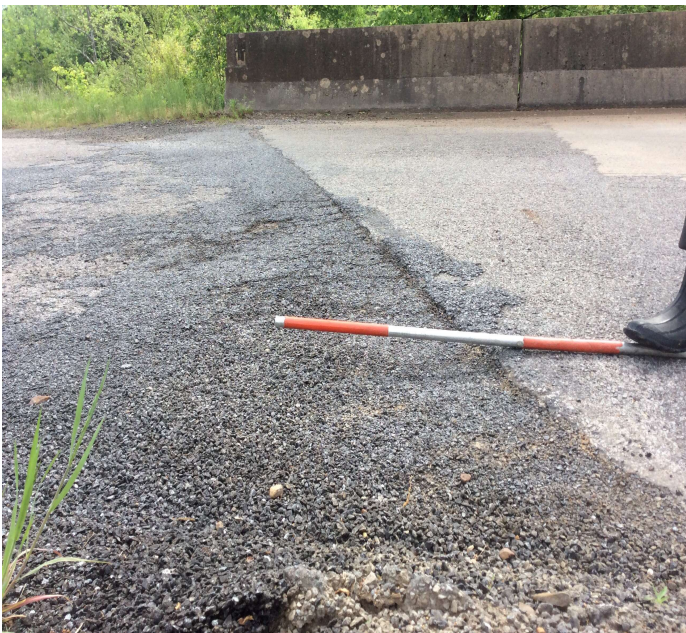
The North approach road has settlement with asphalt cracking and potholes at the bridge end.

PHOTO 1      Description      The North approach road has settlement with asphalt cracking and potholes at the bridge end.

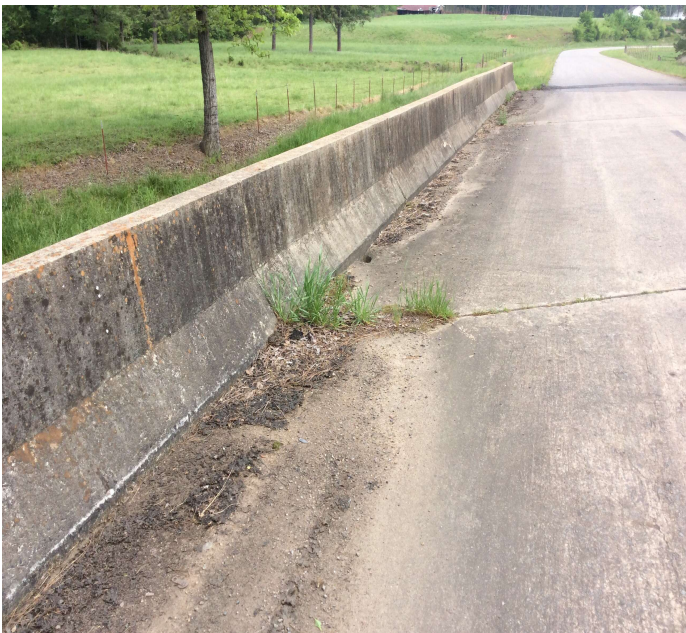
Dirt, debris and vegetation along the Lt and Rt gutters.

PHOTO 1      Description      Dirt, debris and vegetation along the Lt and Rt gutters.

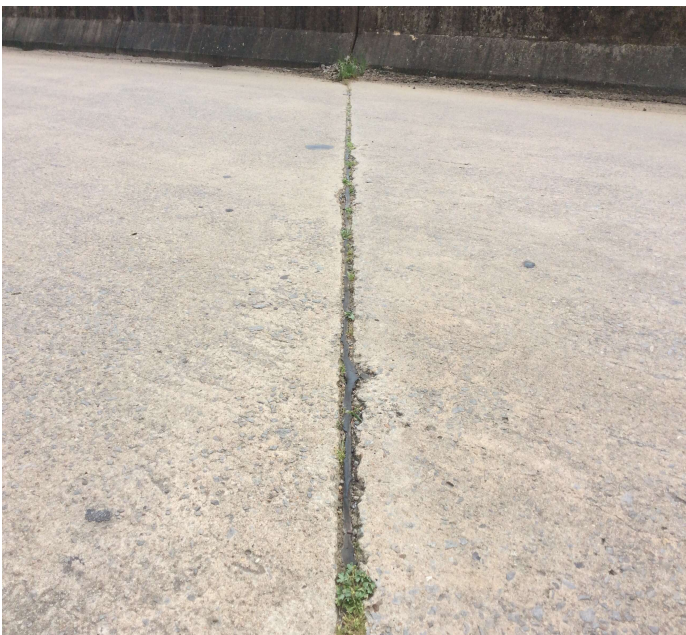
Deck joint sealant is deteriorated and impacted with dirt and debris allowing water to leak on the substructure.

PHOTO 1      Description      Deck joint sealant is deteriorated and leaks water on the caps.

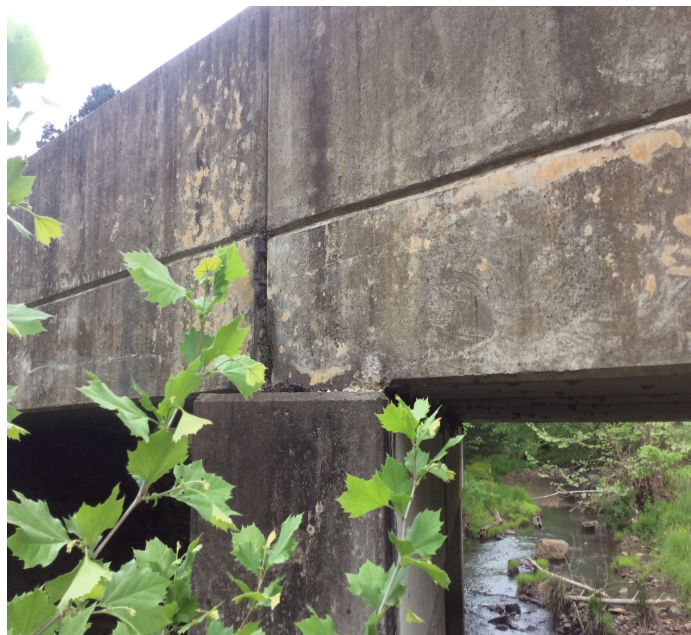
Minor spalling in the edges of the deck and in the caps of Bents # 2 & 3.

PHOTO 1      Description      Minor spalling in the edges of the deck and in the caps of Bents # 2 & 3.
