Bridge Inspection Report

22779

Co.Rd. 39

Prairie Creek Seb. Co.

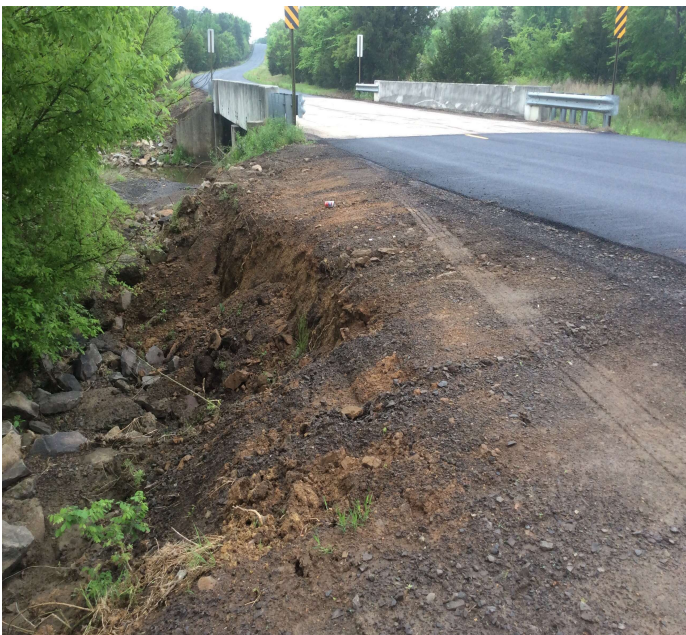
Northeast embankment - The Northeast embankment has an area of erosion adjacent to the North approach roadway. The erosion has not reached the edge of the roadway at this inspection.

PHOTO 1 Description The Northeast embankment has erosion adjacent to the roadway.
