Bridge Inspection Report

22780
CR 39 A
over
Dickson Branch Seb. Co.

Structure Number: 22780

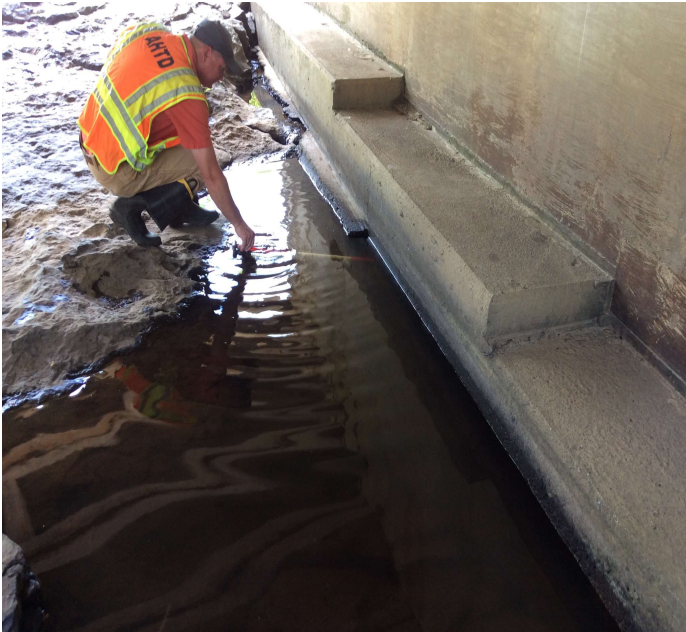
The footings of all bents have minor undermining that has created shallow voids that penetrate up to 3" under the footings. The voids do not reach the columns or abutment breast walls at this inspection.

PHOTO 1 Description Bent 1 minor voids under edge of footing.
