Asset #04607(Routine)

CR 304 EAST MAGNOL over BIG BELLVILLE CREEK

Team Lead: Charlie Rogers, Inspection Date: 02/15/2022

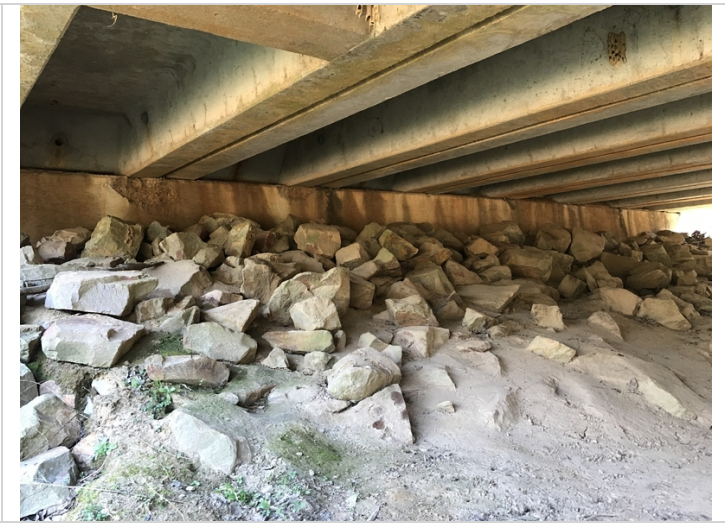
Bent 1 abutment

Comment: 2/15/2022...Spalls on end abutments. Steel encasements on pile starting to rust in various locations...

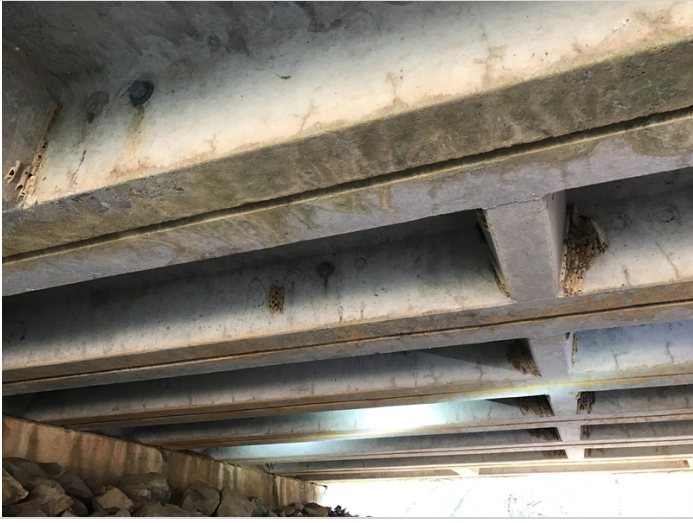
Comment: 2/15/2022...Small typical hairline cracks throughout under side of the deck precast units...

Underside of deck typical all spans 2/2022

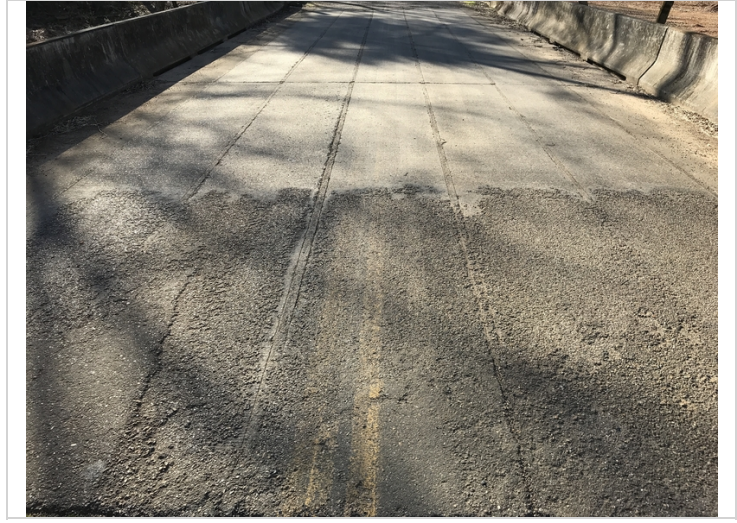
Deck 2/2022

Comment: 2/15/2022....All top flange joints have grout in them per this inspection. All joints have loss of pourable joint material...
