Asset #20440(Routine, NSTM)

CR 304 E MAGNOLIA over BRANCH OF BELLVILLE CR

Location: 1 MI SO OF LOCKSBURG

Team Lead: Jared Kegley, Inspection Date: 06/26/2023

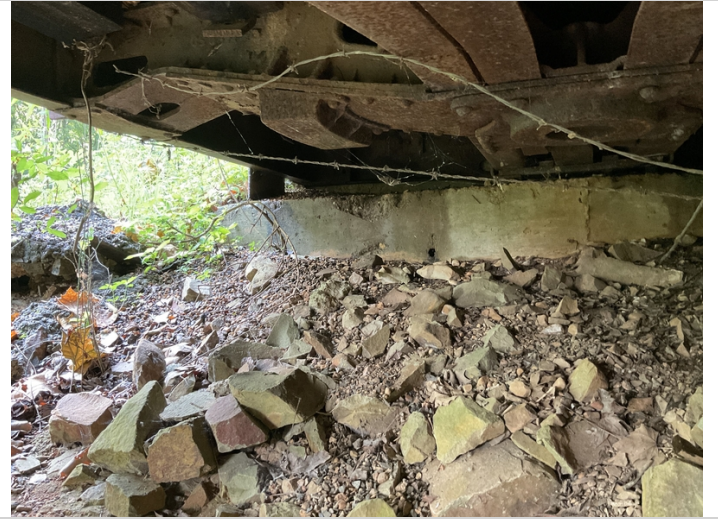
Dropped substructure rating to a 6 due to heavy abrasion on bent 1 with spalling on bent 2 abutment.

Bent 2 spall

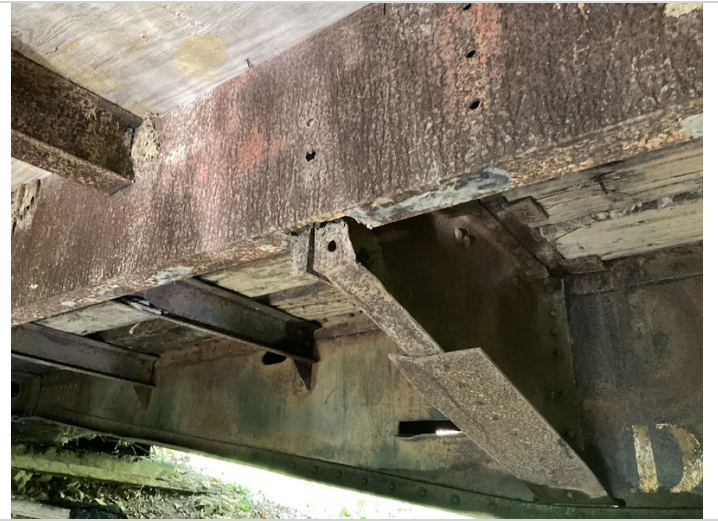
Damage to stringer 2

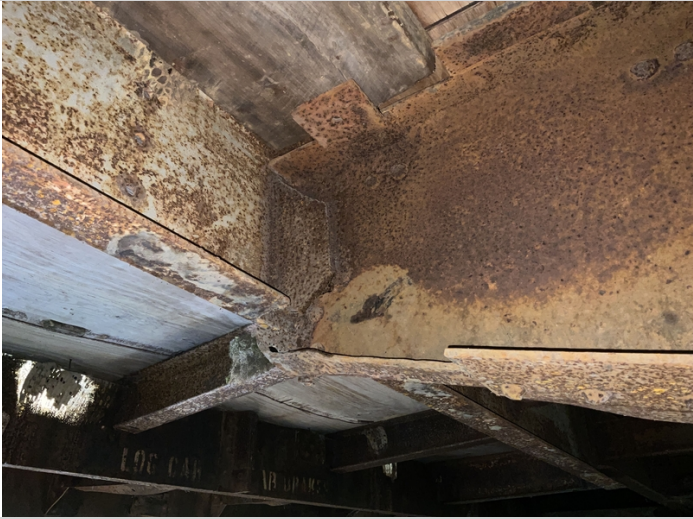
Stringer 2 welded on backside

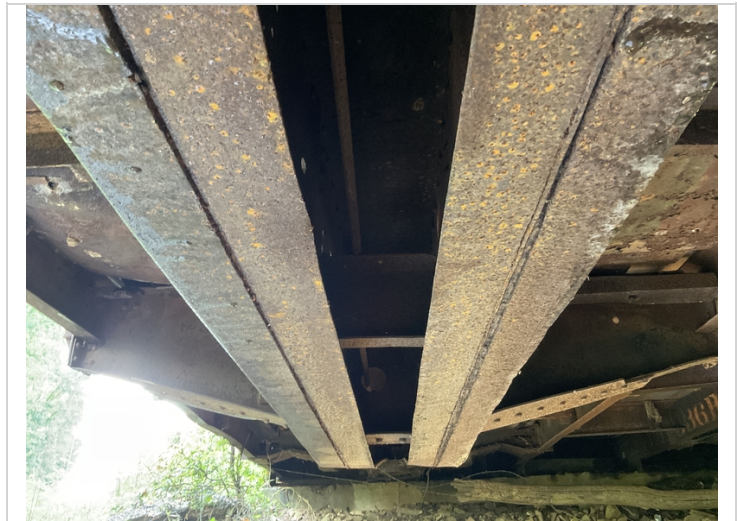
Superstructure is rated a 4 this inspection due to both main beams 1 & 2 as well as bracing having advanced corrosion with pitting throughout various locations. Old damage to beam 1 has large vertical crack near mid span. Portion of crack has been welded on both sides of beam.

Corrosion on beams

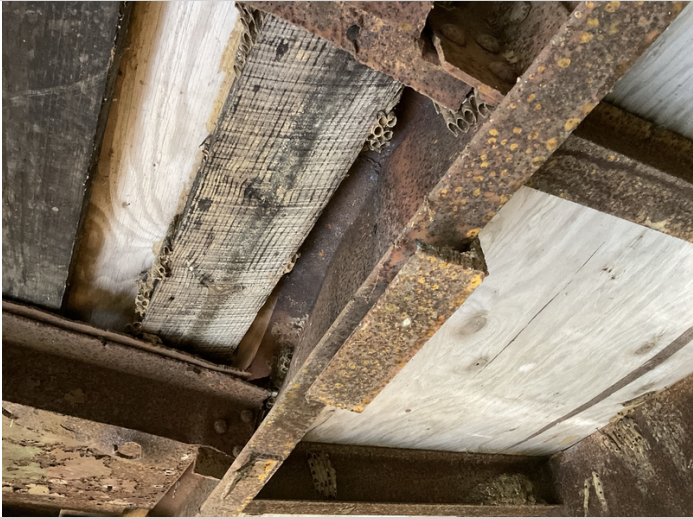
Corrosion on bracing

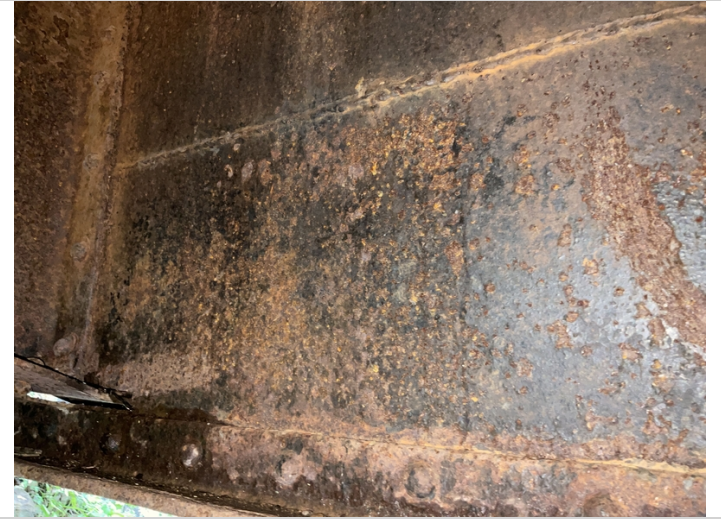
Corrosion on beams

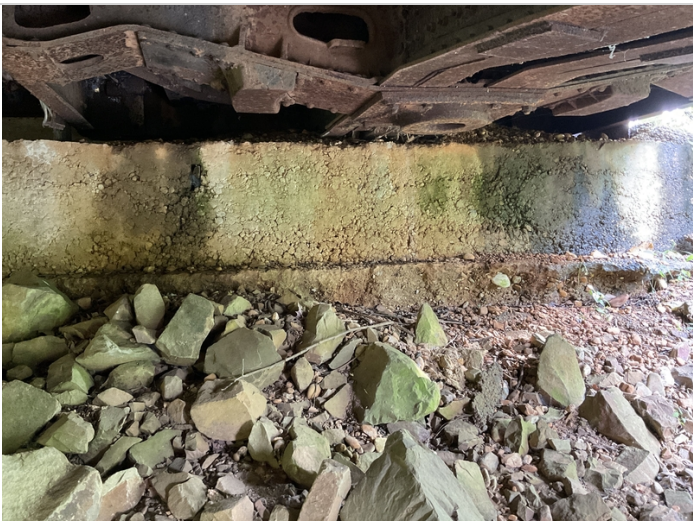
Bent 1 abrasion

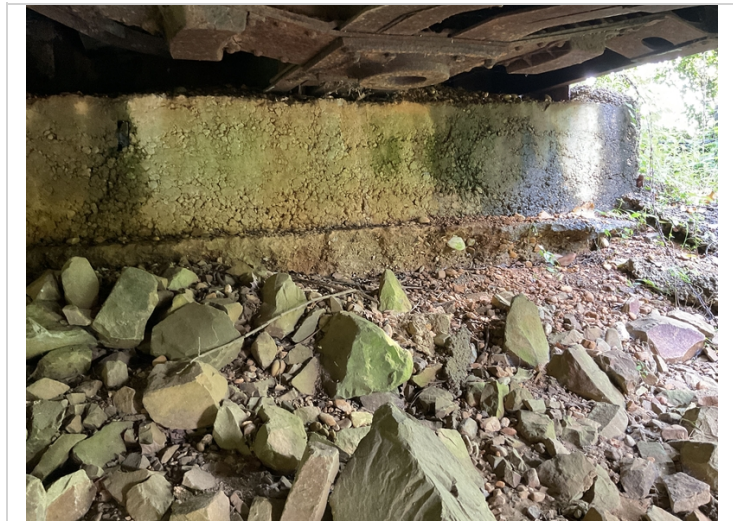
Scour rating is a 6 due to isolated moderate scour around bent 1 abutment.

Bent 1 scour

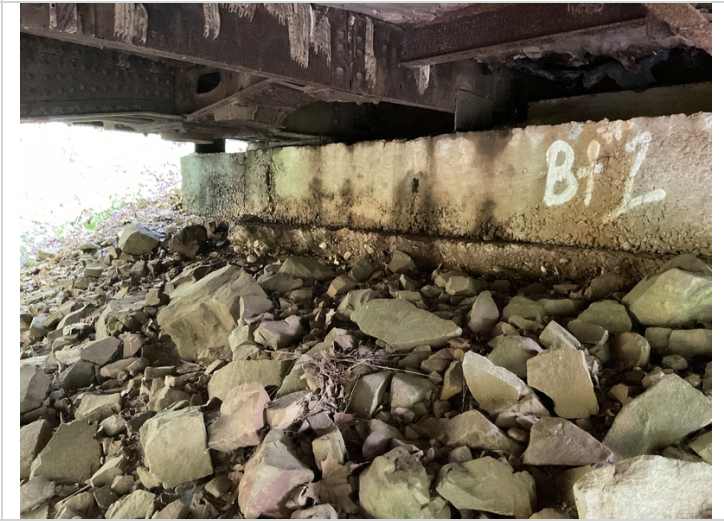
Bent 1 scour

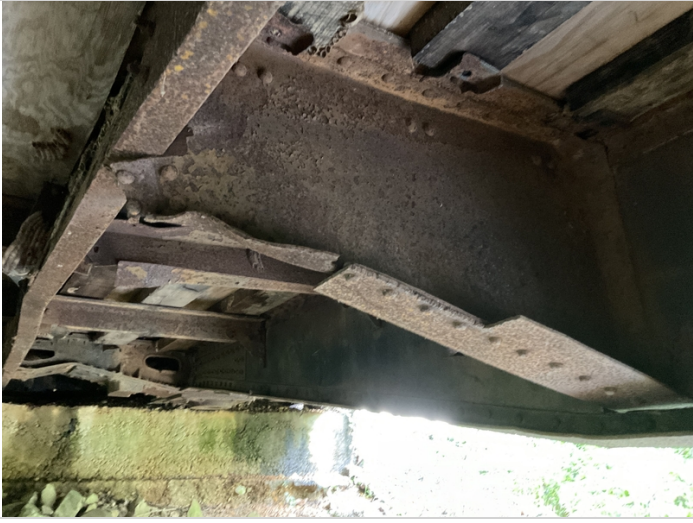
Damage to bracing on inside of beam 1

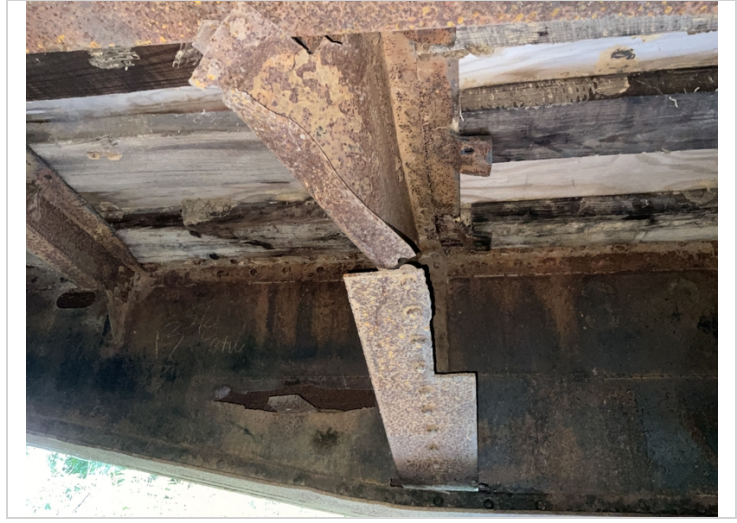
Damage to bracing on inside of beam 1

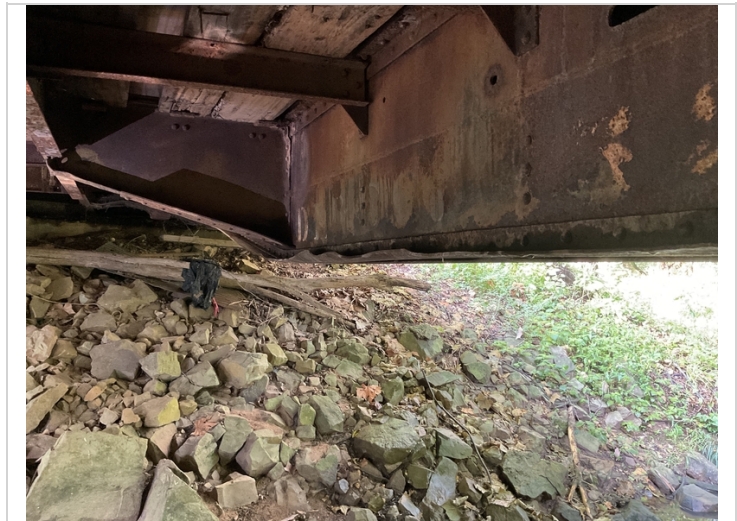
Old damage to beam 2

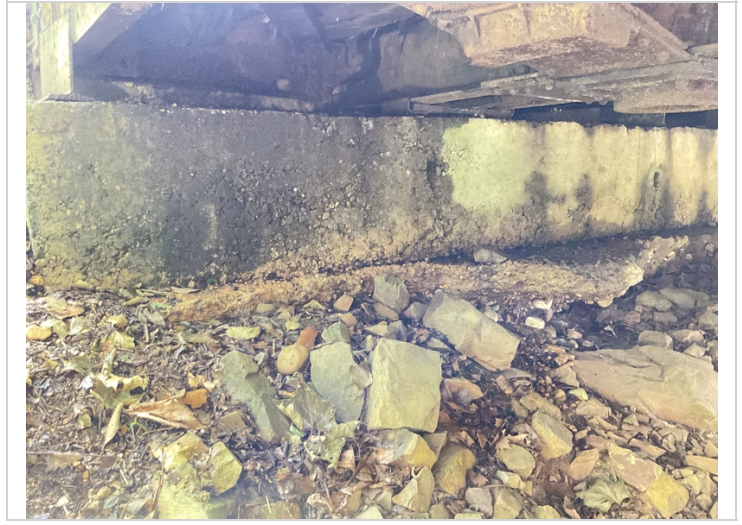
Bent 1 abrasion

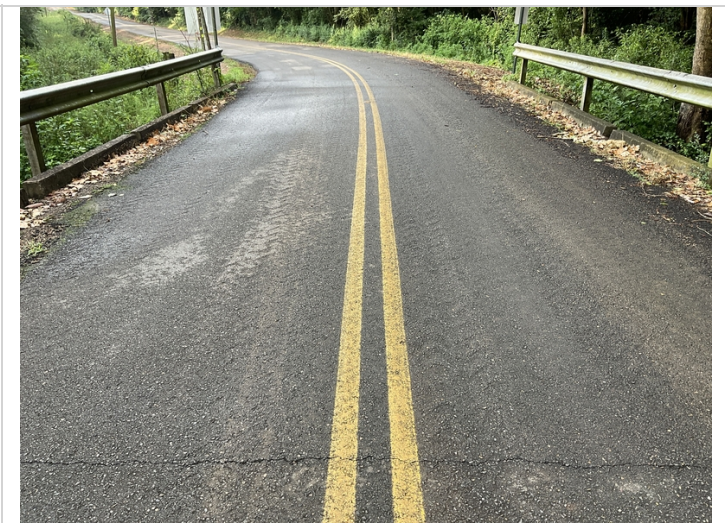
Deck photo. Deck has chip seal overlay

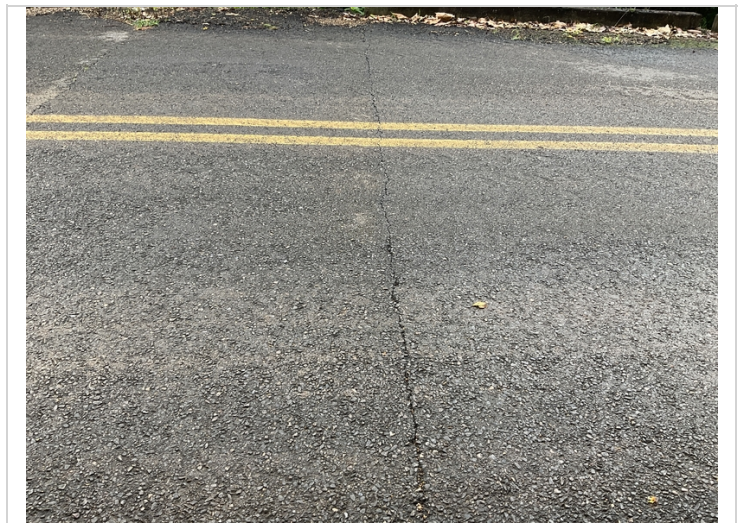
Cracking in wearing surface

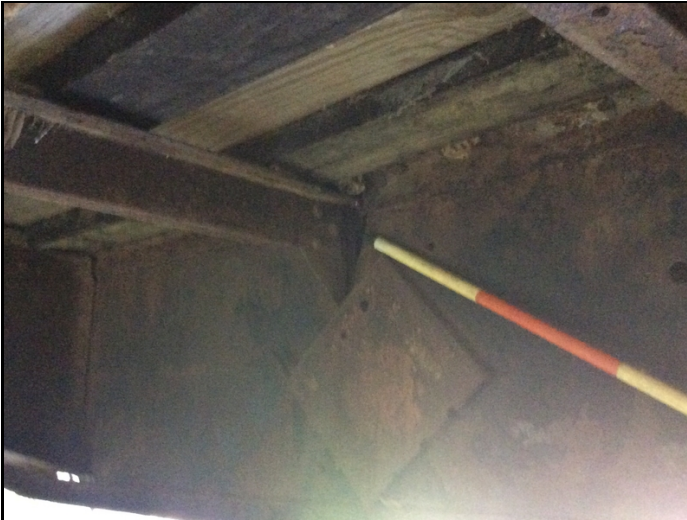
OLD DAMAGE TO MAIN BEAM CAUSING LARGE VERTICAL CRACK. PORTION OF CRACK HAS BEEN WELDED ON BOTH SIDES AND PORTION HAS PLATE WELDED OVER CRACK ON BOTH SIDES. SOME PORTION OF CRACK STILL REMAINS OPEN AT TOP OF MAIN SILL. SEE DRAWINGS AND PHOTOS DATED 6/11/2014.

Inside of car plate over crack. Crack still visible at top of sill

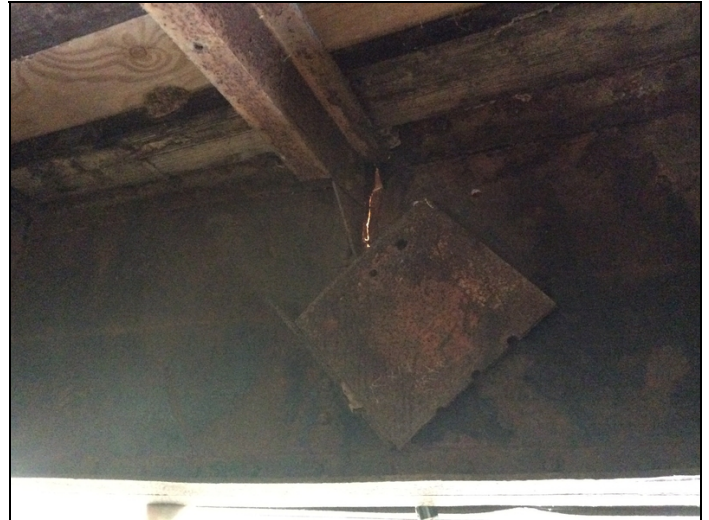
Crack on main beam car 1

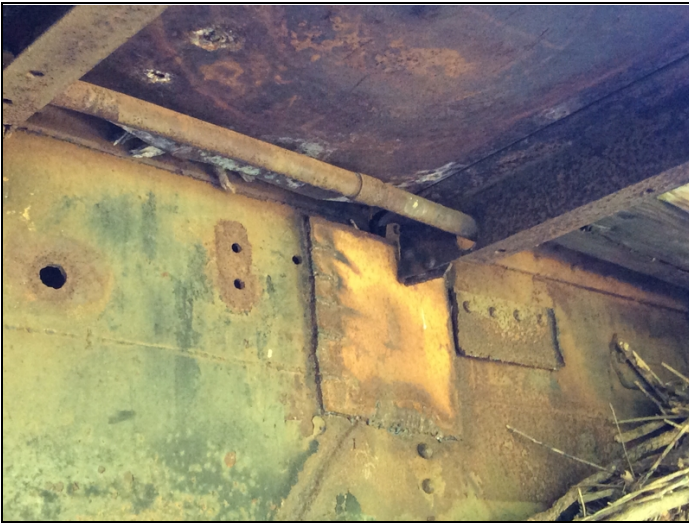
Crack outside of main sill. Plate welded over crack crack
still visible above plate
