Asset #23150(Routine)

C.R. 33 N. PARK AV over RUSSEY CREEK

Location: 0.5 MI. N. OF LOCKSBERG

Team Lead: John King, Inspection Date: 06/06/2022

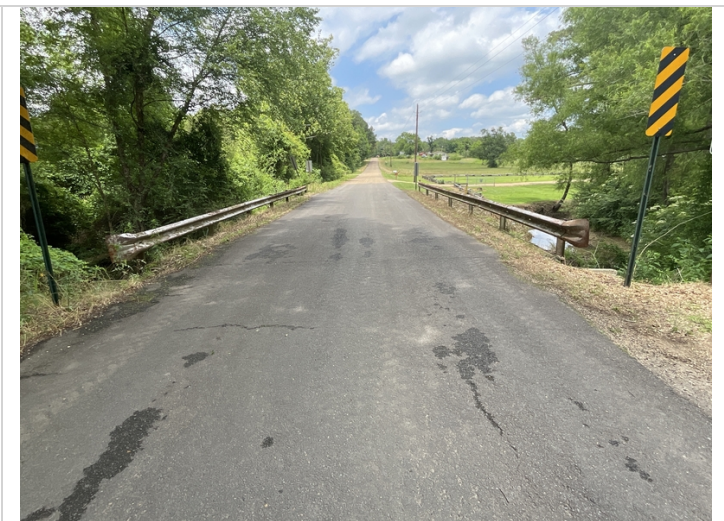
6/22 deck photo

Asphalt overlay, 1" thick. 6/22 deck pans on bottom side starting to rust..

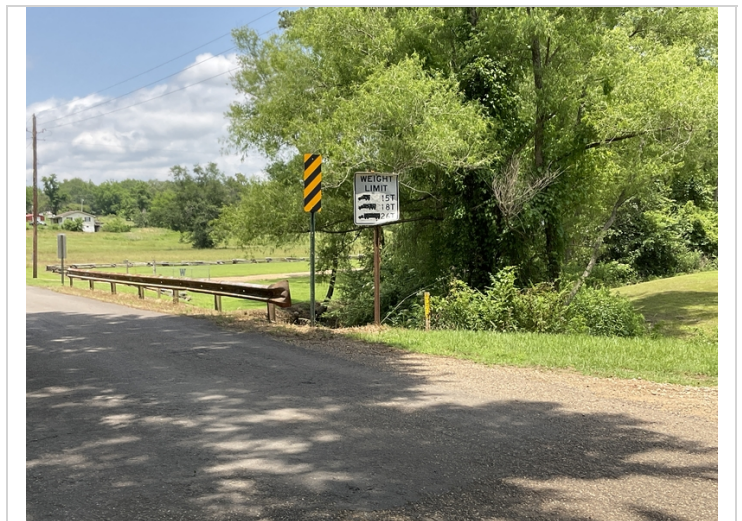
county judge has the bridge posted not required by state....

Posting beginning of bridge bridge. Not required by the state to be posted

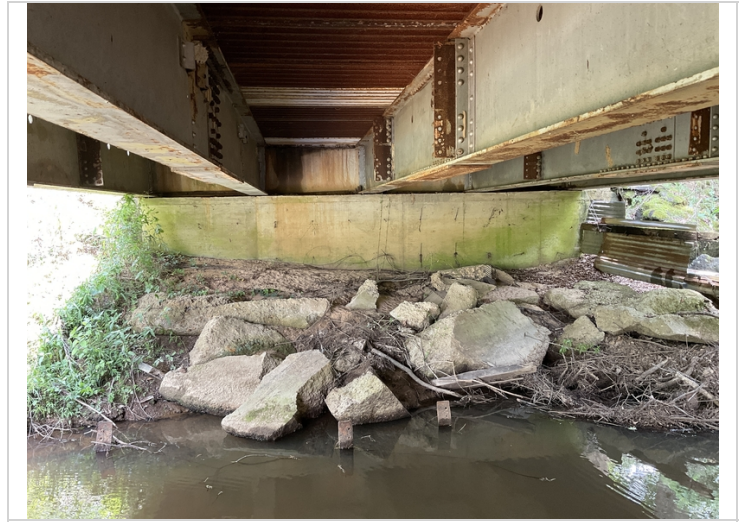
6/22 abutment

6/22 concrete alignment in good shape. Small spall abutment 2 top edges lowered to 7 good

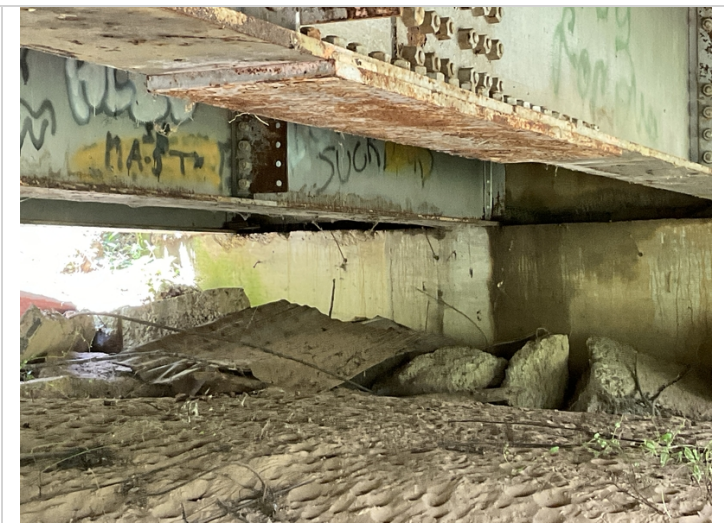
6/22 concrete alignment in good shape. Small spall
abutment 2 top edges
