Date 8-27-2008

Br. No. 23150

BRIDGE INSPECTION REPORT — FORM III

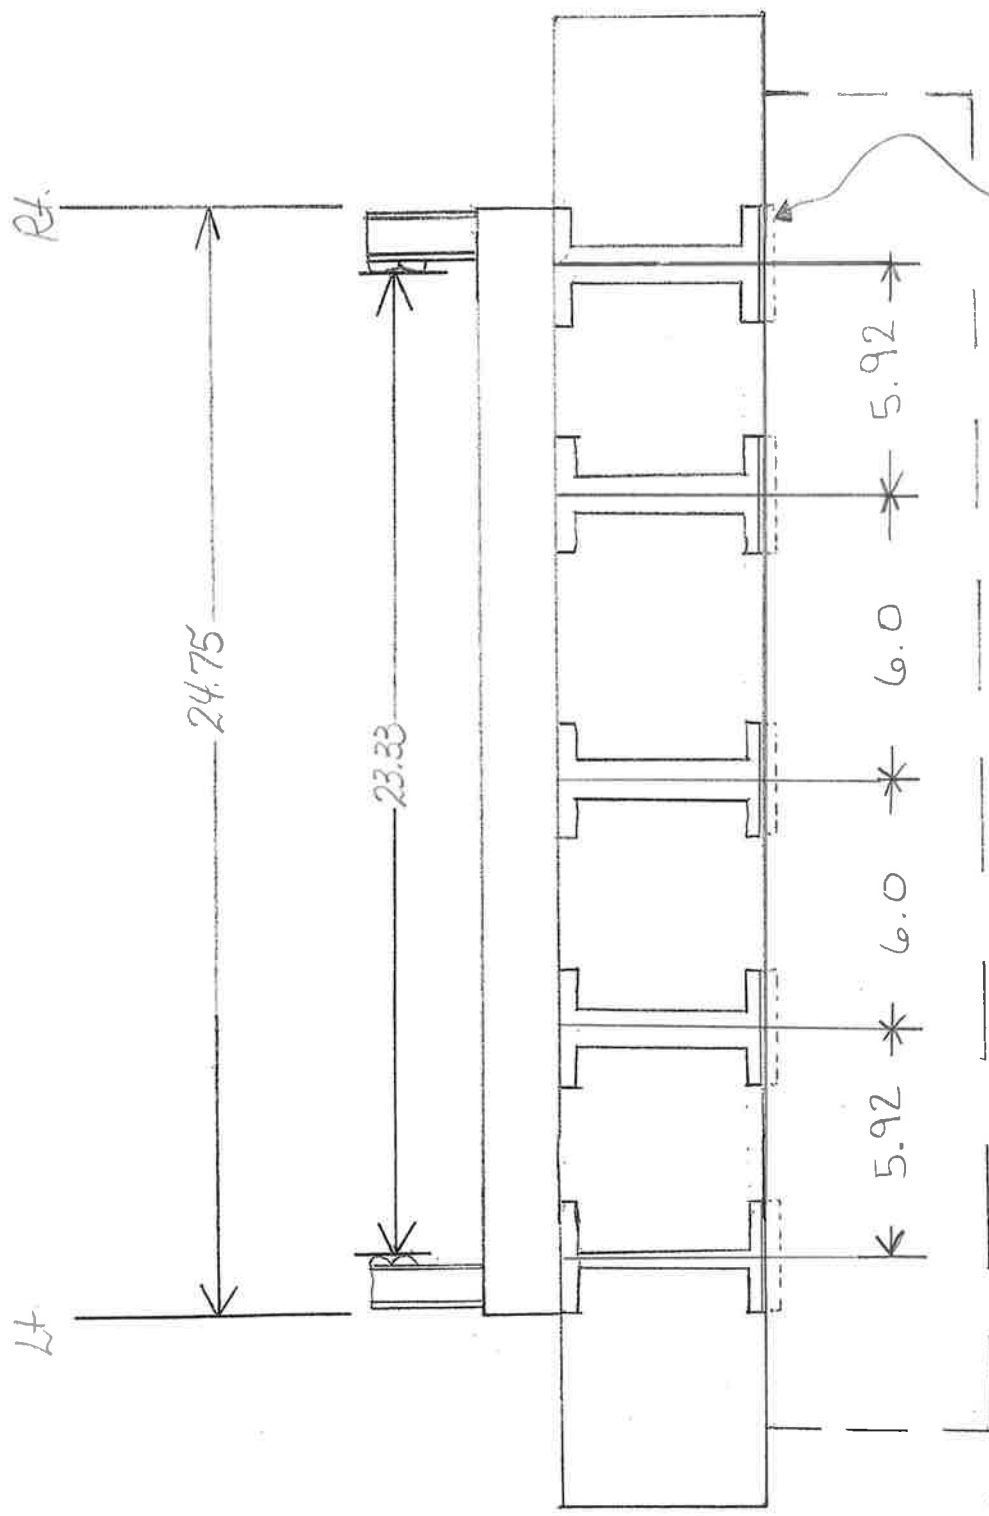
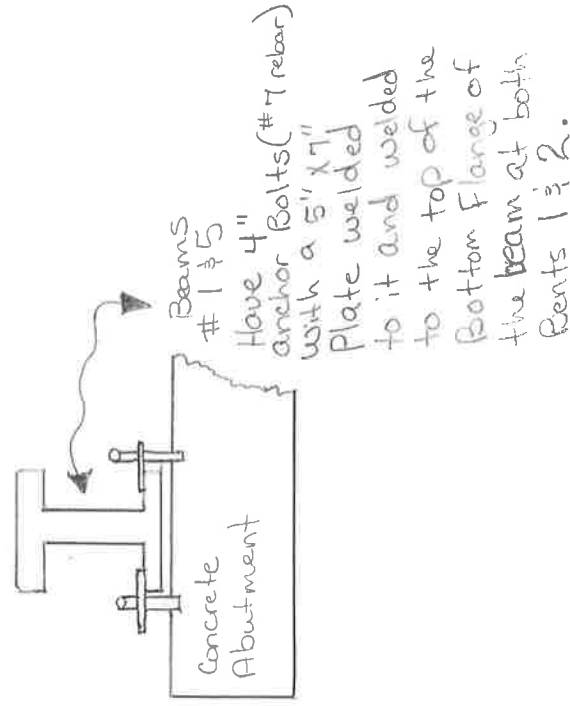
# Beam Layout (Looking Ahead)

Beams # 1 thru # 5 on Bent 1 and Beam # 3 at Bent 2 all set on these plates. Beams # 1, 2, 4 & 5 at Bent # 2 set on top of the Concrete Abutment.
