Asset #23232(Routine)

CR 33,N PARK AVE-H over COLD BRANCH

Location: 1 MILE N LOCKESBURG

Team Lead: John King, Inspection Date: 06/06/2022

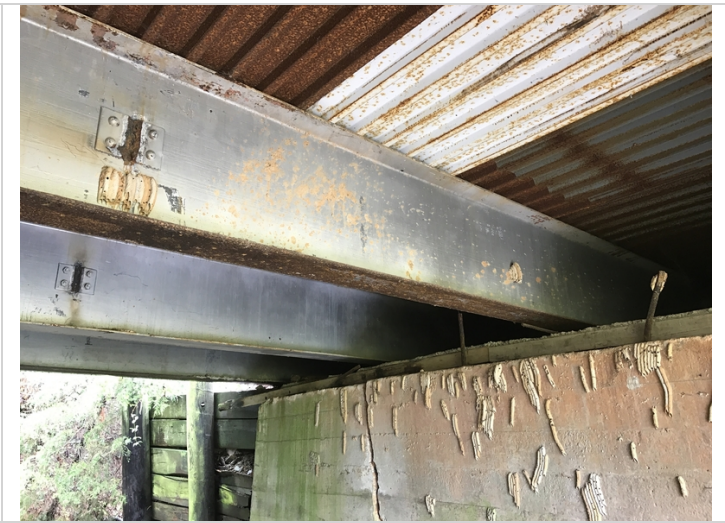
8 very good....6/23/2020...Dropped superstructure to a 7 due to paint loss with some corrosion in various locations... 6/22 little to no change per this inspection...

Beam 3 bottom flange has some corrosion

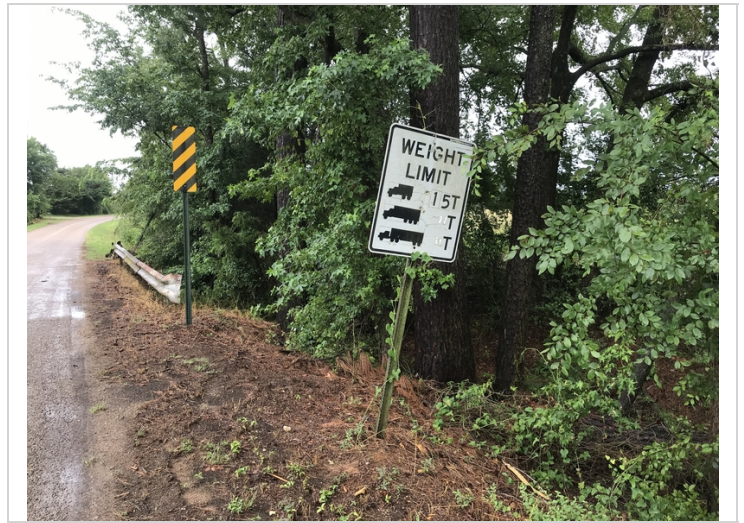
6/23/2020...Bridge has a posting sign at beginning of bridge only, posting is not required...

Posting beginning of bridge

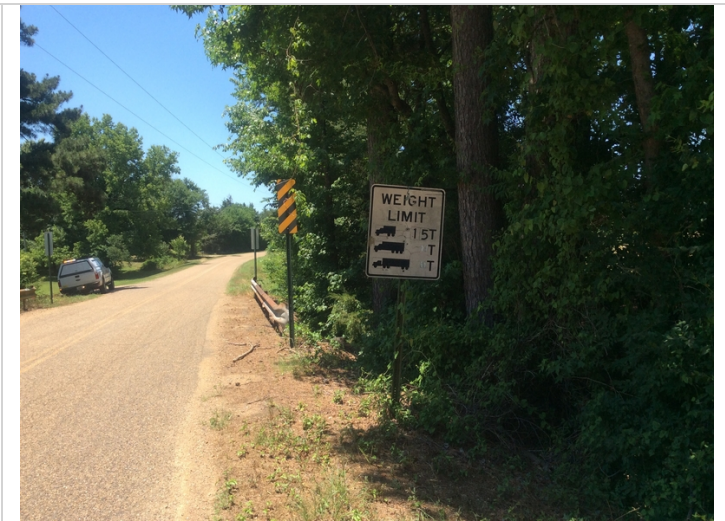
POSTING PHOTO BEGINNING OF BRIDGE

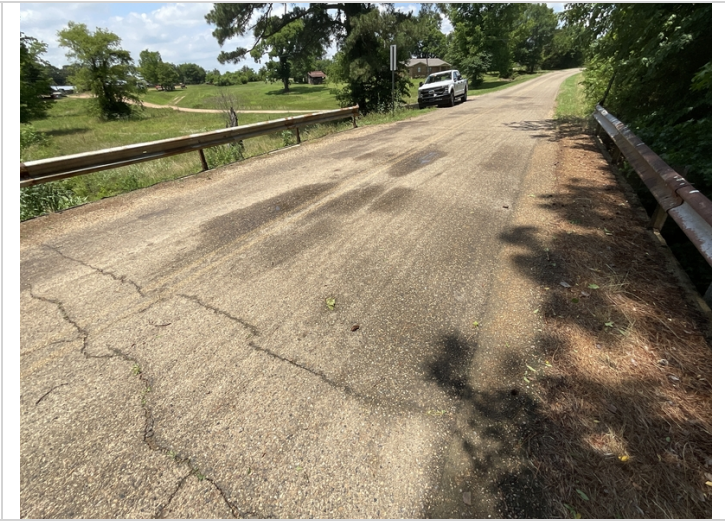
6/22 deck

6/22 asphalt overlay on deck 1.5 inch deck pans rusting on bottom of deck....
