Bridge 23414 Inspection Report

IDENTIFICATION	
(1) State Names	5 - Arkansas
(8) Structure Number	23414
(5) Inventory Route	1
(2) Highway Agency District	03 - District 03
(3) County Code	133 - Sevier County

Team Lead: John King, Inspection Date: 06/16/2025

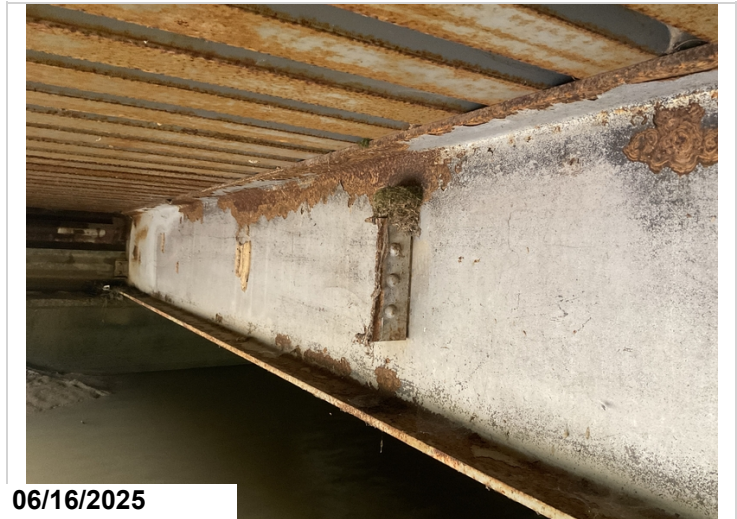
The superstructure is rated a 6 this inspection due to there being minor pitting at the beam ends and paint loss. on all steel beams.

All steel beams have paint loss, CS2.

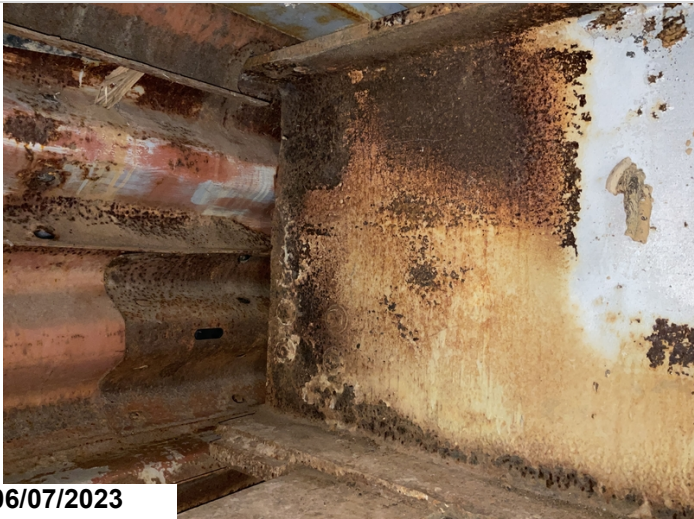
Bent 2, beam 2, section loss in various locations, CS3.

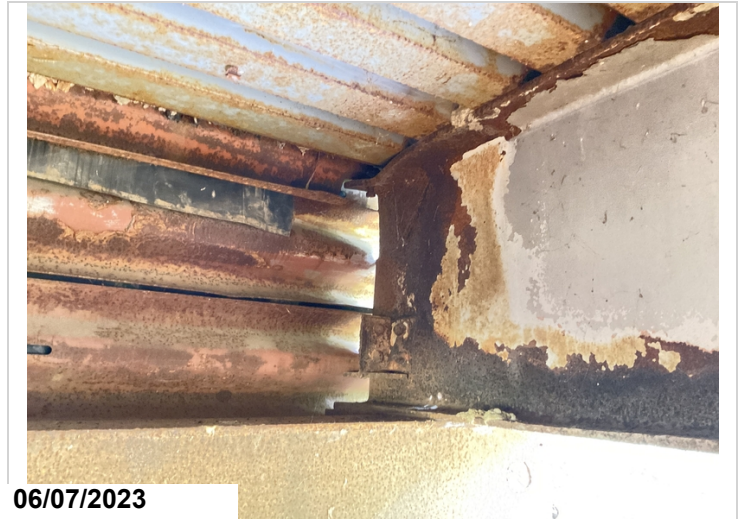
Bent 2, beam 5, The steel beam has damage, CS3.

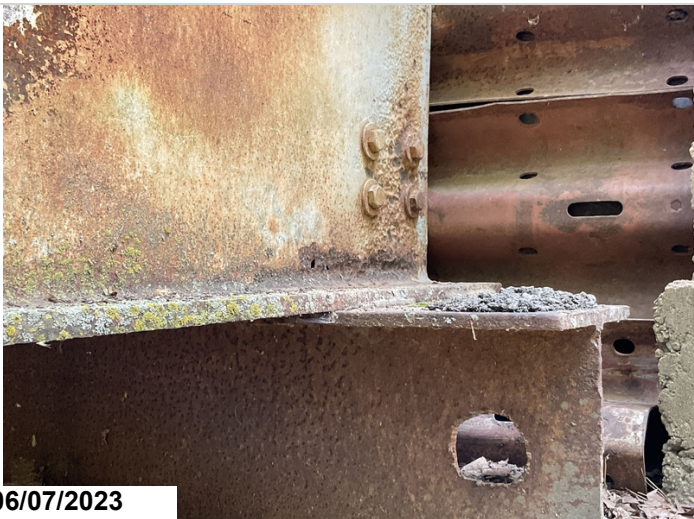
Bent 2, Beam 5, small holes in the beam; it's 13" from the end of the beam in the web area, CS3.

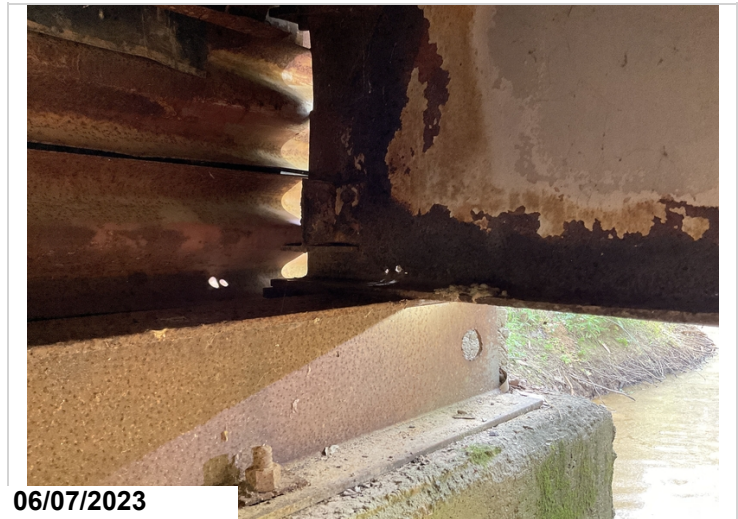
Bent 2, beam 5, small holes with minor section loss, CS3.

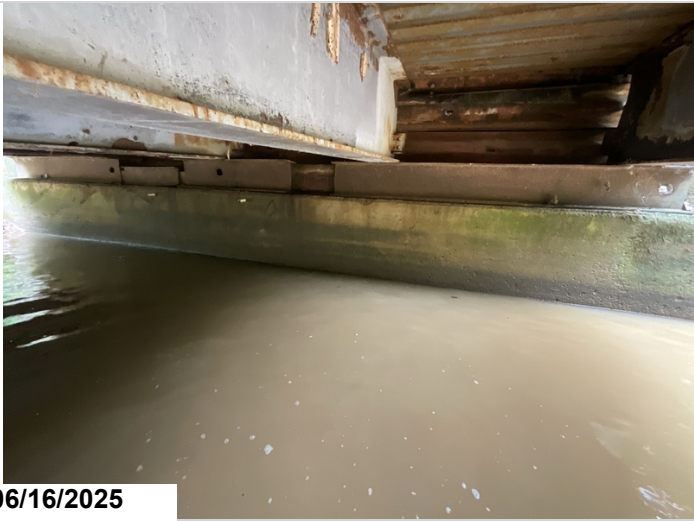
Bent 1 abutment.

The substructure is rated a 6 this inspection due to abrasion/wear in bents 1 & 2 abutment in various locations.

The scour is rated a 6 this inspection due to bents 1 and 2 abutment having minor to moderate scour. Note: The water was high. in order to see the scour.

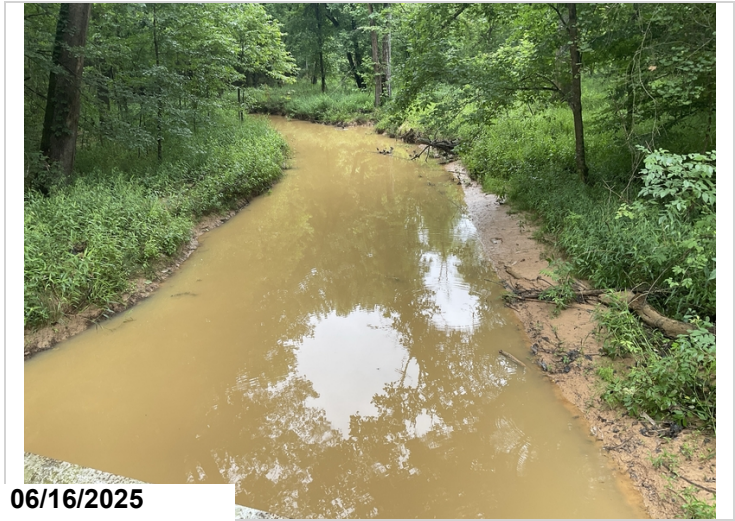
The channel is rated a 6 this inspection due to the upstream channel and downstream channel beginning to slump. Note:

Downstream channel.

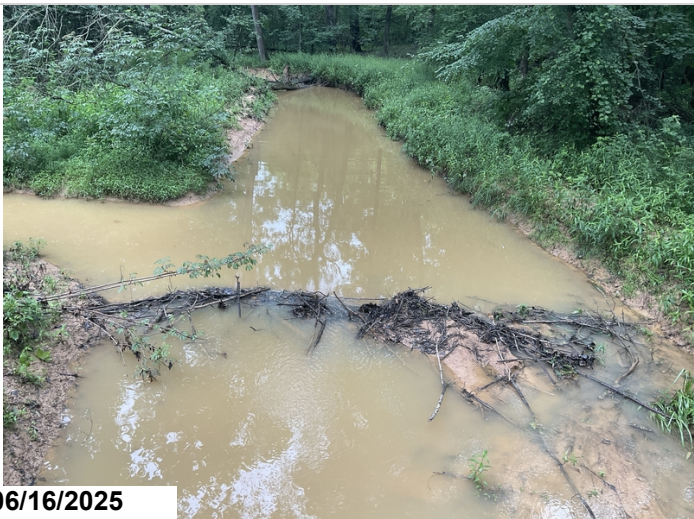
The upstream channel has a beaver dam.

Upstream channel.

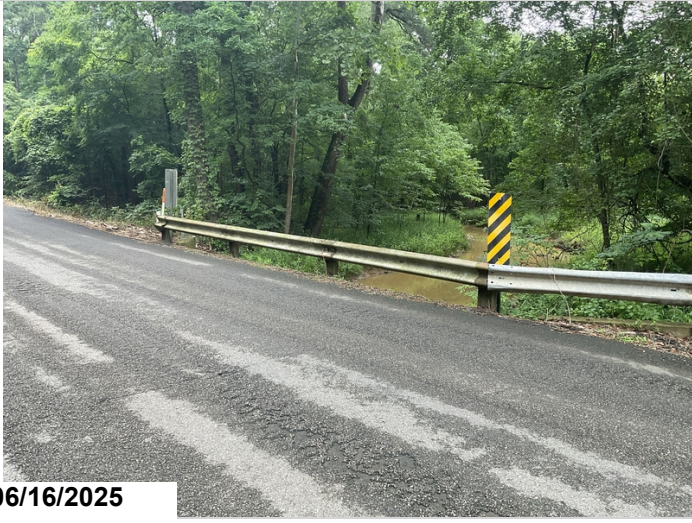
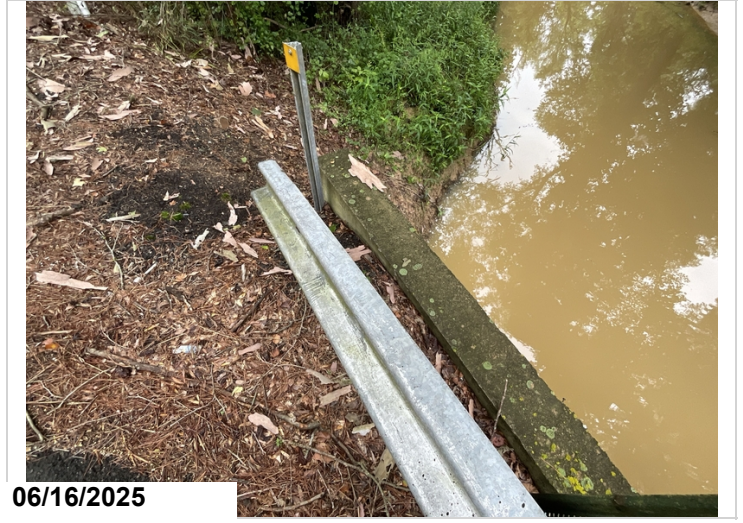
The bridge transition on the left side at beginning of bridge is disconnected.

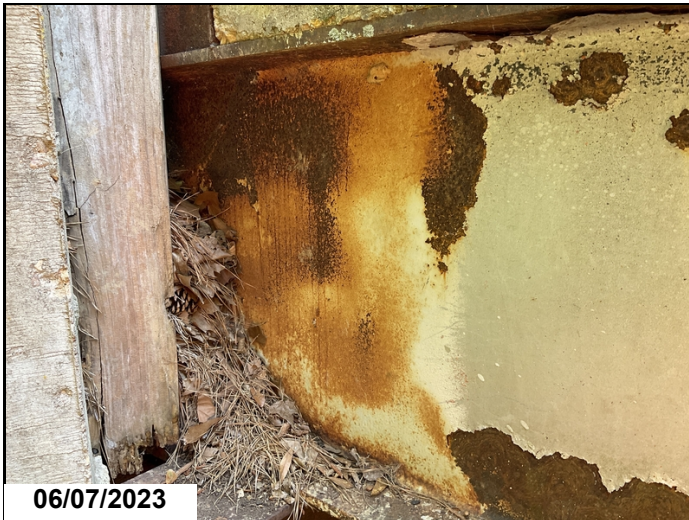
Corrosion to beam ends

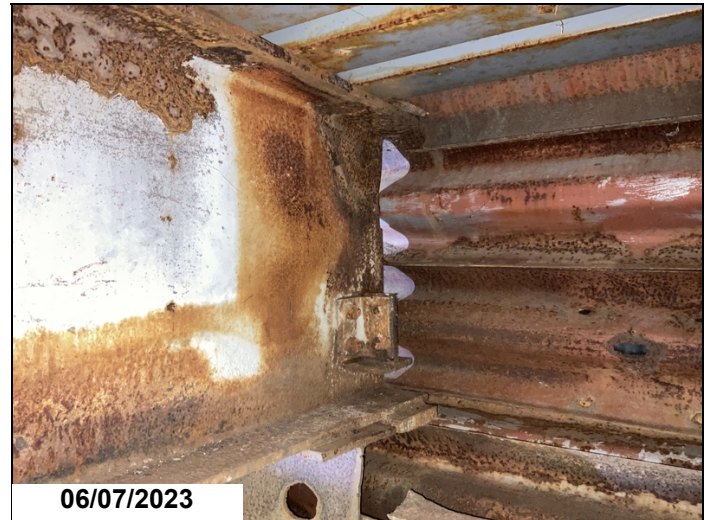
Beam 2 minor damage

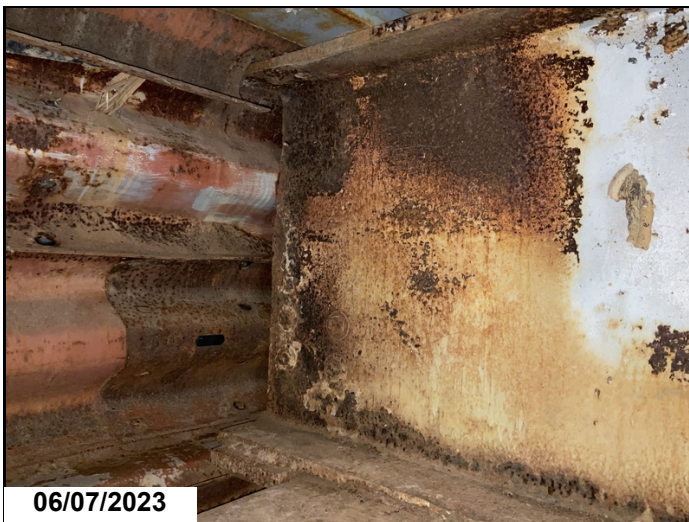
Beam 2 section loss @ bent 2

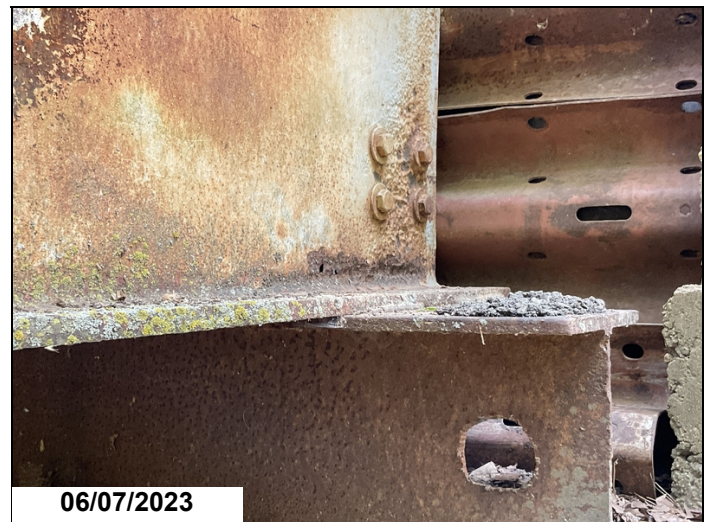
Beam 5 at Bent 2 has section loss holes in beam. Holes are located in bottom of web 13" from end of beam. Various beam ends have areas of section loss.

Beam 5 @ bent 2 has holes in beam. 13" from end of beam in web

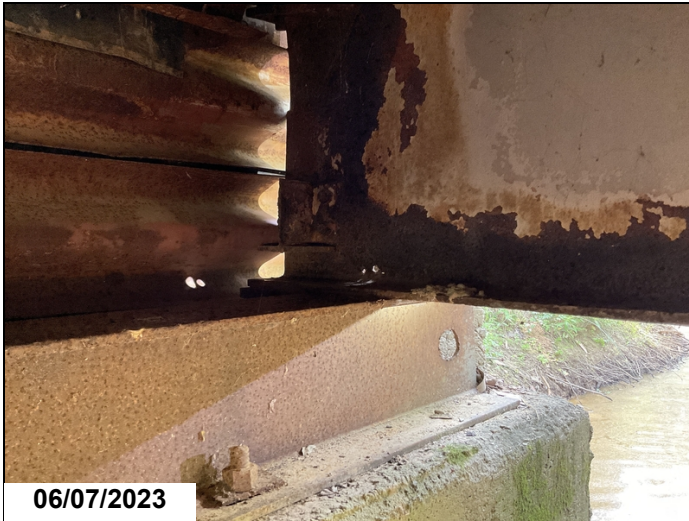
Section loss holes on beam 5 at bent 2
