Asset #22173(Routine, Underwater type 2)

Union CR 5 ZONE J over BAYOU DELOUTRE RELIEF

Team Lead: Rickie Bratton, Inspection Date: 03/28/2022

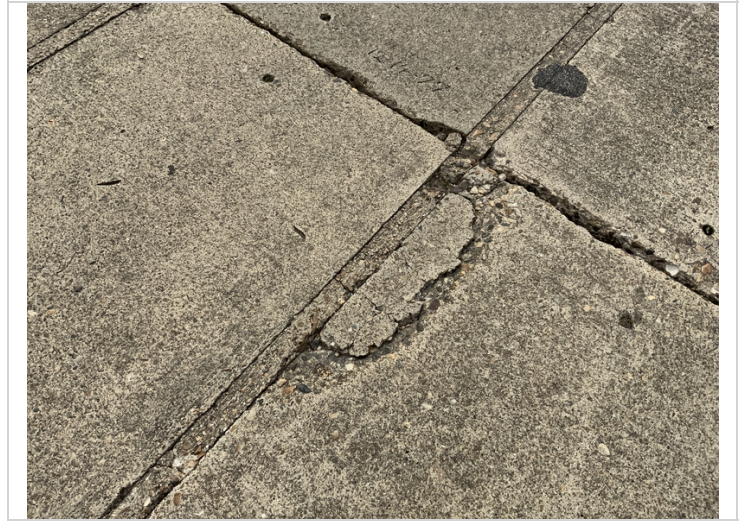
Span 1 unit 5 has spall in deck.

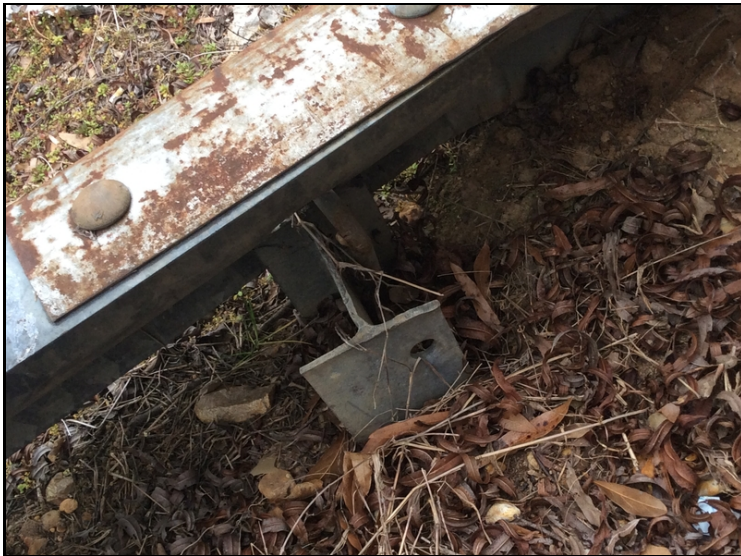
End Post and terminal rail on Rt. side.  
Have collision damage.  
03/01/2016 JPR -- terminal rail is not attached to terminal anchor post.

Rail end not attached right side abutment 2

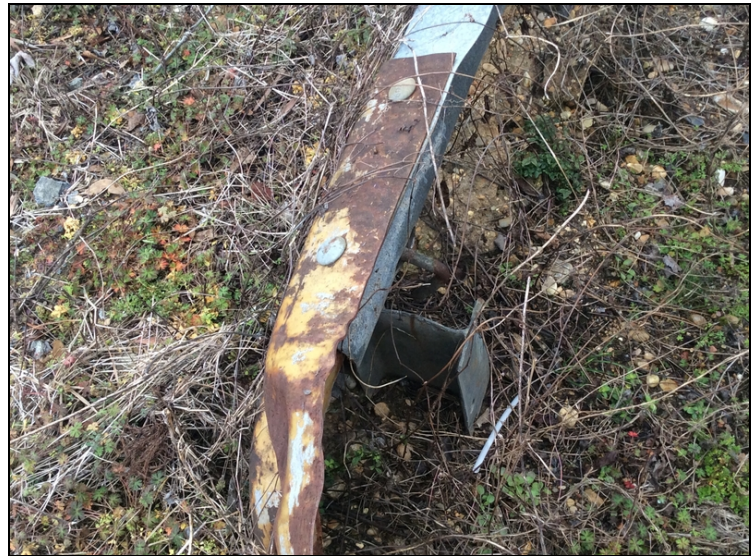
Rail damage right side
