Asset #22511 (Routine, Underwater type 2)

Union CR 5 ZONE J over creek

Location: 3.24 so. US 82

Team Lead: Rickie Bratton, Inspection Date: 02/14/2022

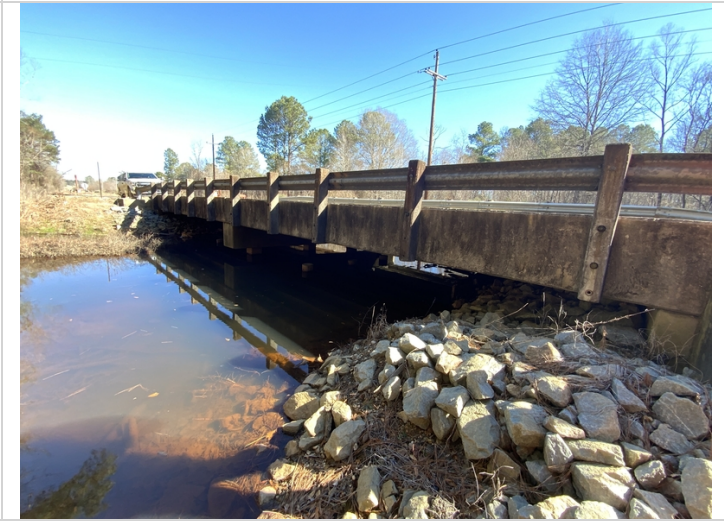
Elevation

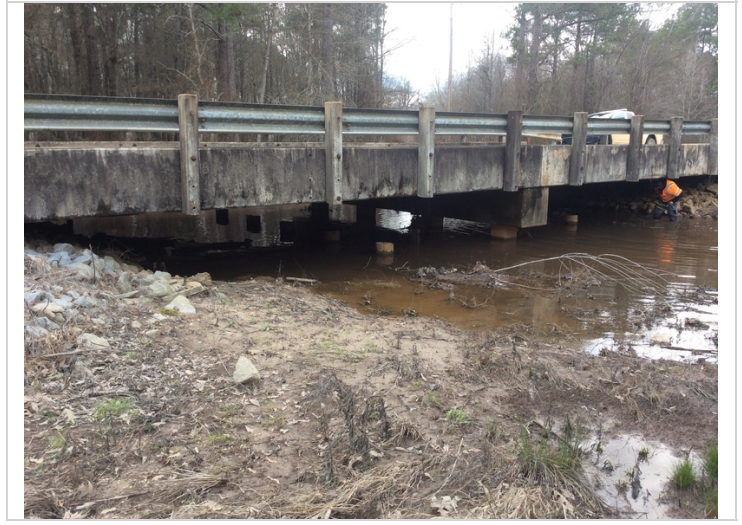
Elevation

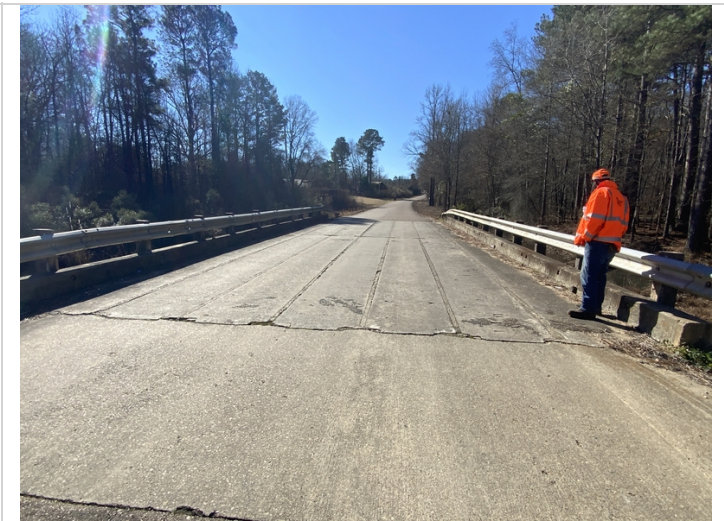
Approach roadway
