Bridge 19828 Inspection Report

Union CoRd 2 Z-J over CREEK

Location: .9 MI SO OF SH 15

Team Lead: Rickie Bratton Inspection Date: 10/27/2025

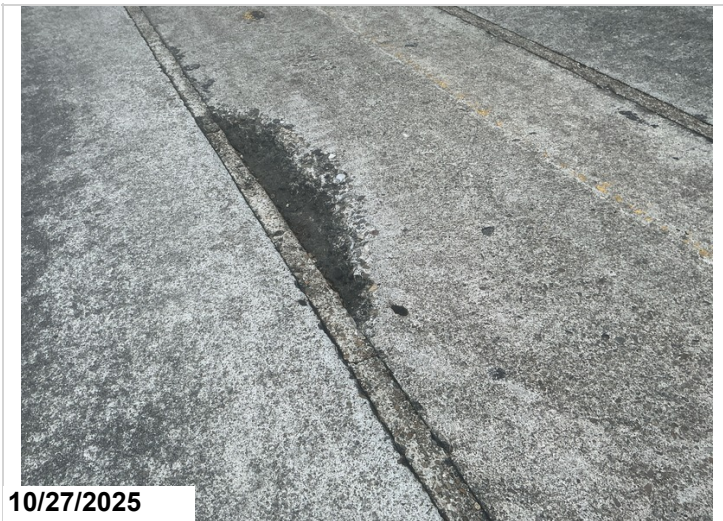
-Units 2 & 4 have minor spalls along the grout keyways.

Span 1 unit 4 spall along keyway

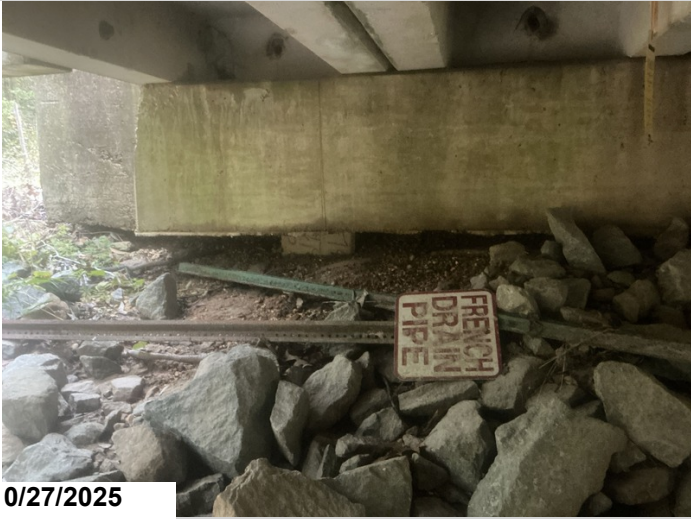
-Embankment has settled for up to 8" below the cap, 6' from the right end.

Embankment has settled for up to 8" below the cap, 6' from the right end.

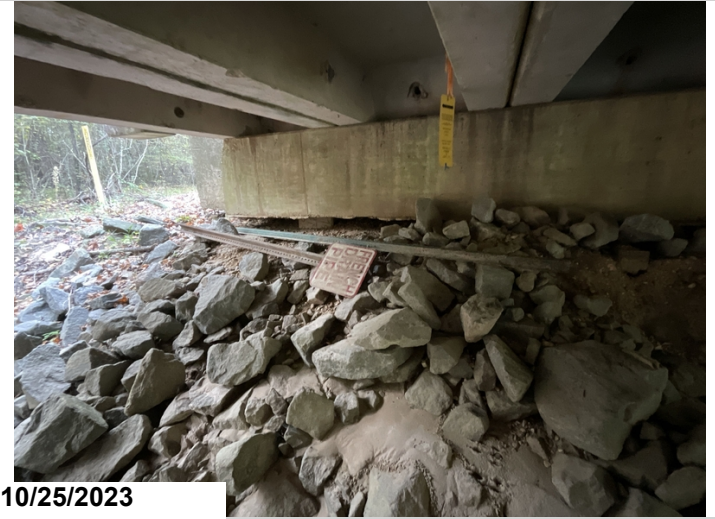
Bent 1 has settled upto 8" for 6' from right end

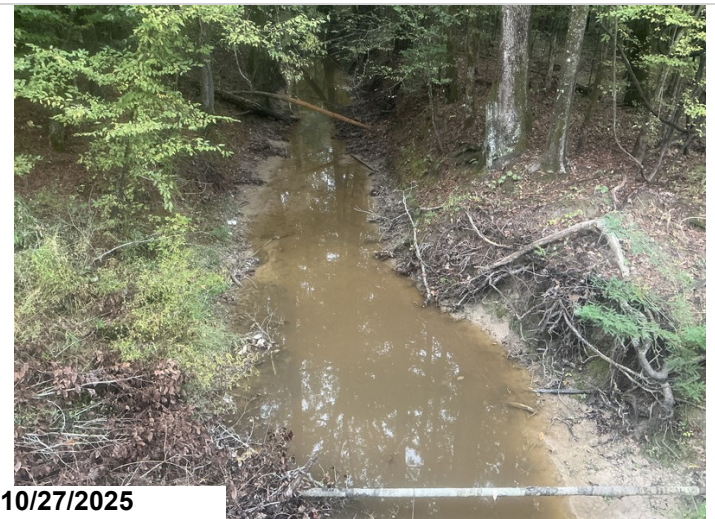
Downstream channel overview right side

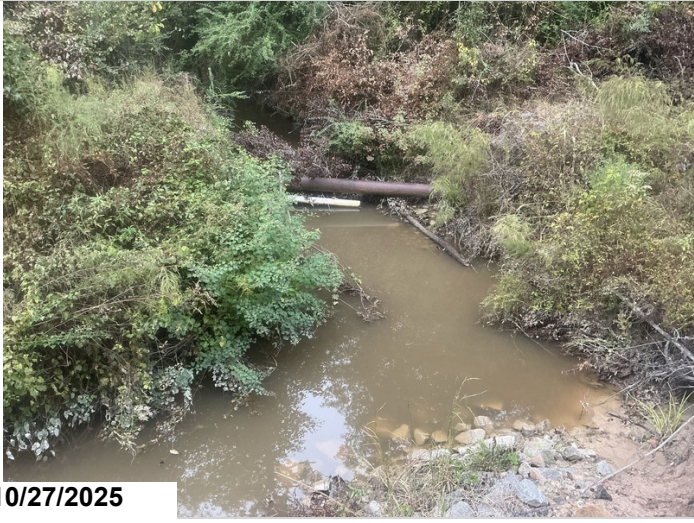
Upstream channel overview left side

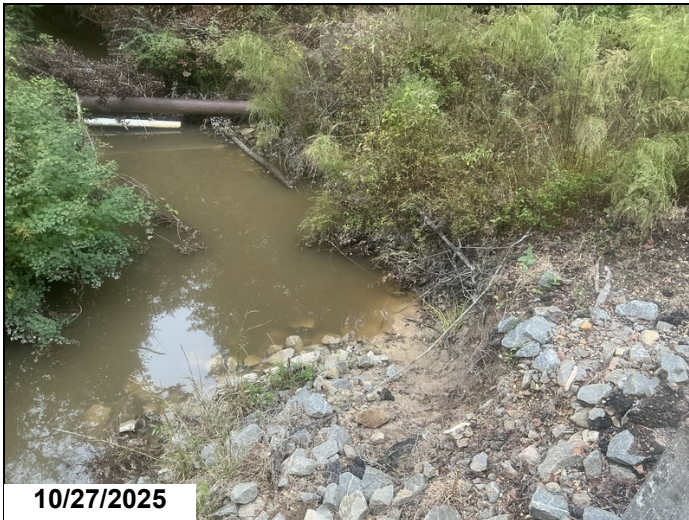
10/27/2025

The channel is eroding the slope to the left side of Bent 3 abutment. The embankment has a vertical drop approximately 10' to the left of the wing wall.

Type of Work: Channel Work/Drift Removal

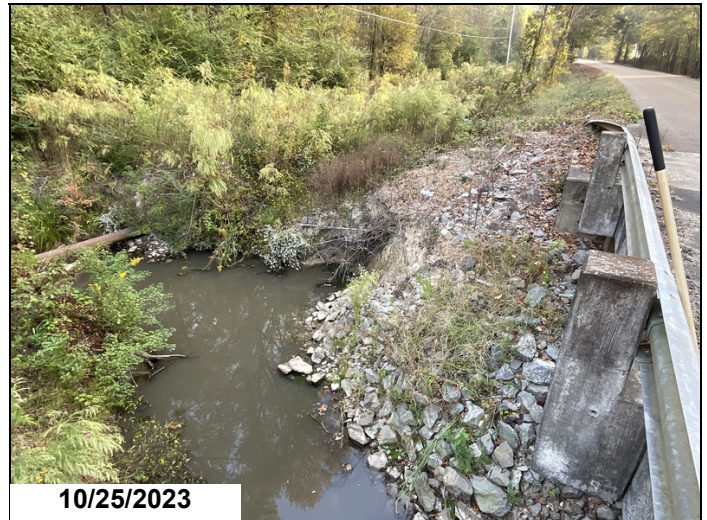
10/25/2023

The channel is eroding the slope to the left side of Bent 3 abutment. The embankment has a vertical drop approximately 10' to the left of the wing wall.

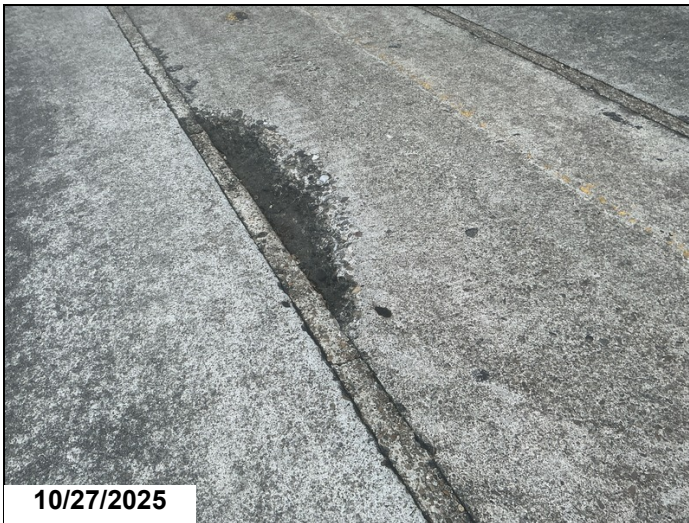
Span 1 Unit 4, 3' spall along the grout keyway of the unit.

Span 1 unit 4 spall along keyway

Type of Work: Deck Repair

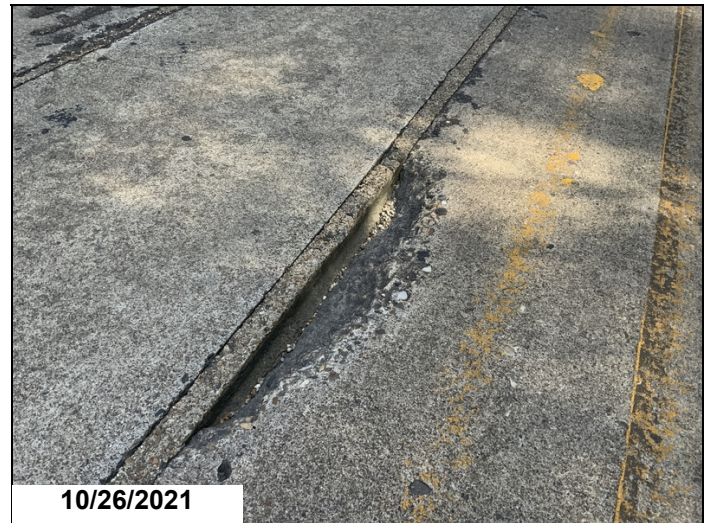
Span 1 Unit 4, at the edge of the grout keyway has a 3'x 6" spall.

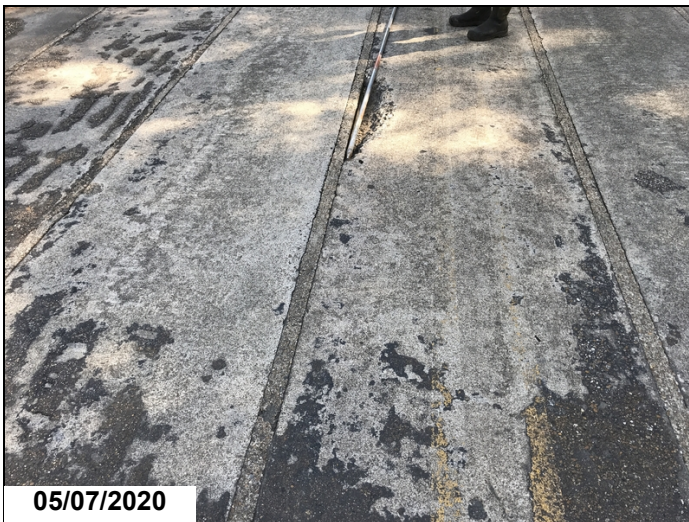
Span 1 Unit 4, 3' spall adjacent to shear key on Lt. side of the PC Unit.

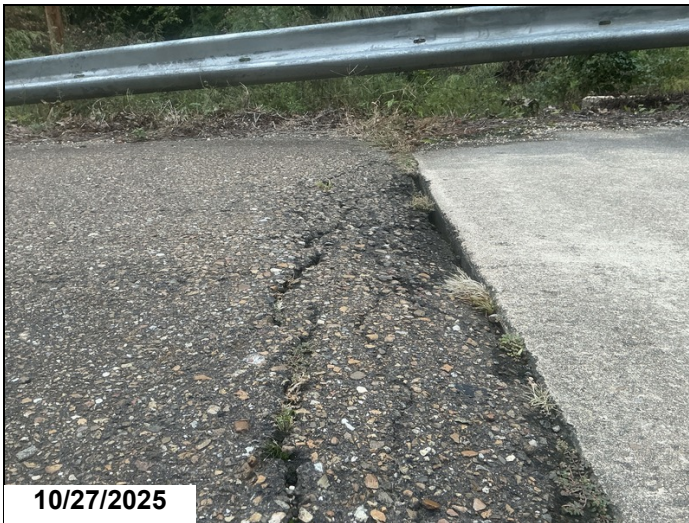
Bent 1, left lane roadway has settled.

Approach at bent 1 left lane has roadway settlement

Type of Work: Repair (General)

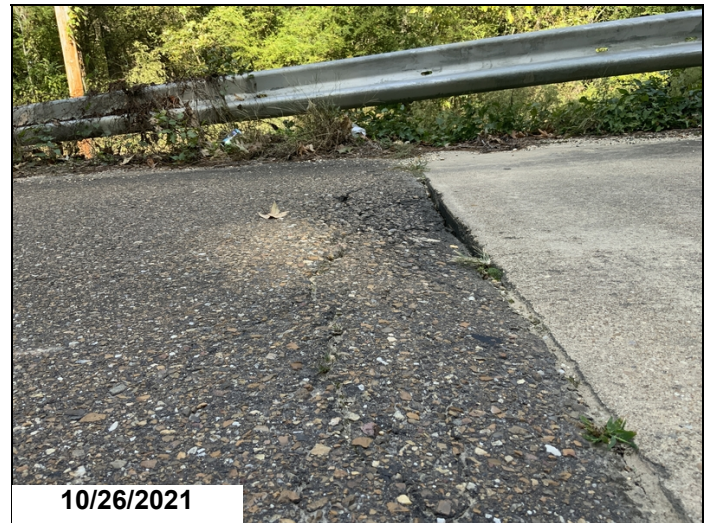
Bent 1, left lane roadway has settled.
