## **Bridge 22104 Inspection Report**

Team Lead: Rickie Bratton, Inspection Date: 09/04/2025

**Asset #22104**(Routine)  
**Union CR2 Z-J over CORNIE CREEK**  
**Location: 1.66 MI SO IF SH 15**

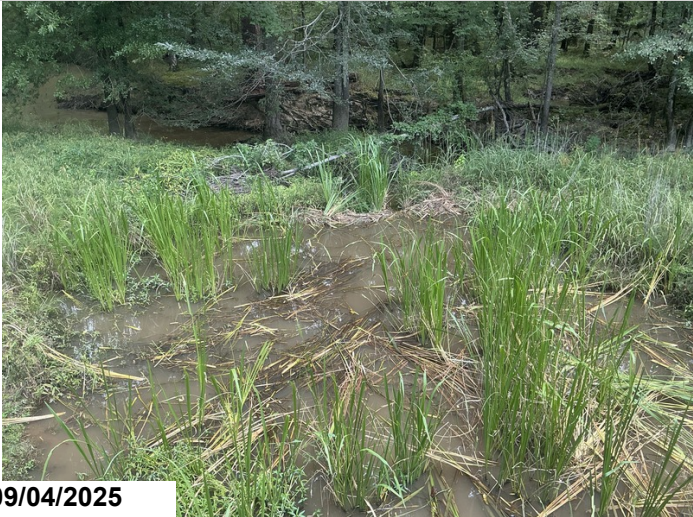
Channel downstream overview right side

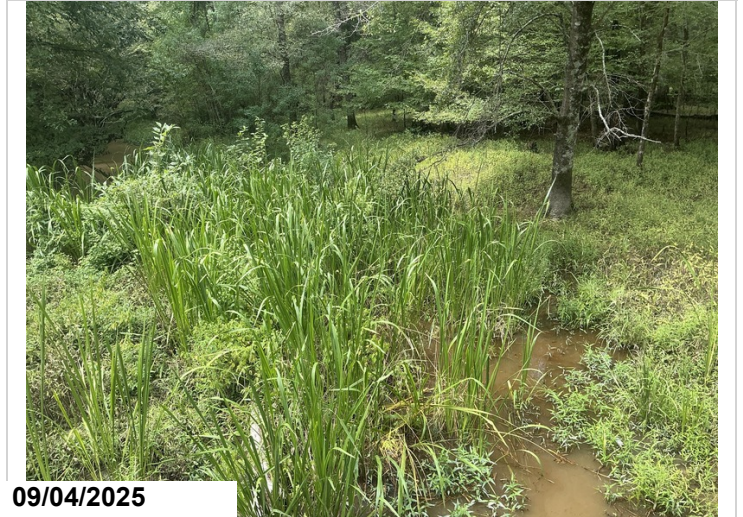
Channel upstream overview left side

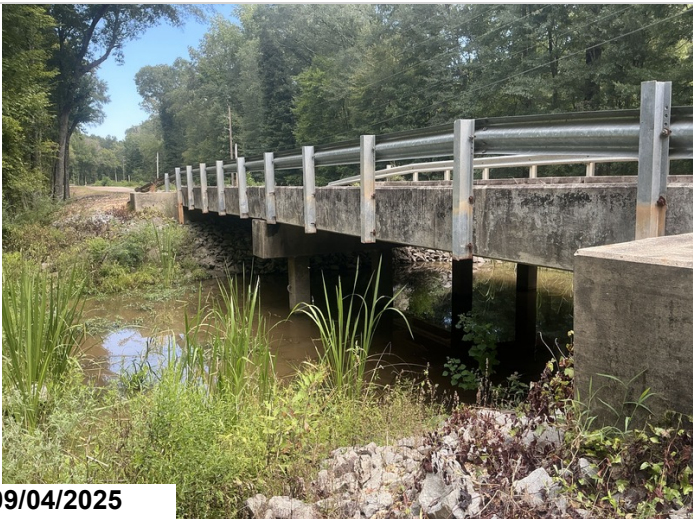
Elevation

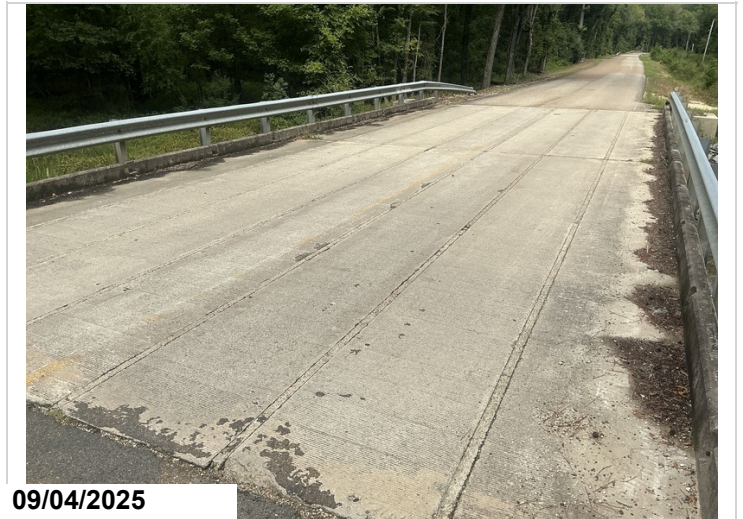
Deck overview

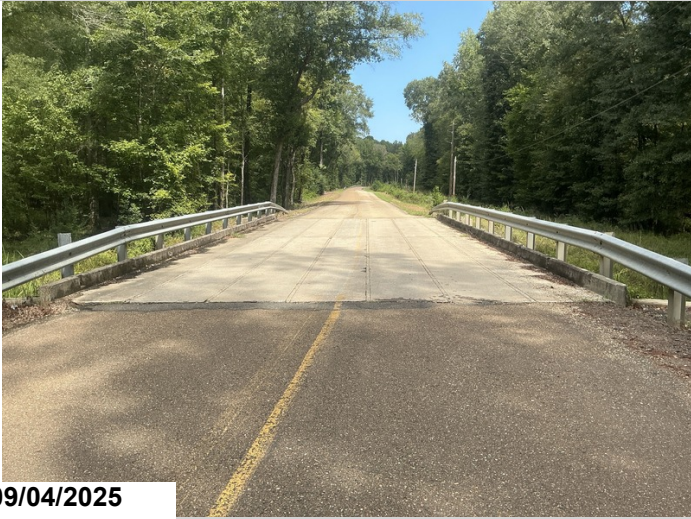
Approach roadway Northbound

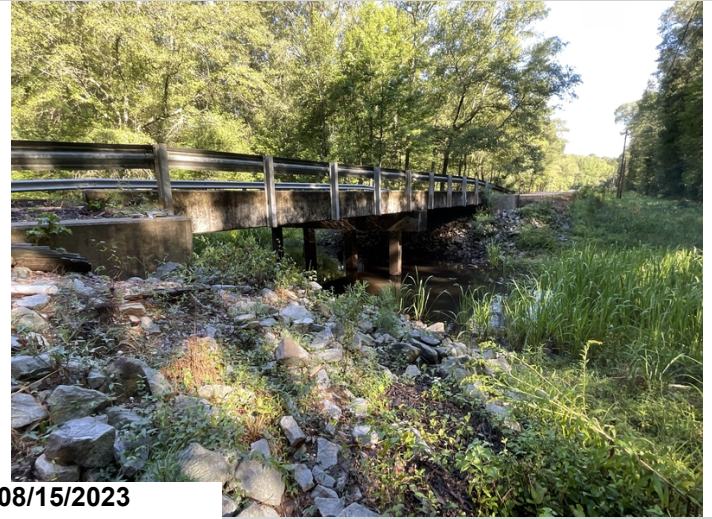
Elevation

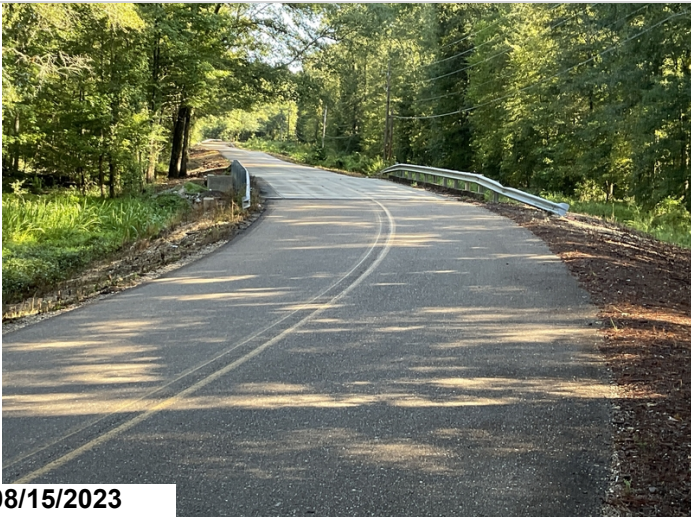
Approach

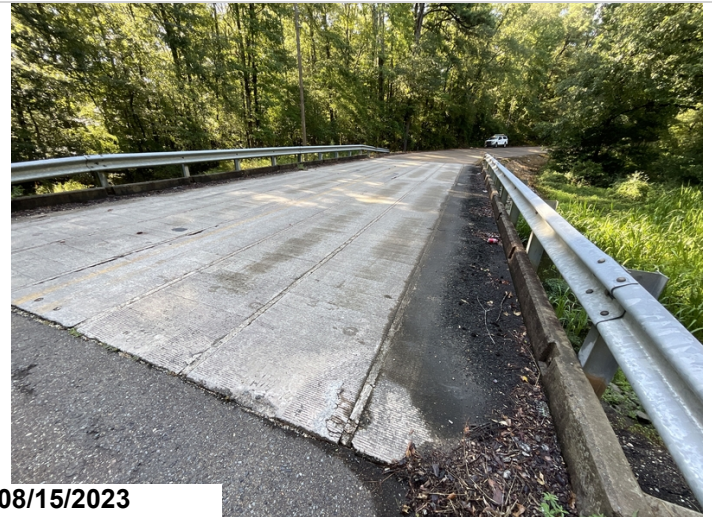
Deck overview

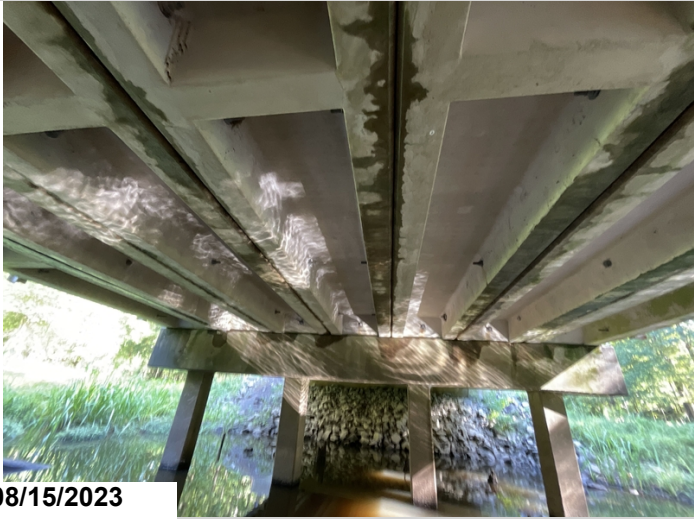
Deck Underview

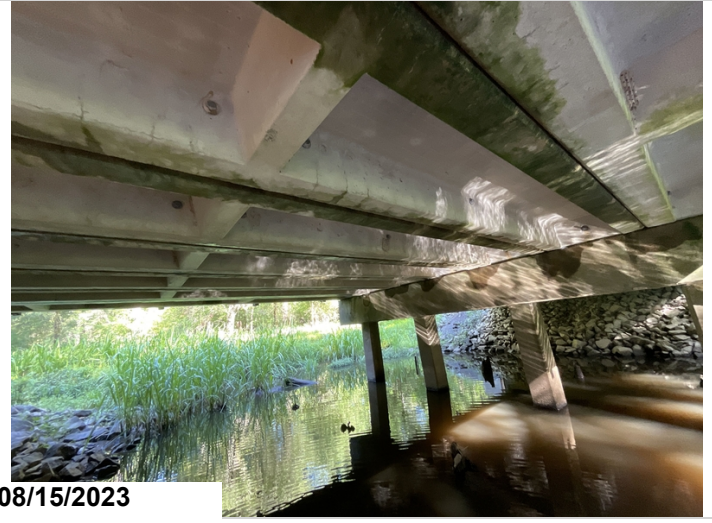
-All stems have hairline flexural cracks on the bottom of the stems.

Typical superstructure

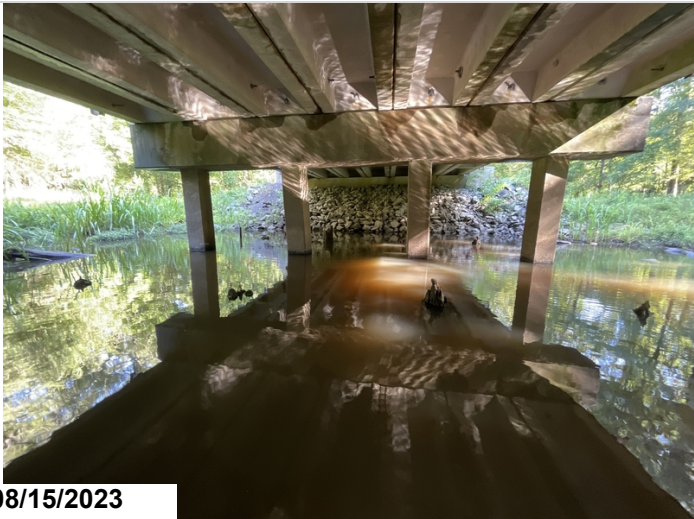
-All piles have light abrasion at the waterline.

Typical substructure

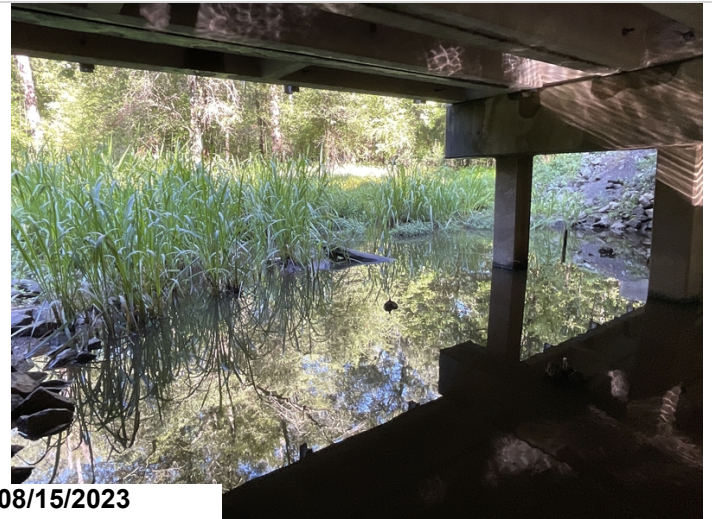
Channel is vegetated with rip rap on slopes.

Channel left side

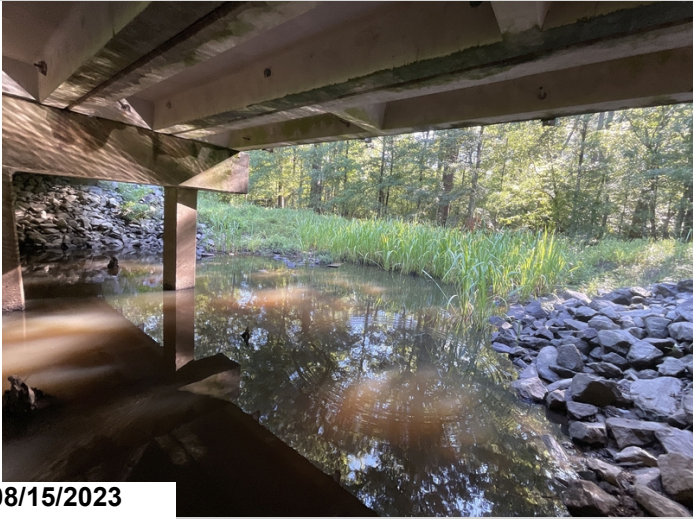
Channel right side
