Bridge 22105 Inspection Report

(4) Place Code	0
(6) Features Intersected	CORNIE CREEK
(7) Facility Carried	Union CR2 Z-J
(9) Location	1.5 M S SH 15 & CR 2
(11) Mile Point	10.798 mi
(12) Base Highway Network	No

Team Lead: Rickie Bratton, Inspection Date: 09/04/2025

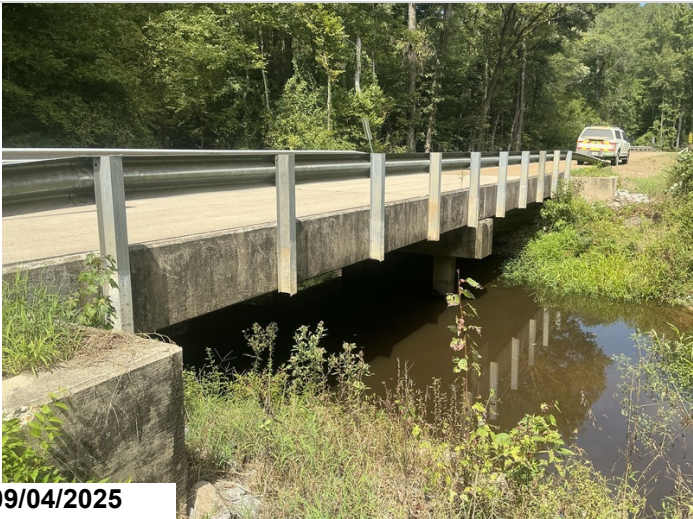
Elevation

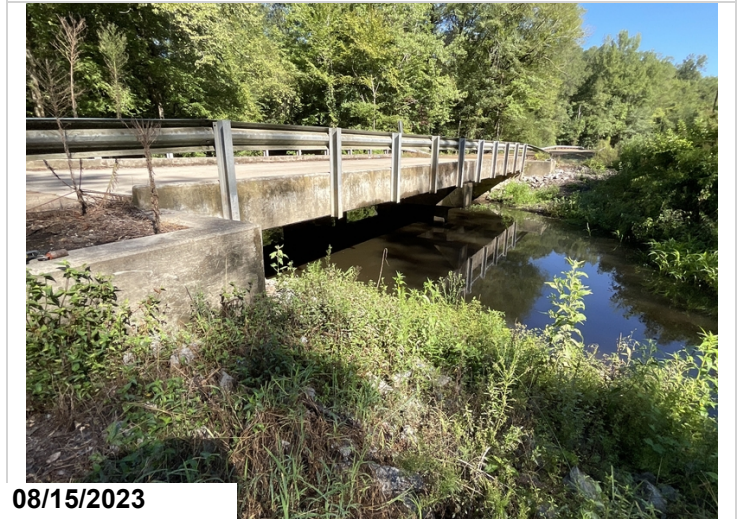
Elevation

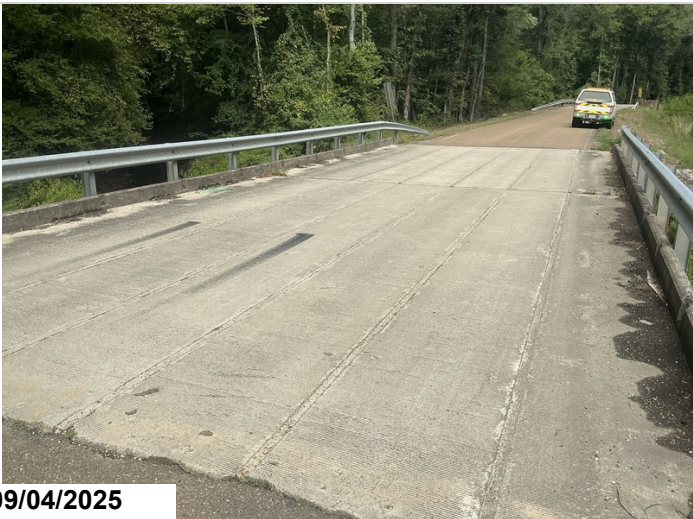
Deck overview

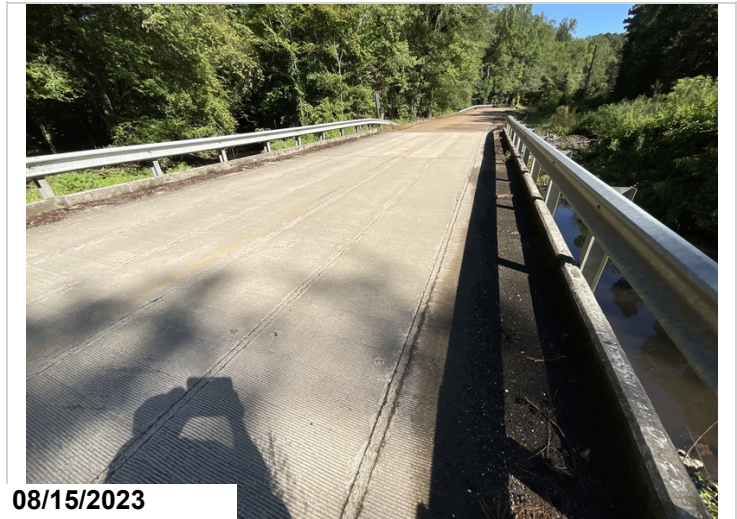
Deck overview

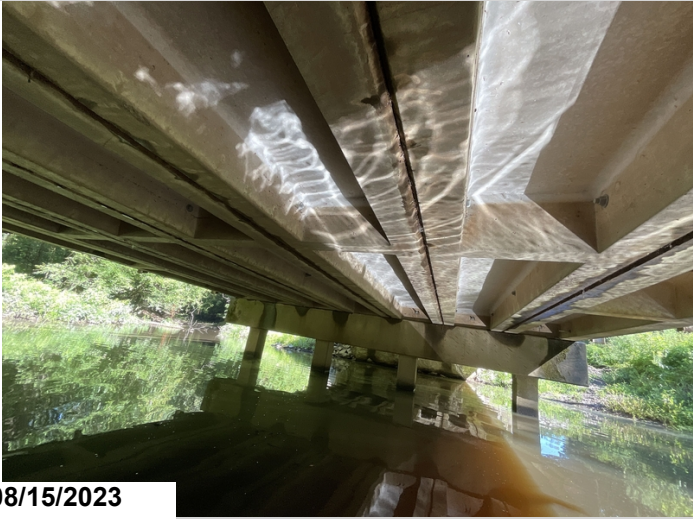
08/15/2023

Deck Underview

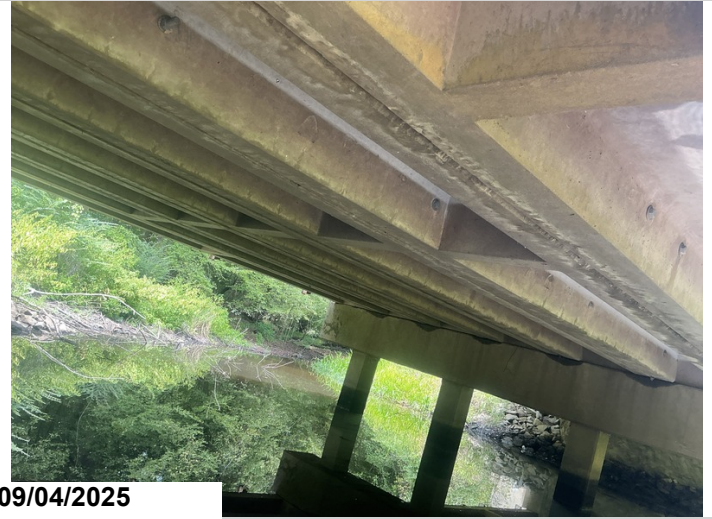
09/04/2025

Undersurface overview span 1

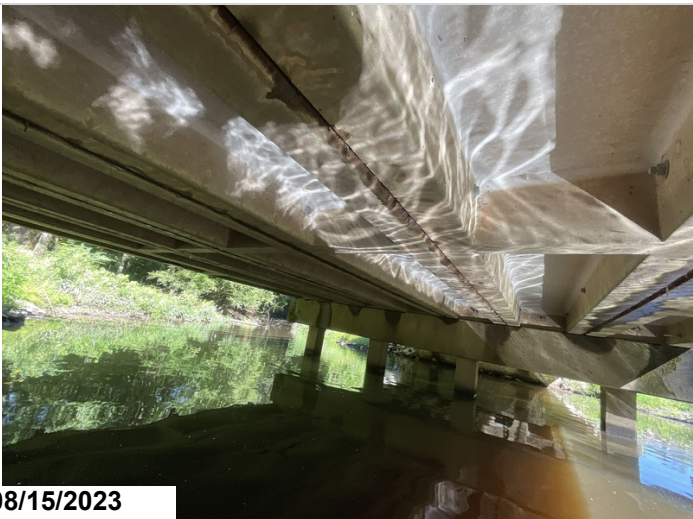
08/15/2023

Typical superstructure

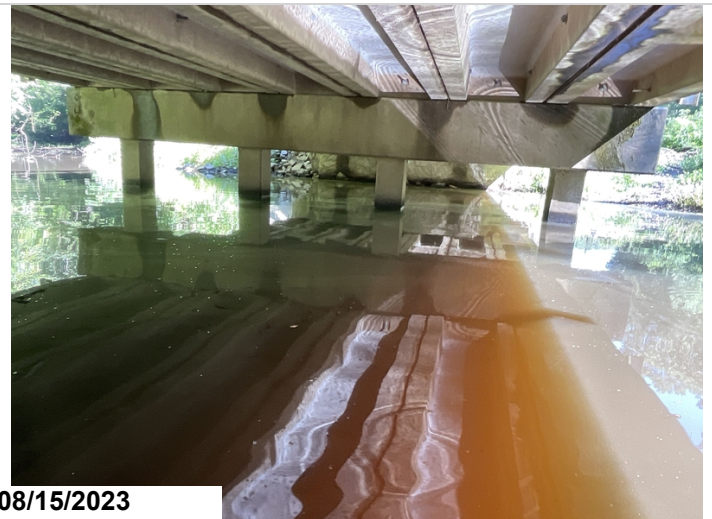
08/15/2023

Typical substructure

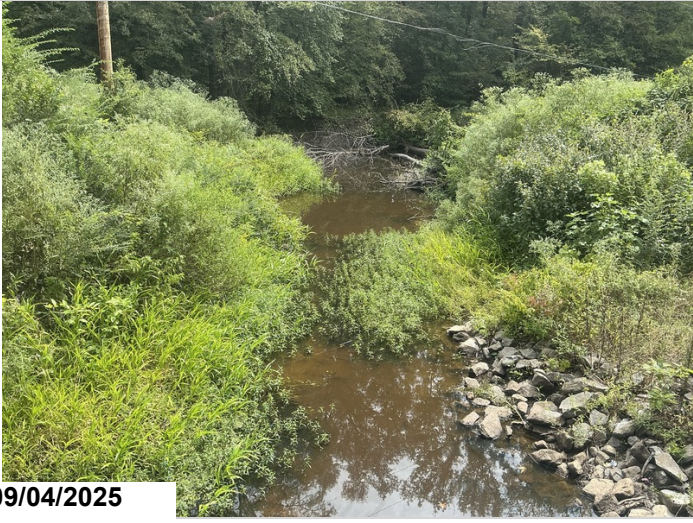
Downstream channel overview right side

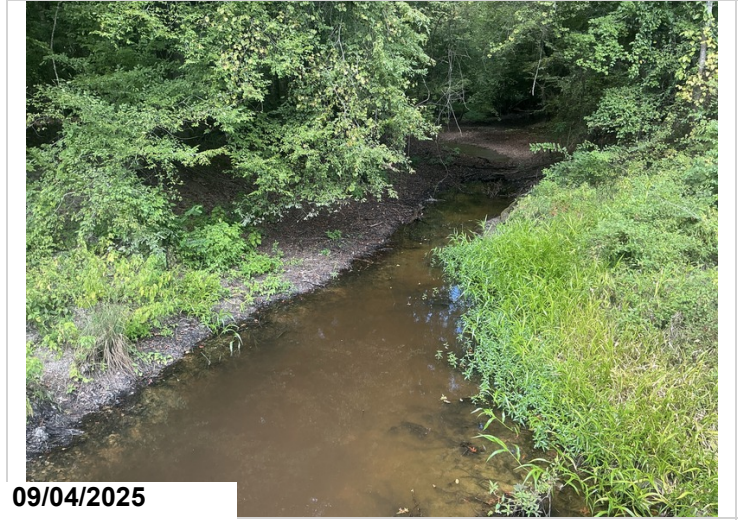
Upstream channel overview left side

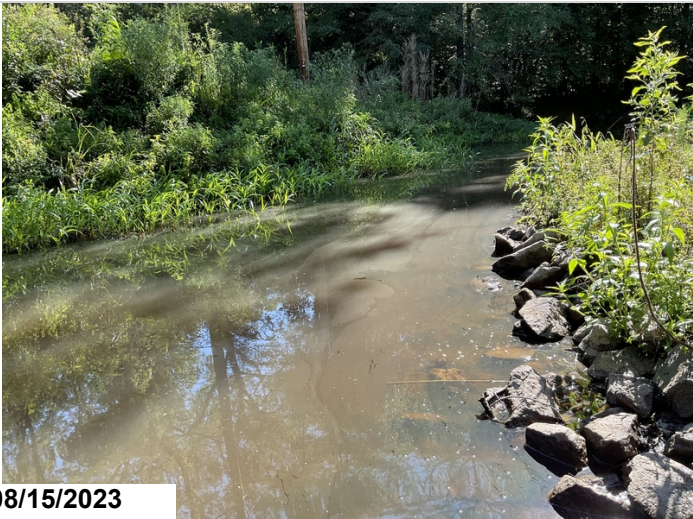
Channel right side

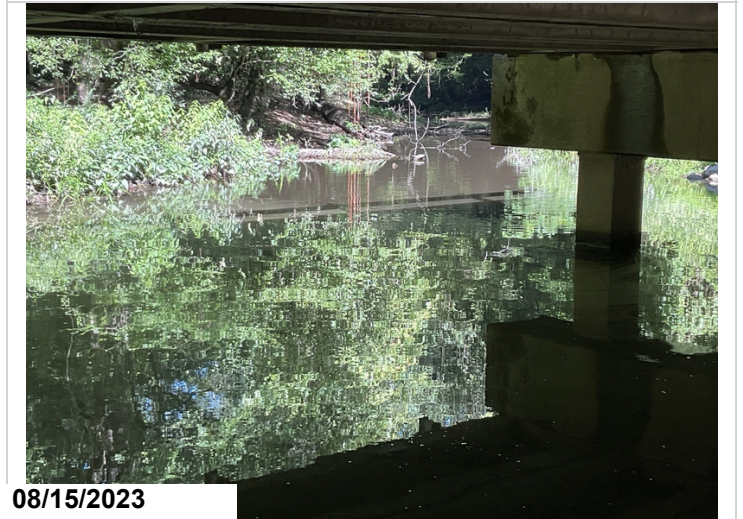
Channel left side

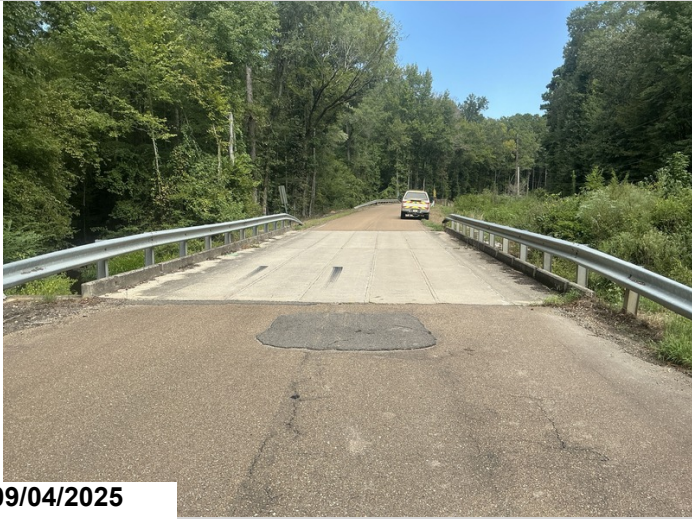
Approach roadway Northbound

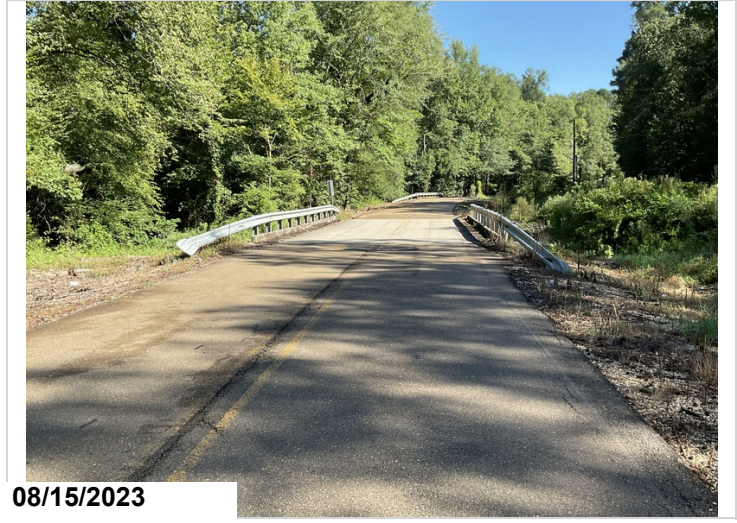
Approach
