## Bridge 22106 Inspection Report

Team Lead: Rickie Bratton, Inspection Date: 09/04/2025

**Asset #22106**(Routine)  
**Union CR2 Z-J over CORNIE CREEK**  
**Location: 1.47 M. S SH 15 & CR 2**

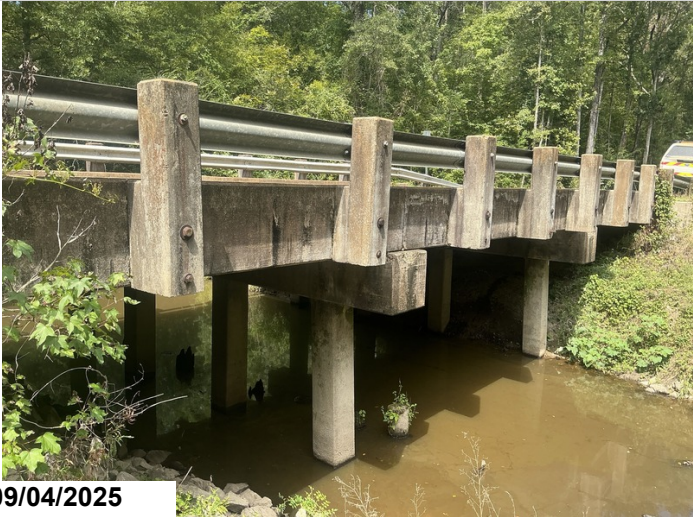
Elevation

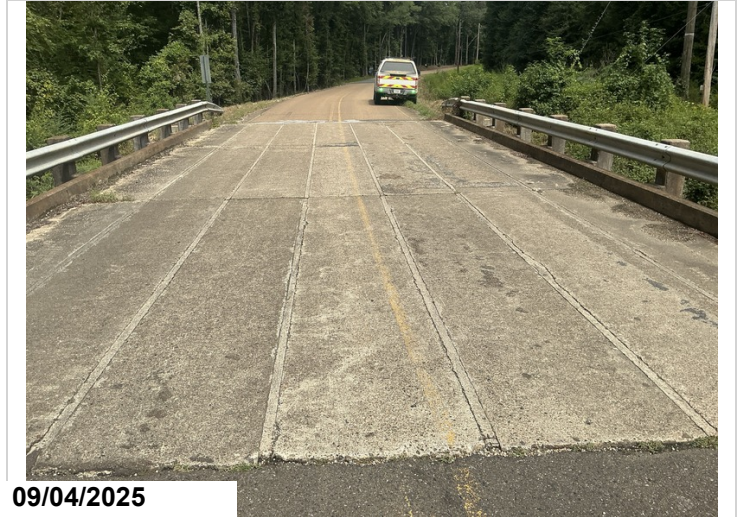
Deck overview

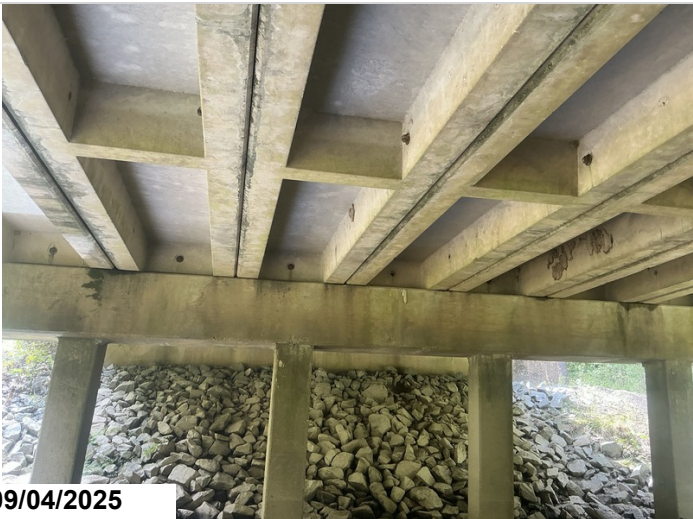
Span 2 undersurface overview

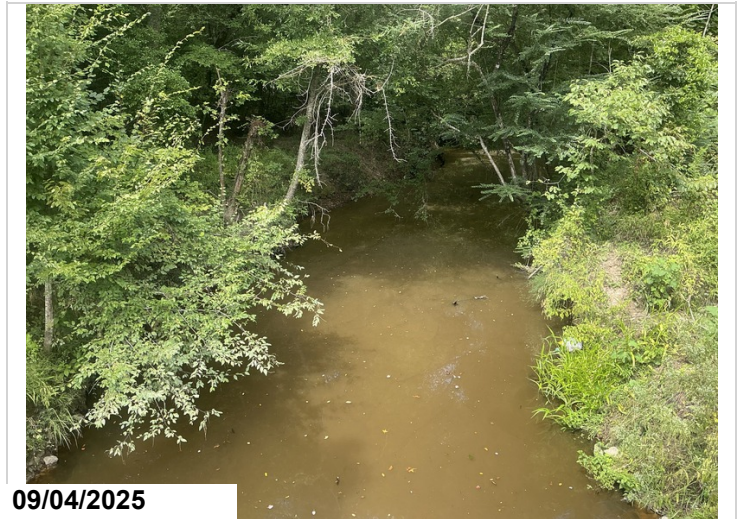
Upstream channel overview left side

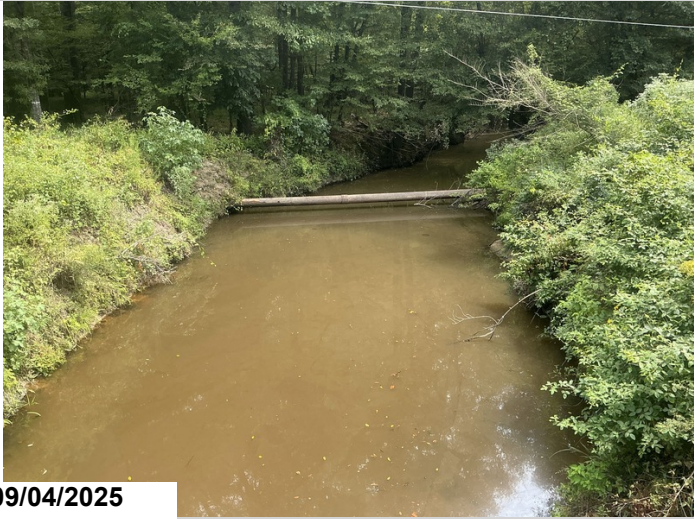
Downstream channel overview right side
