Bridge #04316(Routine)

CR 68 ZN C Benton over LIMEKILN CREEK

Location: 6 M NE PEA RIDGE

Team Lead: Benjamin Smith Inspection Date: December 14, 2020

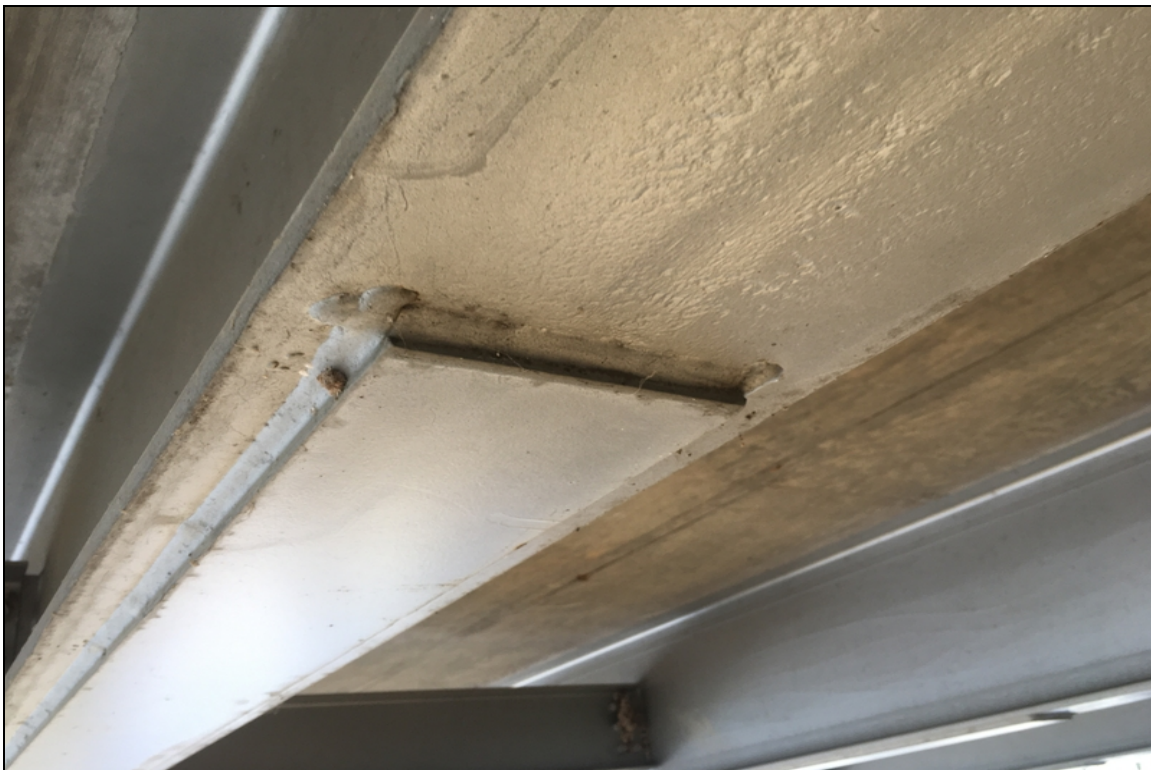
Typical cover plate detail.

The cover plates are cut square with the beams and welded at the ends. No cracking was noted at these locations.

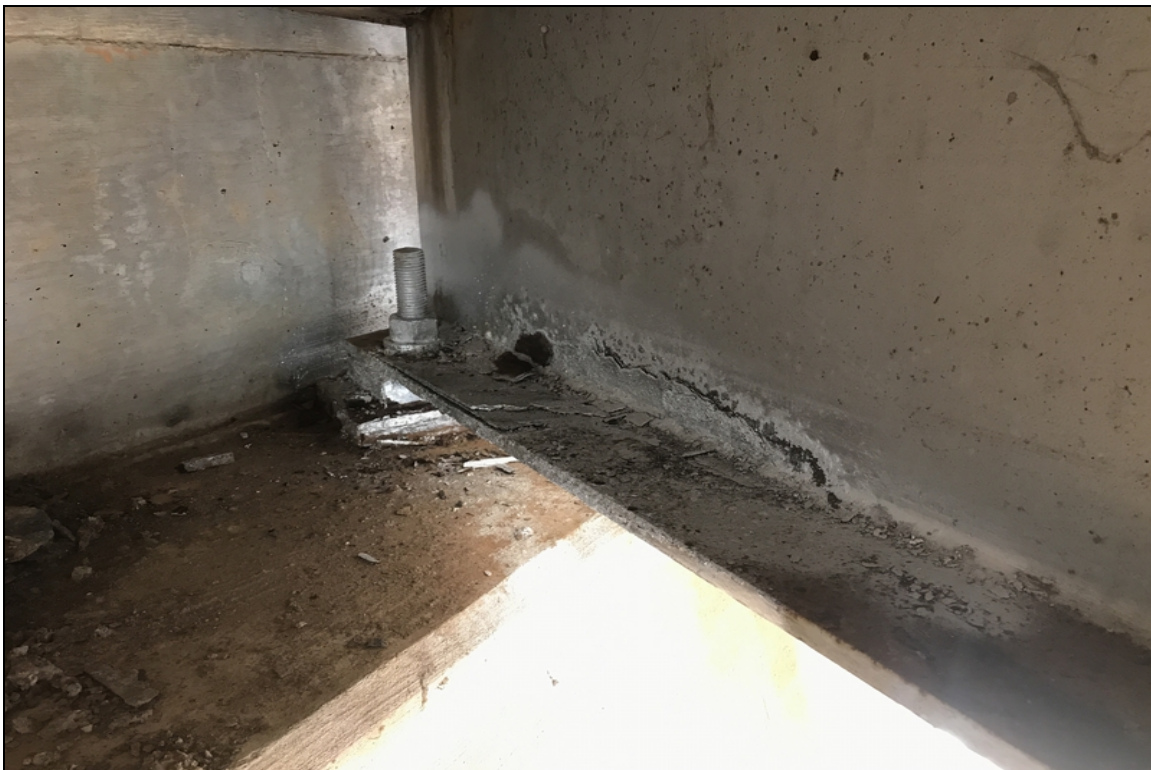
Beam #3 at abutment #2 flaking rust with failed paint repair.

-Beam #3 of span #3 has active corrosion with flaking rust and initial section loss to the lower portion of the web and the bottom flange over abutment #2.

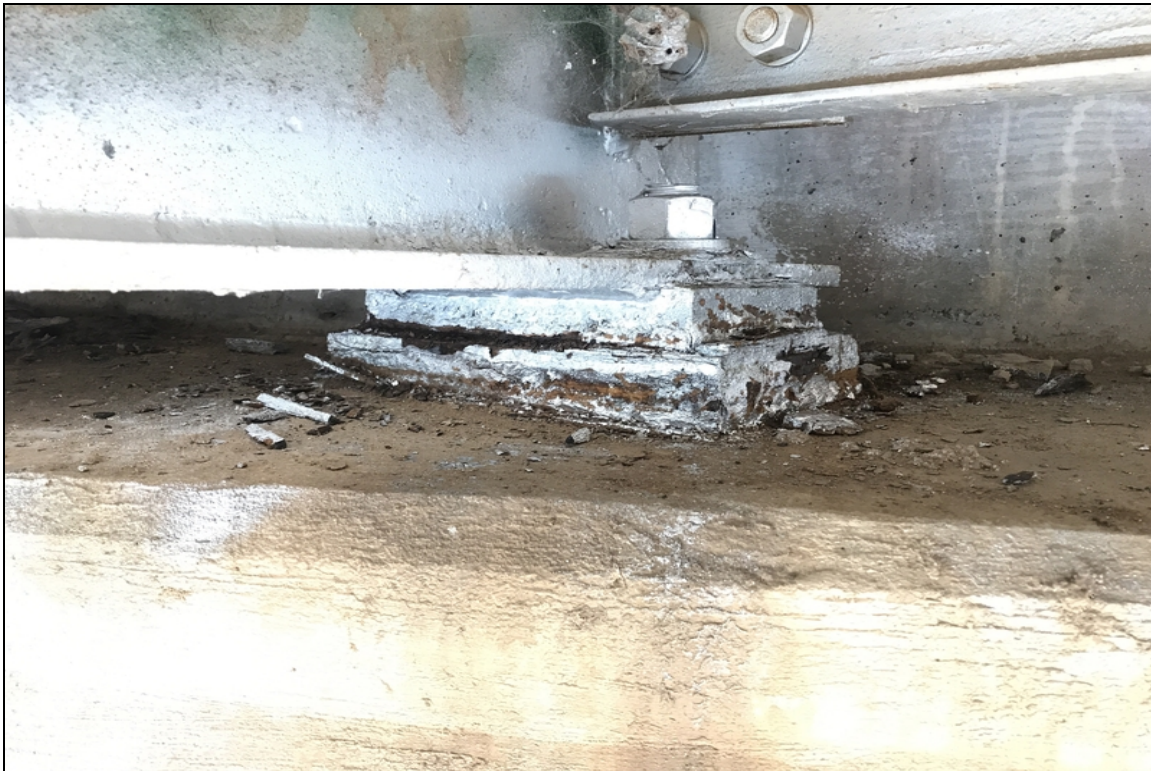
Abutment #2 bearing #3 flaking with a failed paint repair.

-Abutment #2 Bearings #1 and 3 are the most extreme case with active corrosion and heavy flaking rust between the sole and masonry plates.

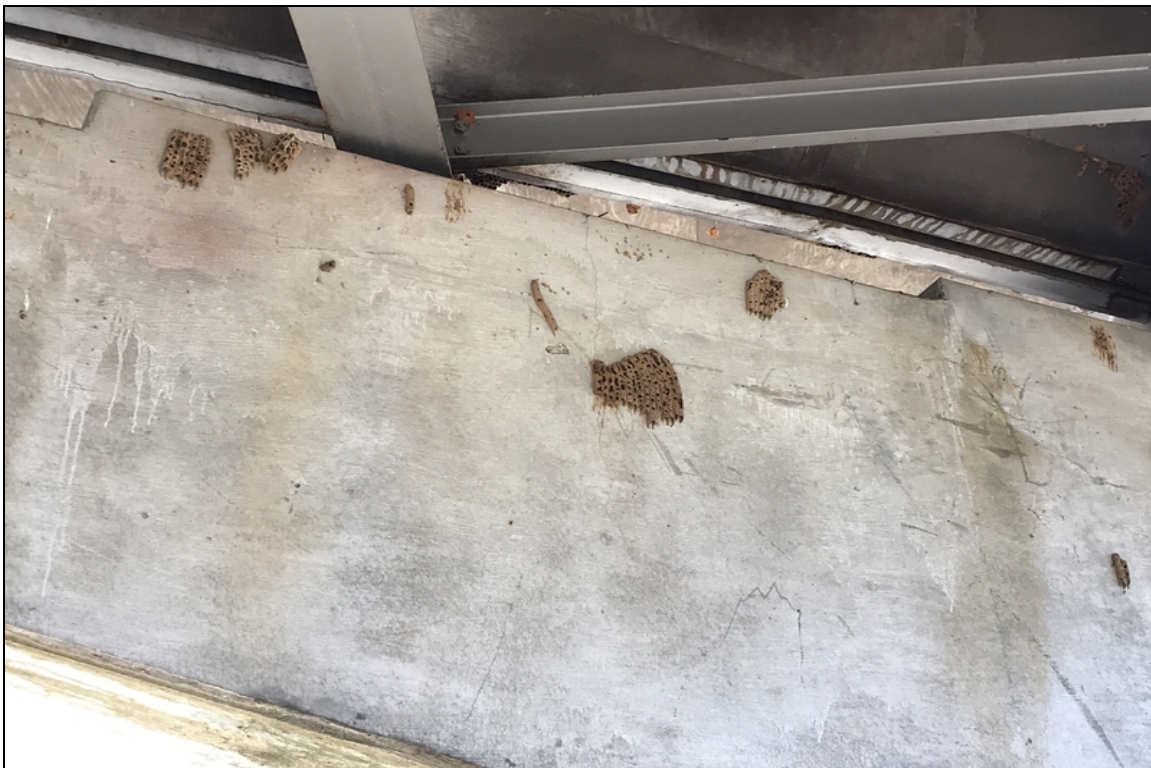
Pier #2 behind and ahead vertical face of hammerhead cap at bearing #3 has a short duration vertical crack.

-Pier #2 behind and ahead vertical face of hammerhead cap has vertical hairline cracks at the step downs. The widest crack is beneath bearing #3. Pier 2 column has a previous embankment scour area that has been repaired with large rock.

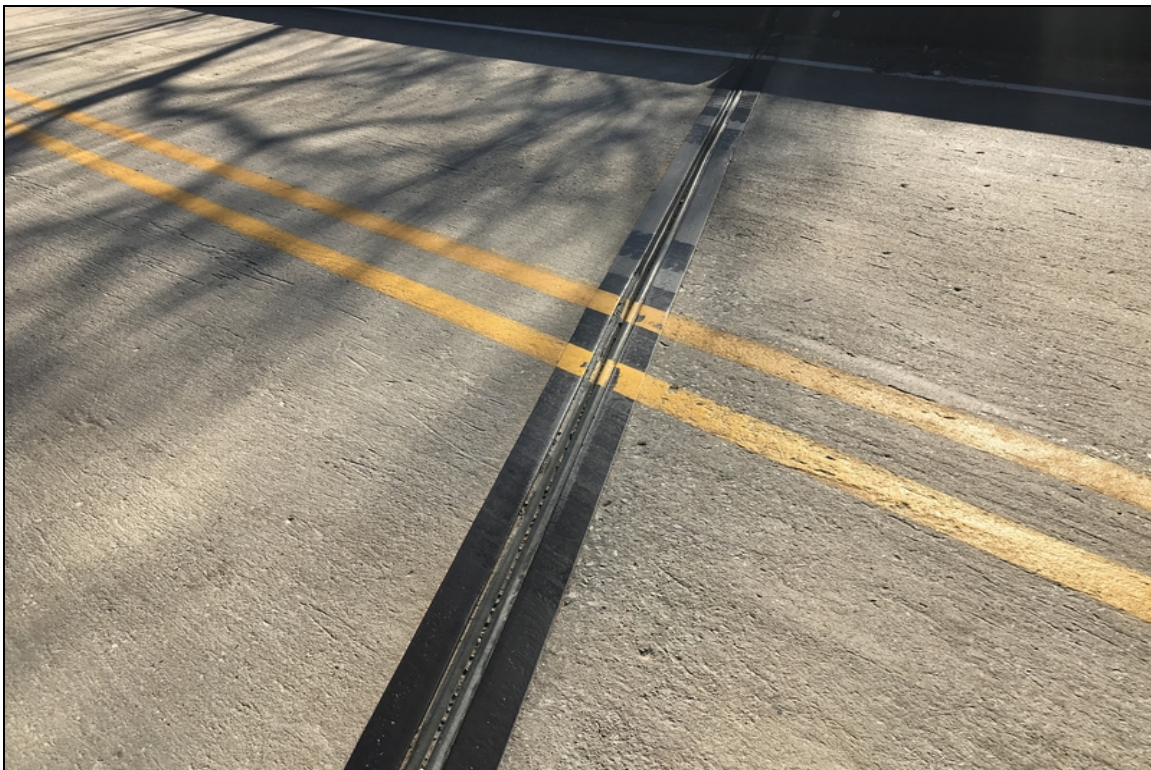
Bent #2 joint material cracking and minor debris impact.

The compression joint seals at all bents have deteriorated and have minor debris impaction and adhesion failure allowing water to leak onto the substructure.

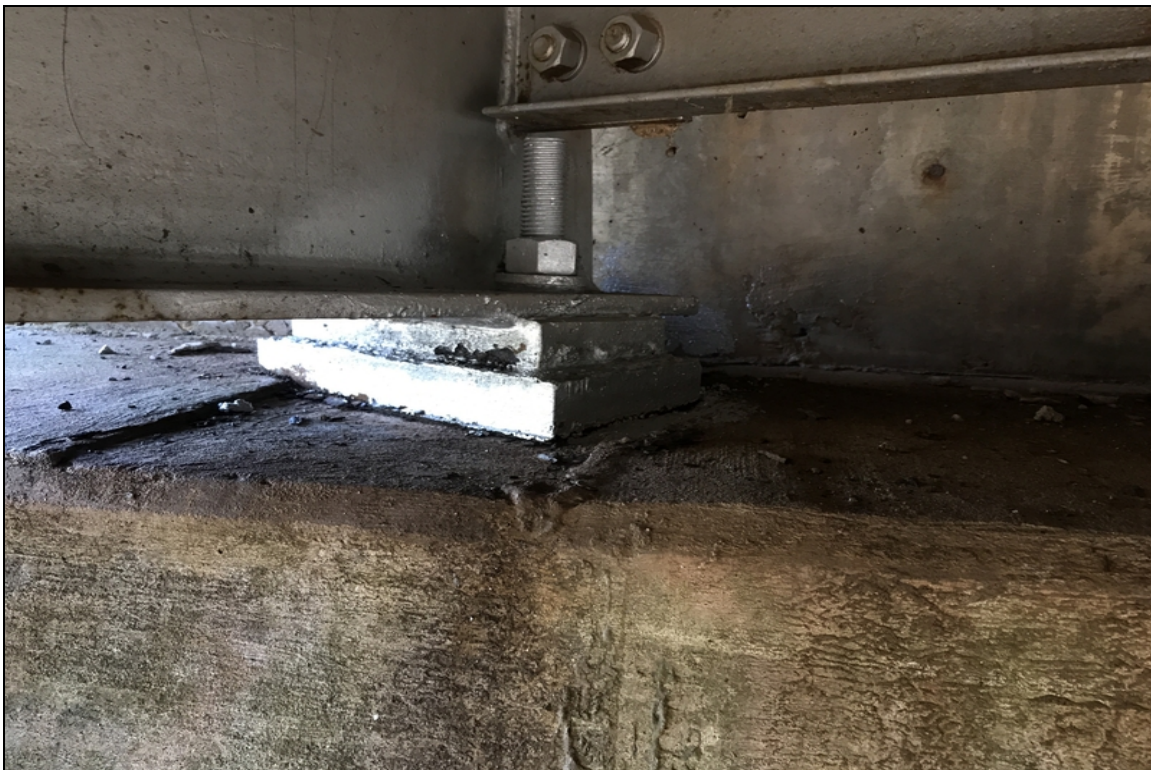
Abutment #2 bearing paint repair attempt

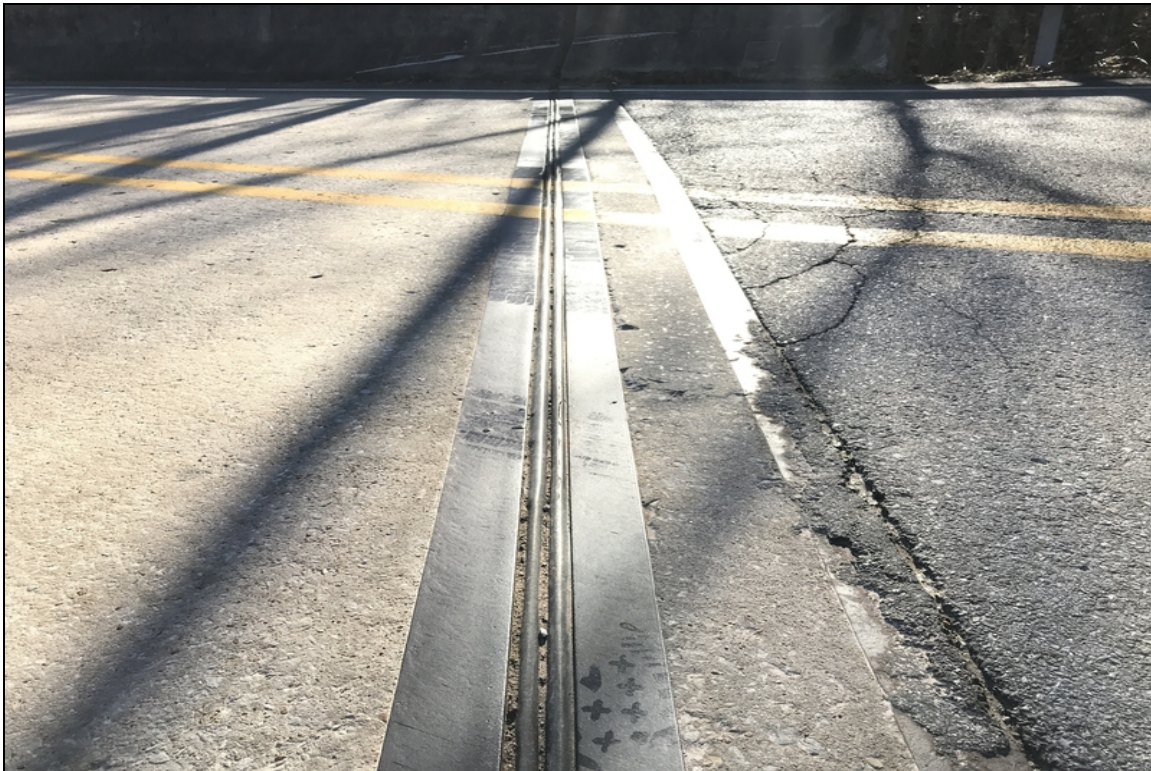
Abutment #1 joint material.

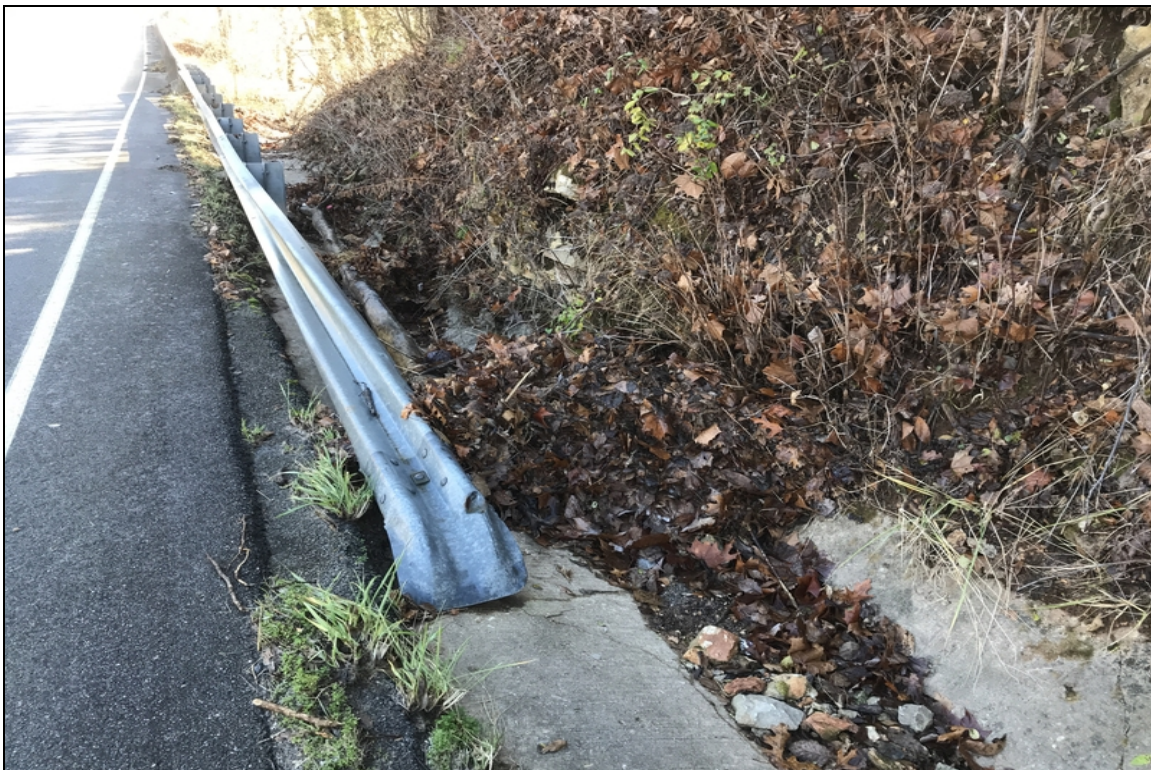
Drift accumulation in ditch paving possibly redirecting water to roadway.

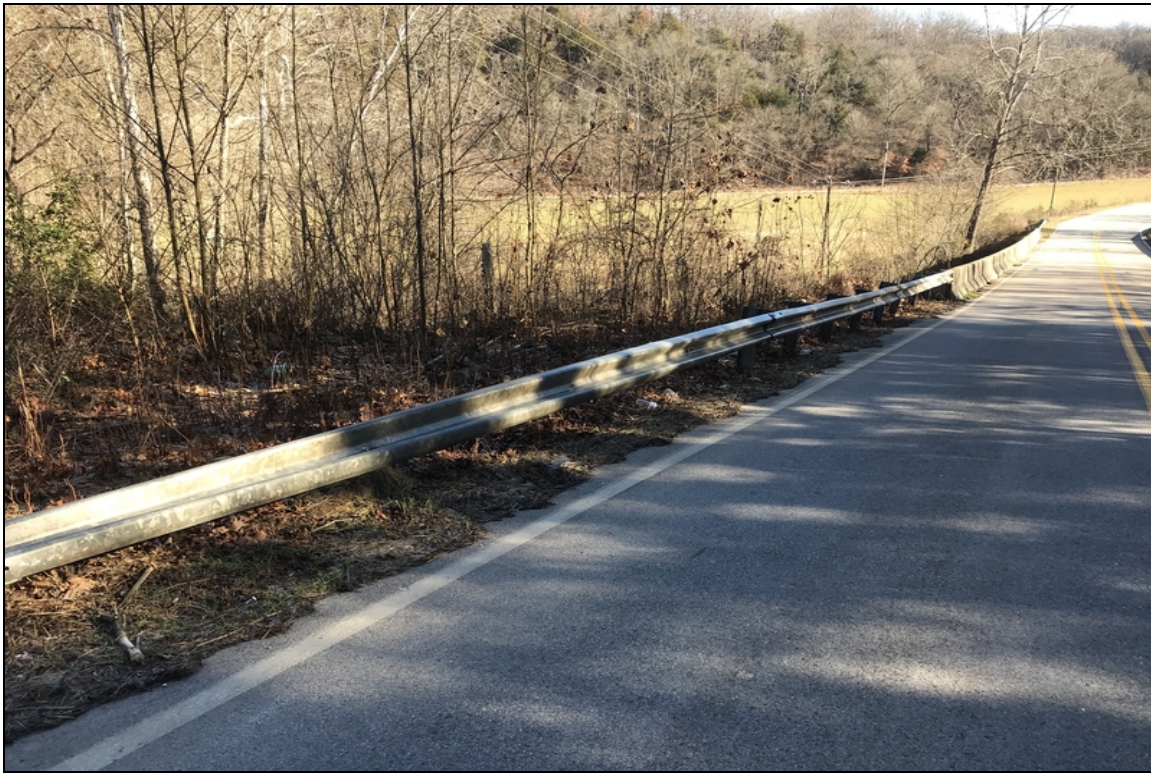
Northwest approach railing repair.

The Northwest approach guard railing has collision damage that has created a "pocket" in the railing. Several railing posts are bent and leaning out of plumb.

Northwest approach guard railing has collision damage that has created a "pocket" in the railing. Several railing posts are bent and leaning out of plumb.

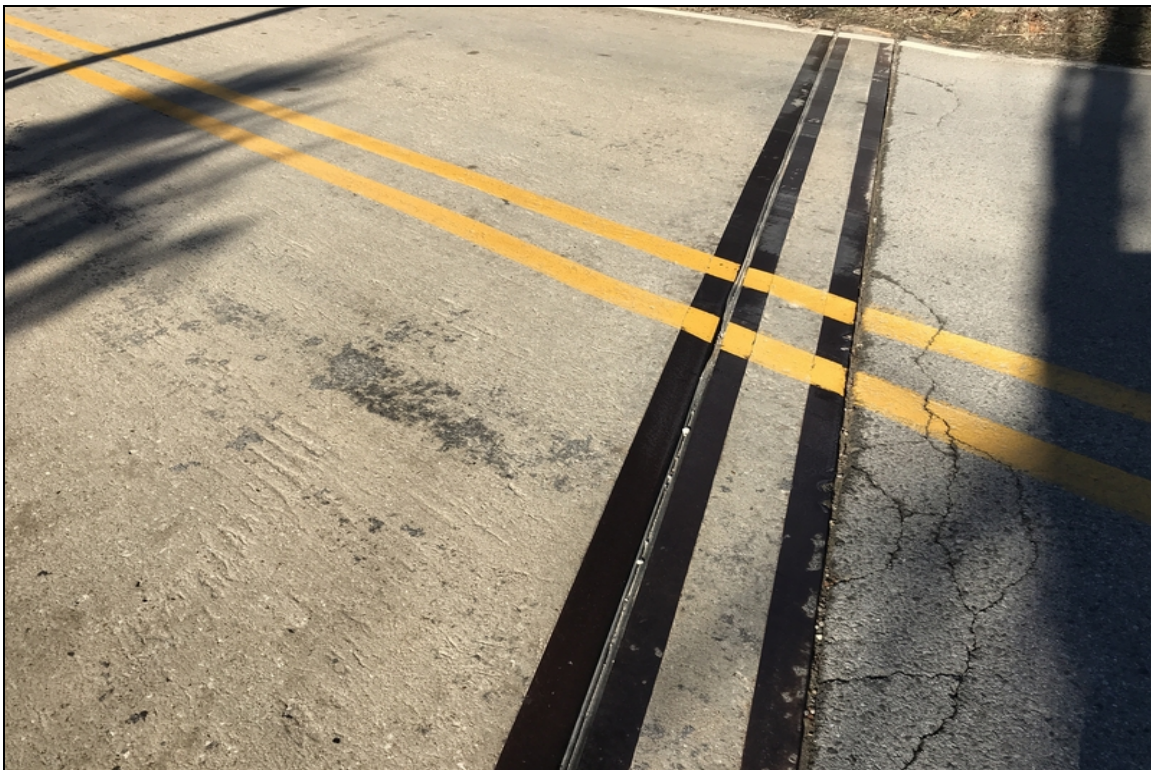
Abutment #2 joint material.

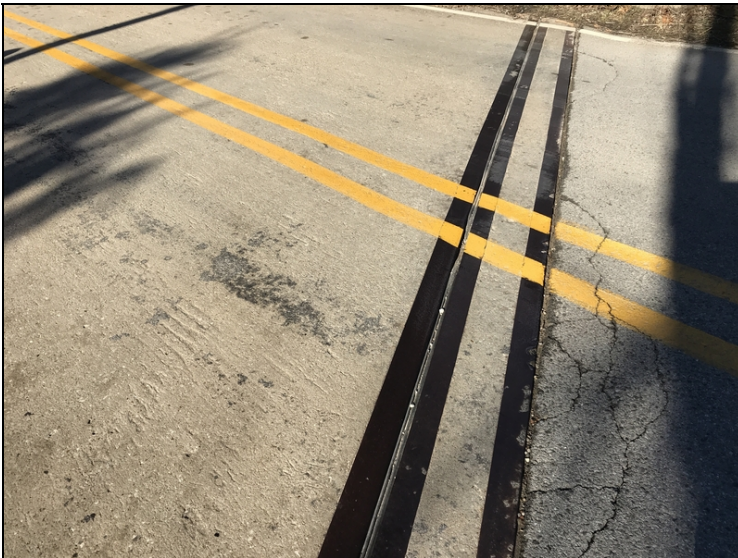
The compression joint seals at all bents are deteriorated and have adhesion failure allowing water to leak onto the substructure.

Abutment #2 joint material.

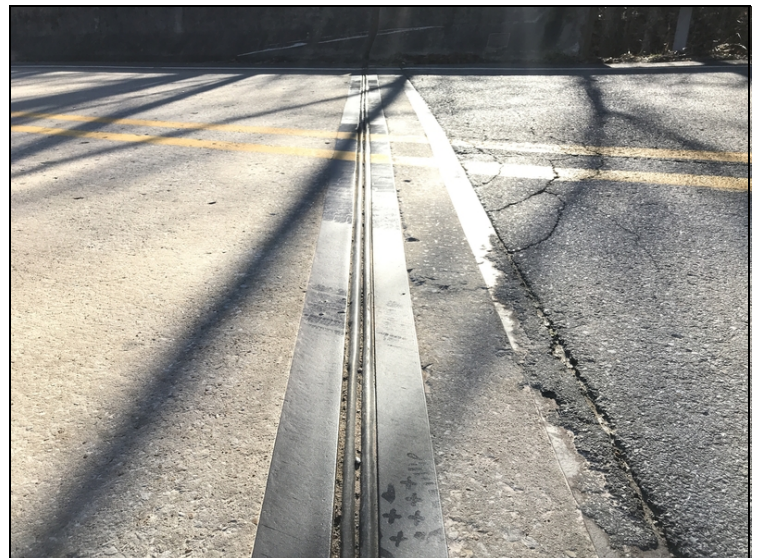
Abutment #1 joint material.

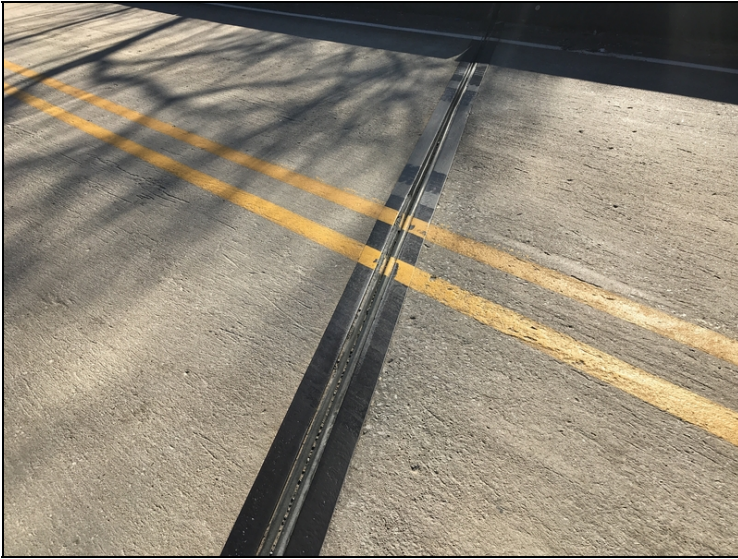
Bent #2 joint material cracking and minor debris impaction.

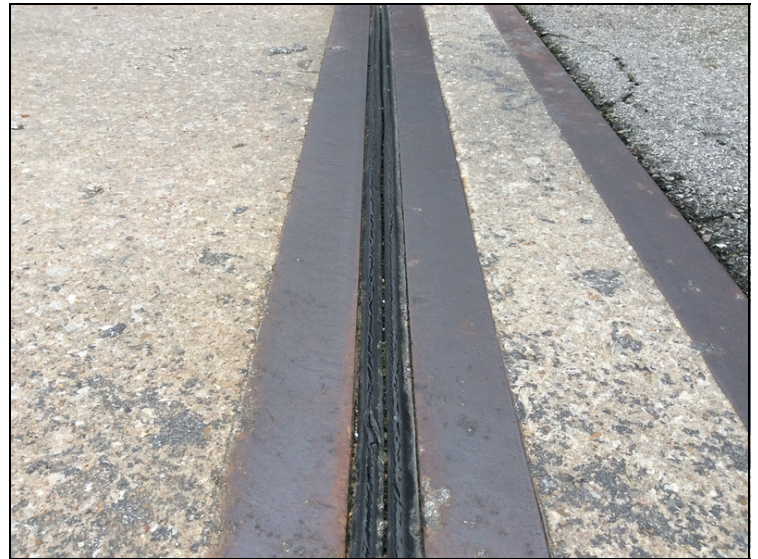
Abutment #1-Deteriorated compression joint seal.

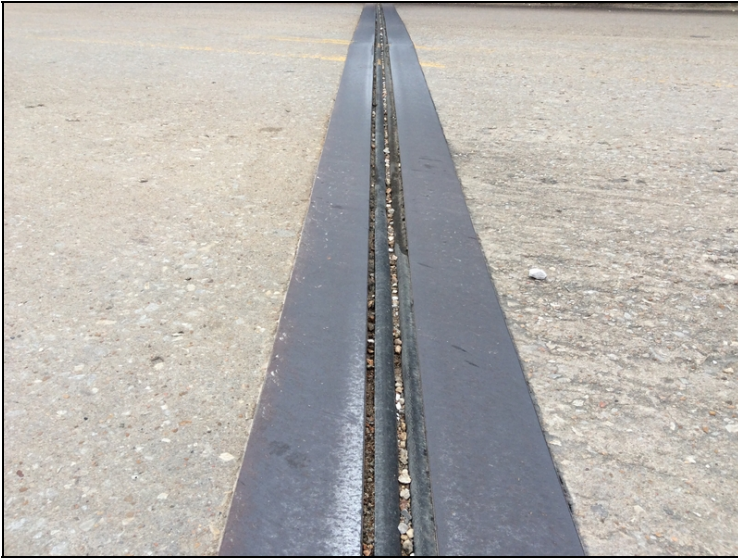
Bent #1 compression joint seal-Adhesion failure.

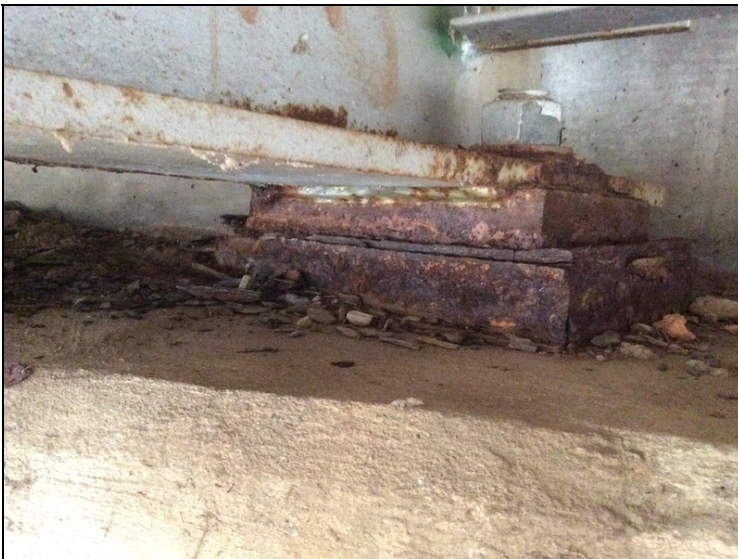
Superstructure - The bearings at all bents have a failing paint system with active corrosion and a rust coating. The most notable case is bearings #1 and 3 over abutment #2 which has heavy flaking rust between the sole and masonry plates. The Beams have areas of active corrosion. The Most notable area is beam #3 over abutment #2 which has corrosion with flaking rust and initial section loss to web and bottom flange.

Abutment #2, bearing #3-Corrosion with heavy flaking rust.

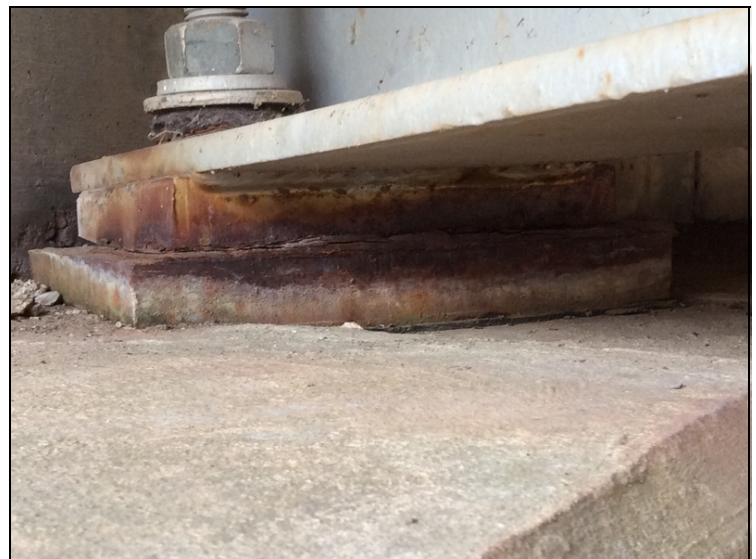
Abutment #2, bearing #1-Corrosion with flaking rust.

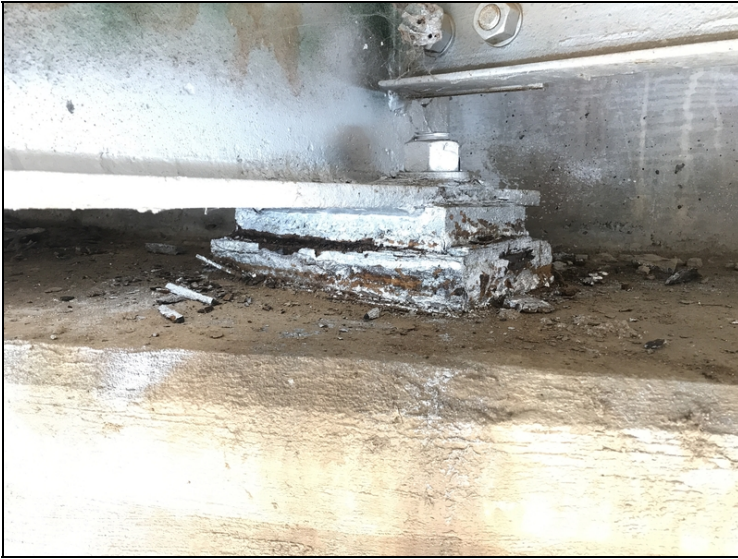
Abutment #2 bearing #3 flaking with a failed paint repair.

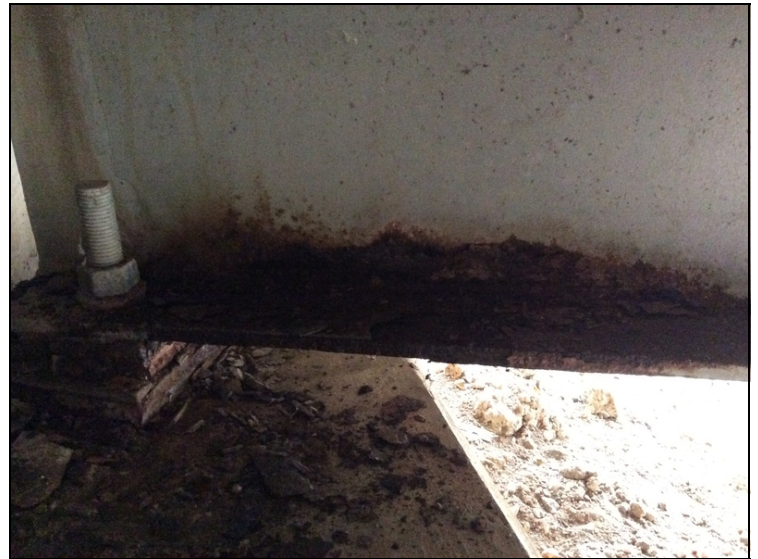
Abutment #2, Beam #3 corrosion with flaking rust to web and bottom flange.

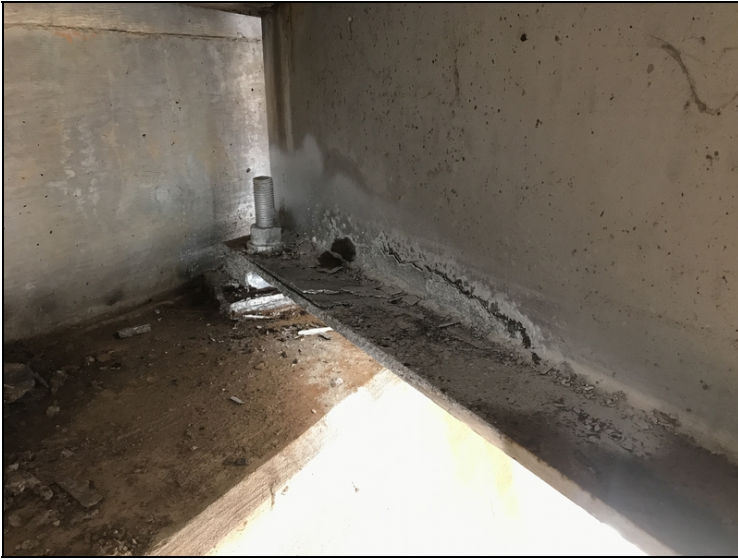
Beam #3 at abutment #2 flaking rust with failed paint repair.
