Asset #18313(Routine, Underwater type 2)

Hogeye Road over Illinois River-Wash. Co.

Location: 0.05 M JCT SH 156 & 265

Team Lead: Eric West, Inspection Date: 12/05/2022

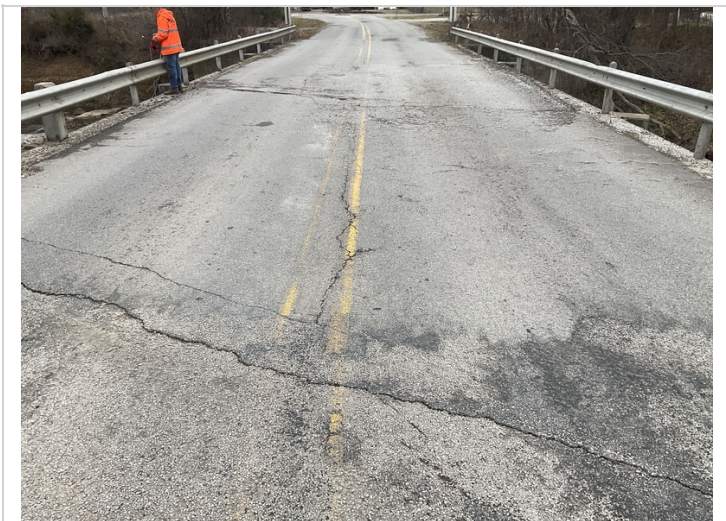
- Span # 2 Rt driving surface near bent # 3 has a 3' long x 6" wide area with the ACHM missing that has created a pothole in the driving surface. Concrete deterioration is visible in the structural deck in the affected area.

Typical driving surface of the deck.

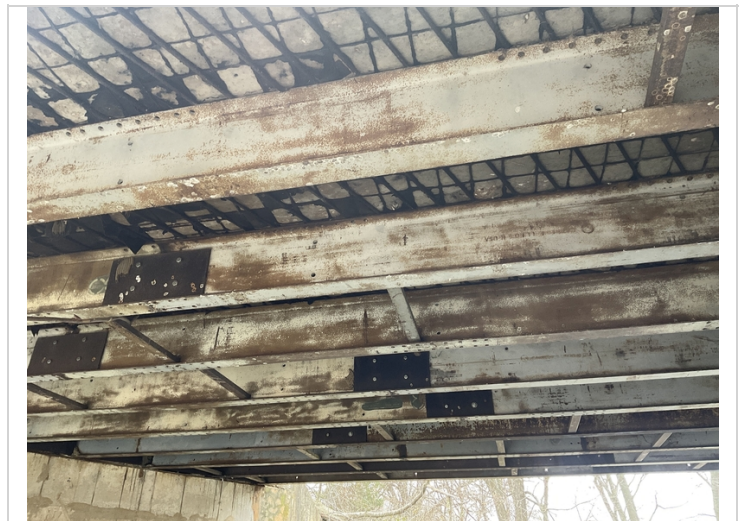
Span #1 typical undersurface of the deck.

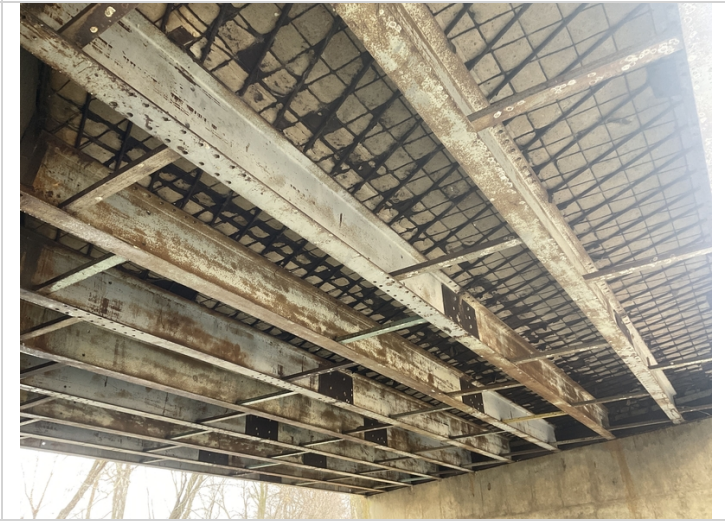
Span #2 typical undersurface of the deck.

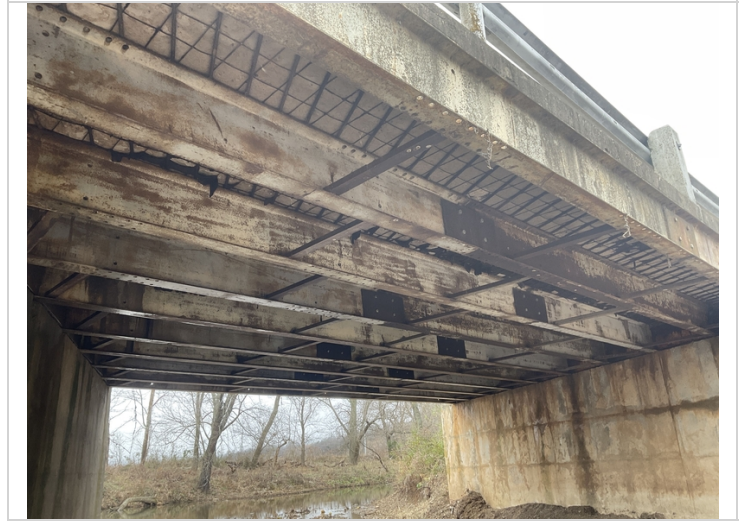
Span #3 typical undersurface of the deck.

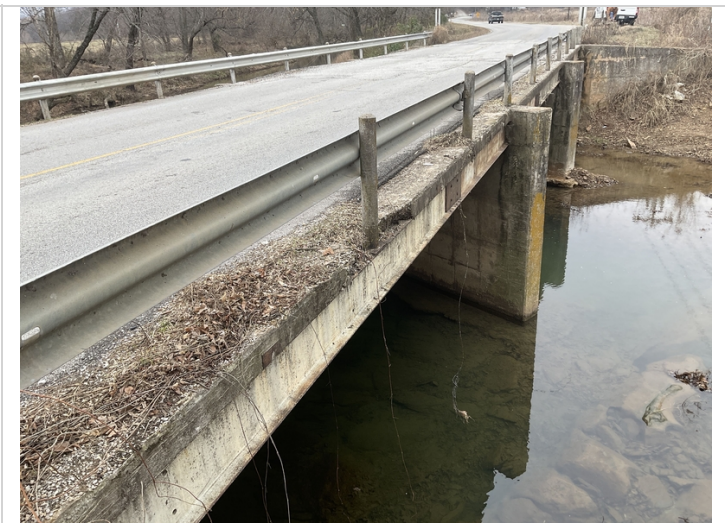
Span #1 Rt deck spalling.

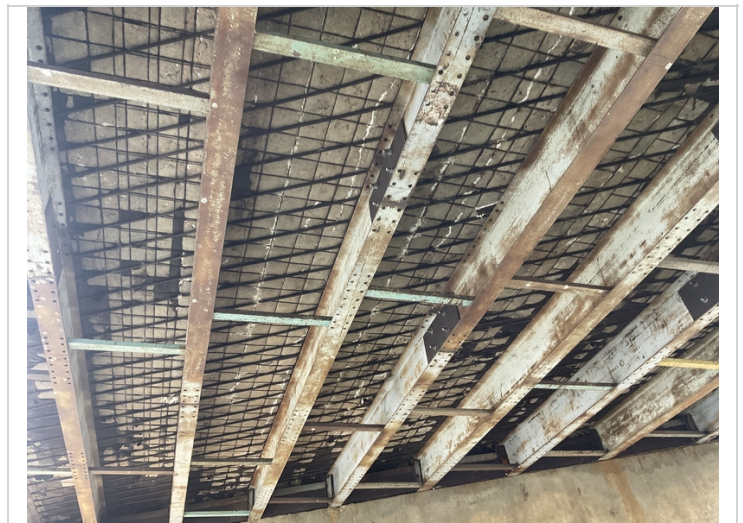
Span #2 longitudinal cracking with efflorescence buildup.

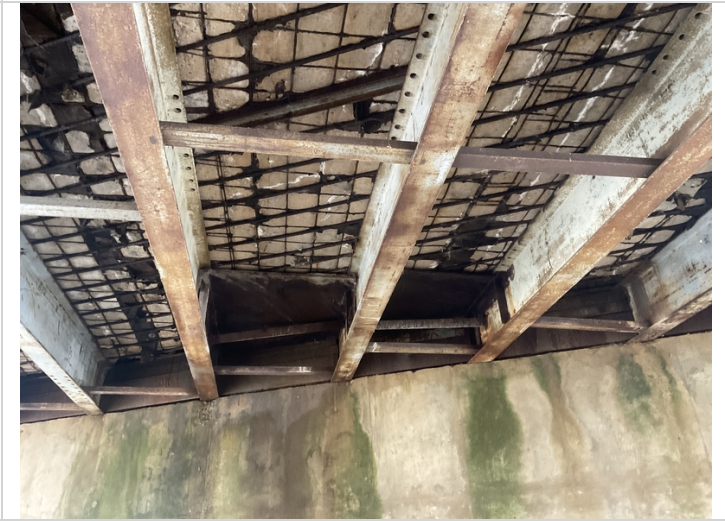
-Maintenance forces have repaired the previously documented 3' area of spalling with exposed reinforcing steel in the deck over bent # 3 since last inspection. The repair was accomplished by installing steel plates under the spalled portion of the deck supported by angle iron welded horizontally along the top of the webs of three of the beams located near centerline with additional supports in a couple locations constructed from angle iron welded vertically to the beams. The repair appears to be functioning as intended with no visible cracks at this inspection.

Span #3 deck repair still holding.

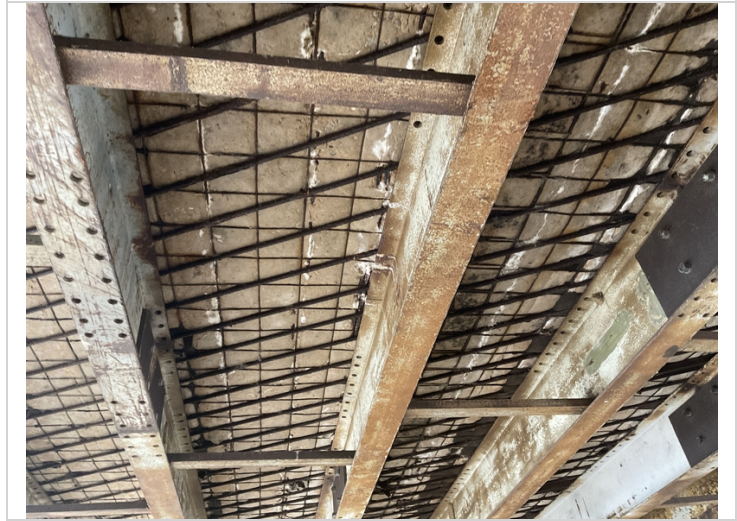
Span #3 undersurface spalling with exposed reinforcing steel.

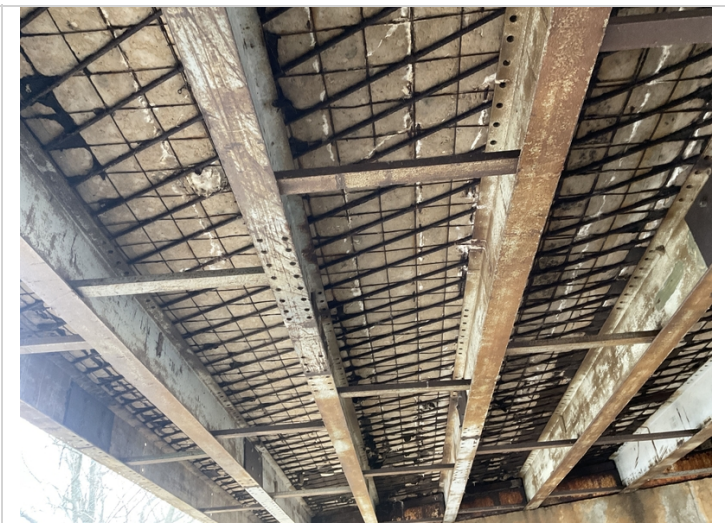
Span #3 longitudinal cracking with efflorescence buildup.

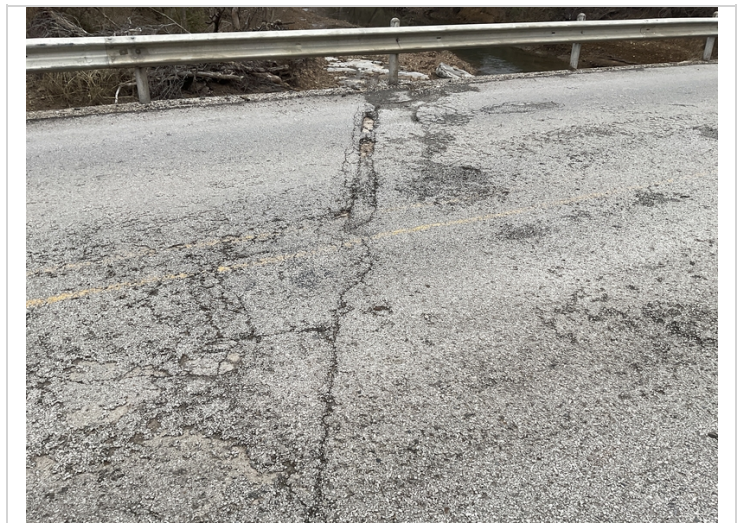
Asphalt deterioration over bent #3.

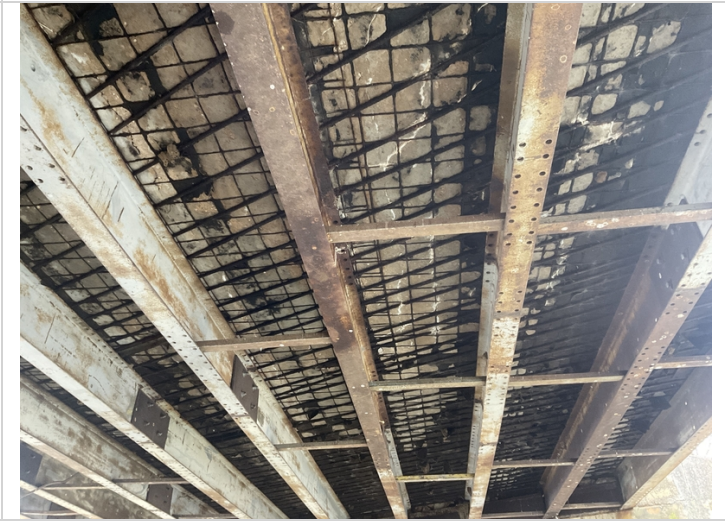
Span #1 Lt longitudinal cracks with efflorescence buildup.

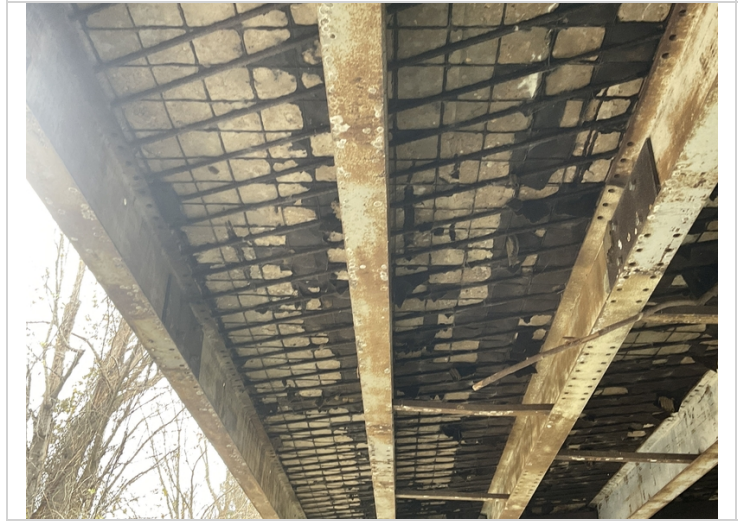
Span #1 bay # 8 & 9 spalling with exposed reinforcing steel.

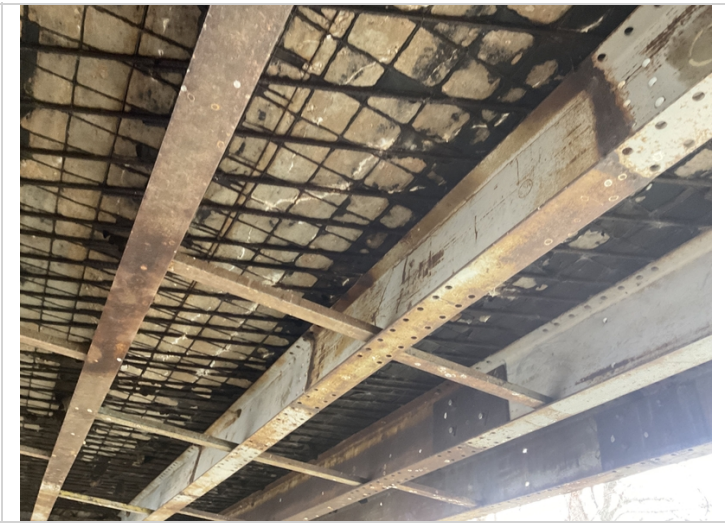
-Span # 1 Beam # 3 has three welded splices with no steel plates bolted to the webs. No visible cracks during this inspection.

Span #1 beam #3 welded splices with no cracking visible.

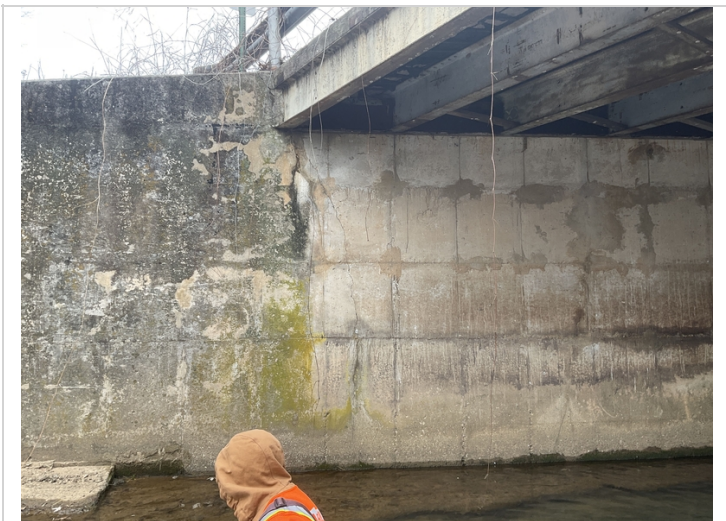
- Abutment #1 has a diagonal crack at the Lt & Rt wing wall juncture and a vertical crack in bay #7.
- Abutment #2 has diagonal cracks adjacent to beams # 1 & 10 at the wing wall juncture.
- Light abrasion along the base of the abutments.
- Footings appear to be founded on a non-uniform solid rock channel.

Abutment #1 Rt vertical crack at the wing wall juncture.

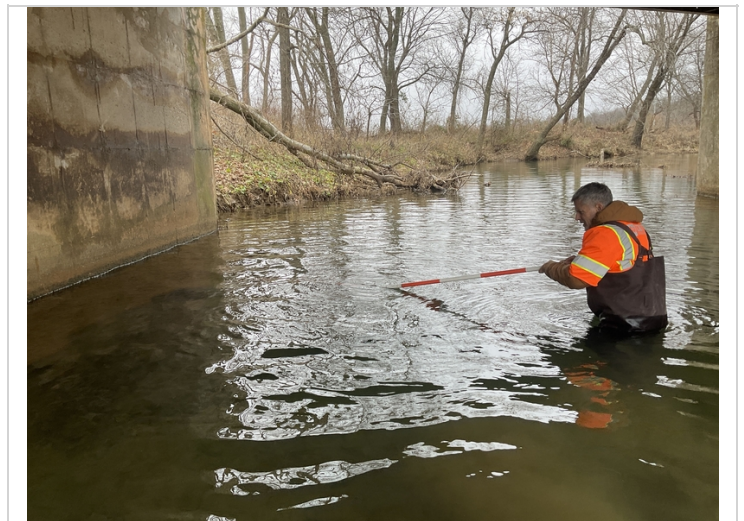
Abutment #1 probing.

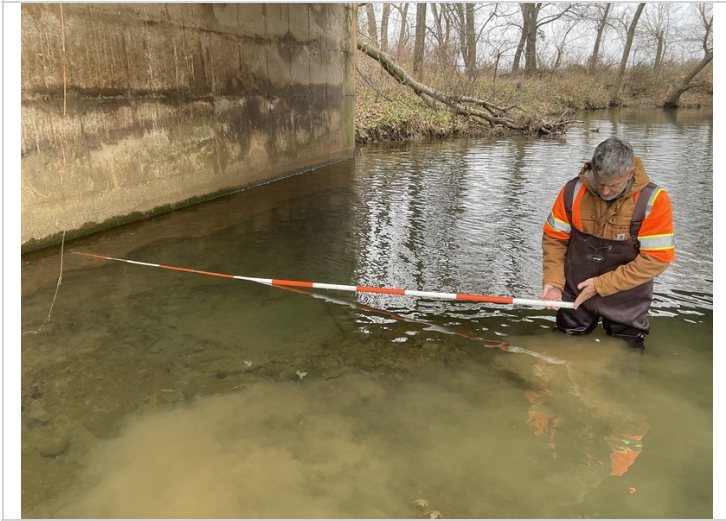
- Abutment #1 footing is exposed with voids along and under the footing. Some voids reach within 1" of the abutment stem but no voids were found that extends under the abutment stem.
- Bent #2 footing is exposed with voids along the edge of the irregular footing. The backside of the footing has minor voids along the edge of the footing. The aheadface has voids that extend up to the face of the pier wall. The inlet end appears to be completely undermined for approximately 18" under the footing longitudinally.
- Bent #3 footing has voids that penetrate under the edge of the footing but do not reach the face of the pier wall. The aheadface is partially exposed but not undermined.
- Abutment #2 footing has cover and is not exposed.

Abutment #1 footing partially undermined.

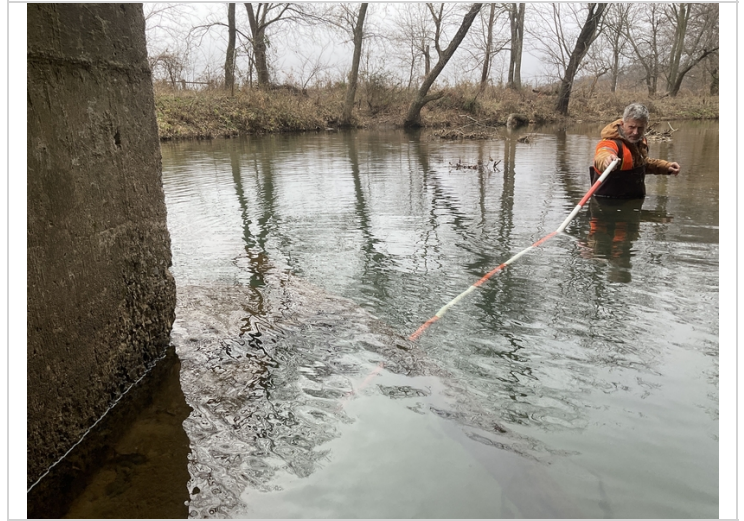
Bent # 2 inlet end with complete undermining for approximately 18" .

Bent # 2 footing has undermining the full length of the footing along both sides of the bent. The most severe area of undermining is the left end of the bent (inlet end) which has undermining that extends the full width of the footing and reaches approximately 18" under the end of the Bent wall.

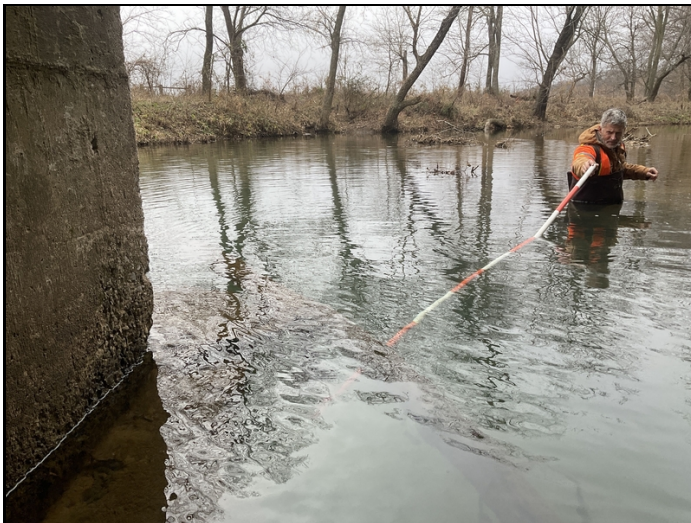
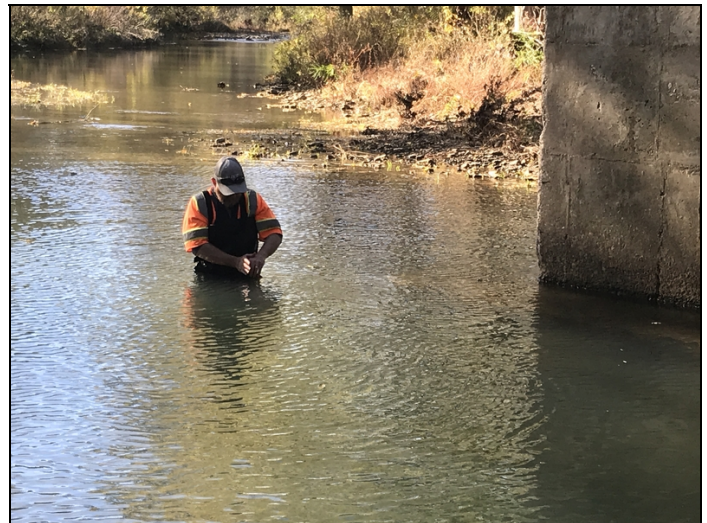
The end of Bent # 2 footing has full depth undermining.
Photo # 1.

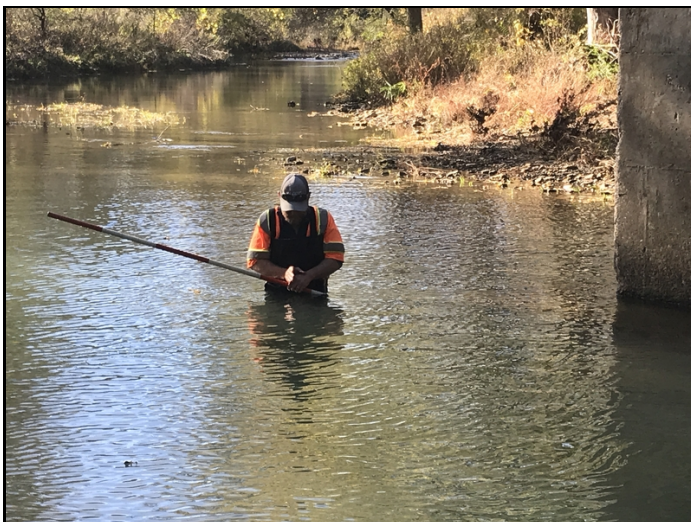
The end of Bent # 2 footing has full depth undermining.
Photo # 2.

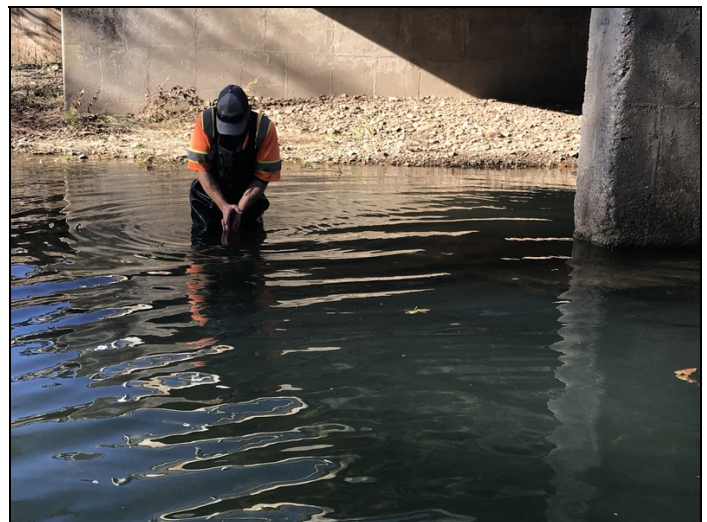
Bent # 2 left end has up to 18" of undermining. Photo # 1.

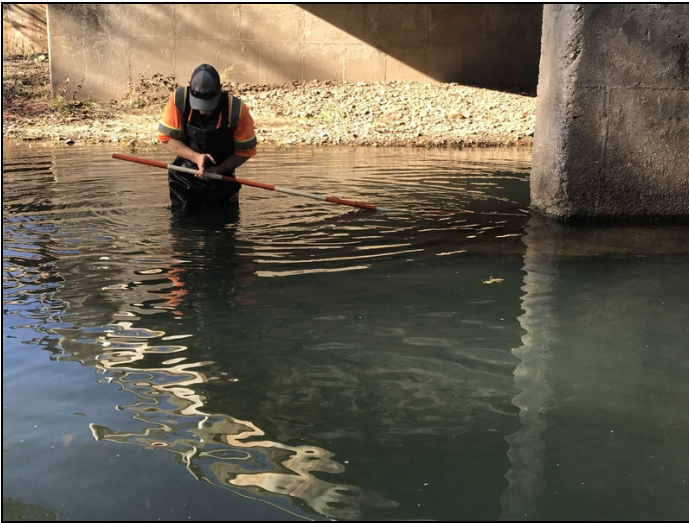
Bent # 2 left end has up to 18" of undermining. Photo # 2.

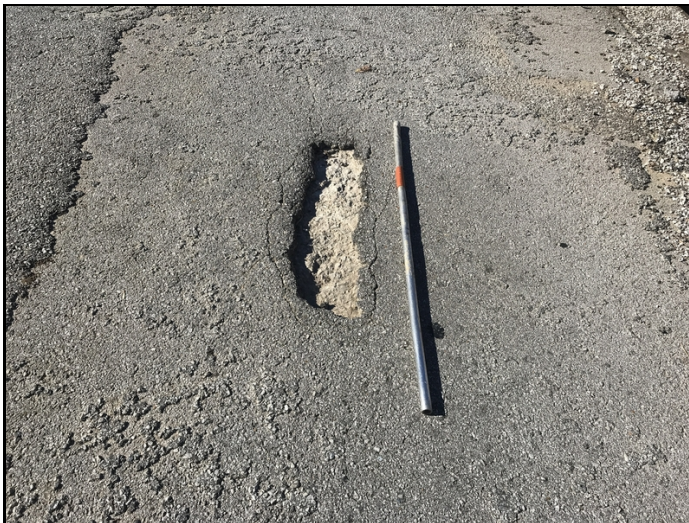
A portion of the asphalt driving surface approximately 2' long x 8" wide is missing in the right lane of span # 2 near bent # 3 that has created a pothole in the driving surface.

Span 2, right lane at bent # 3-Spall / pothole in driving surface.

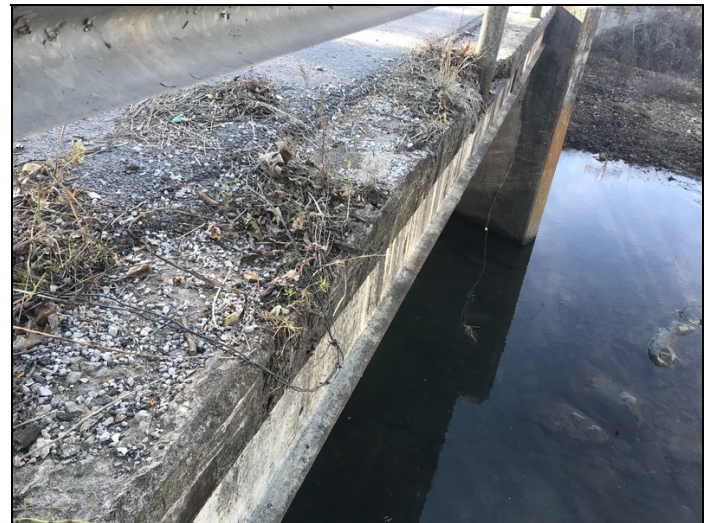
The right edge of deck has areas of spalling and concrete deterioration in Spans # 1 and # 3.

Span 1, right side-Concrete spalling / deterioration.

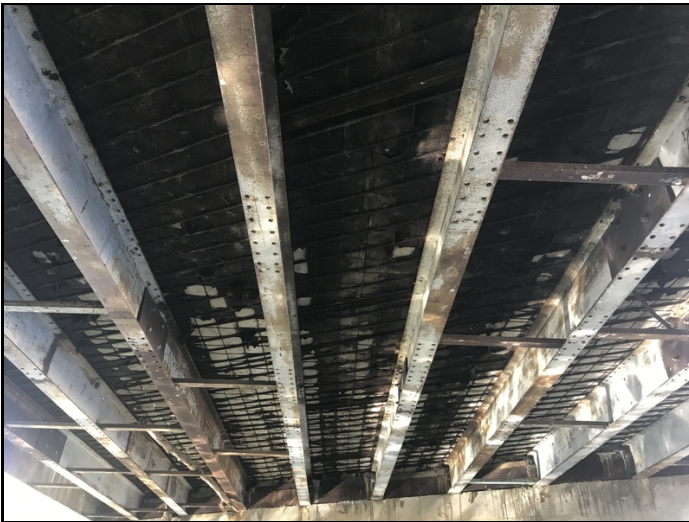
The superstructure paint system has areas with rust forming.

A-60 - Full Beam Painting Needed (Yes)

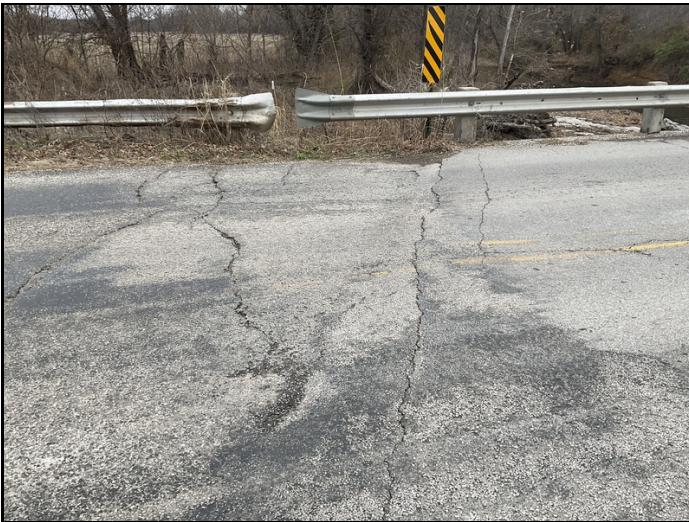
Approach Roadway-
The west approach roadway has approximately 1" of asphalt settlement.

West approach roadway with asphalt settlement at the bridge end.
