Bridge #18344(Routine, Underwater type 2)

CR 75 White Co. over DITCH

Location: JCT CORD 241 & 75

Team Lead: Nathan Edwards Inspection Date: February 07, 2022

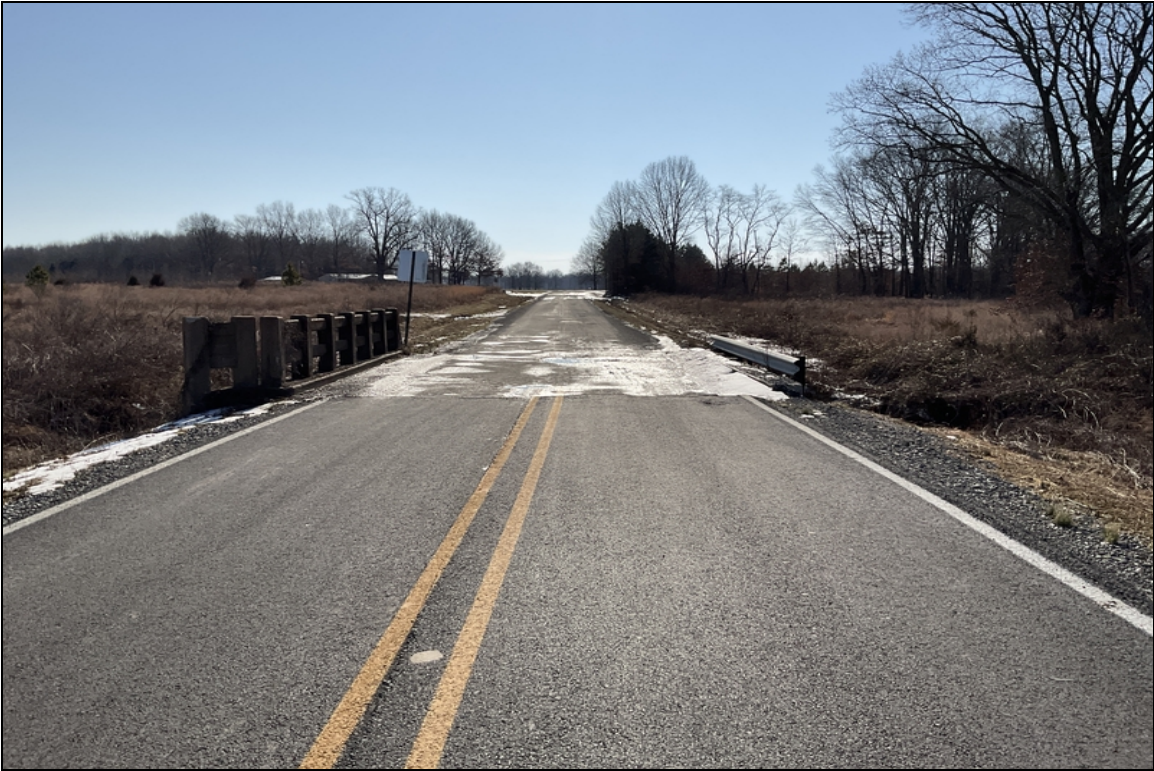
Roadway with Log Mile running North to South.

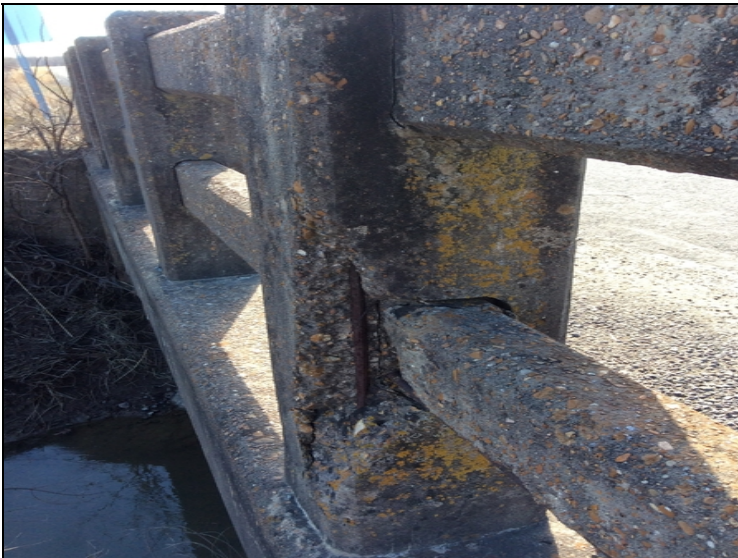
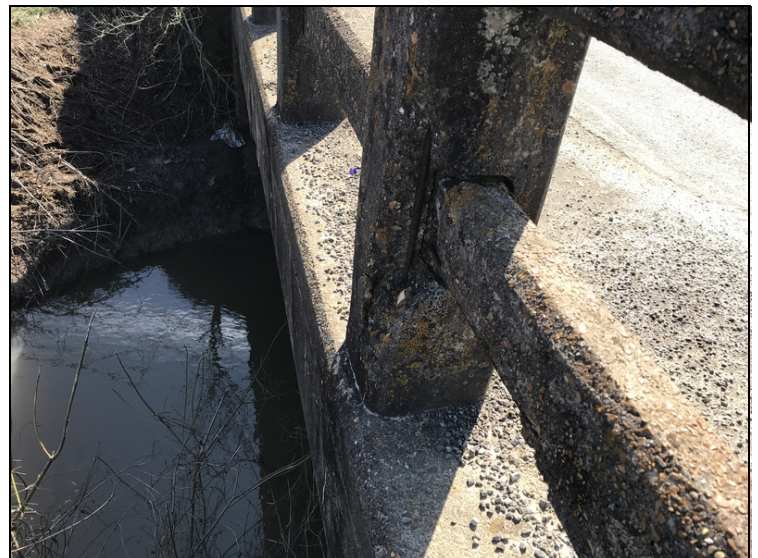
3rd concrete post on Left is cracked & spalled with 2' of rebar exposed.

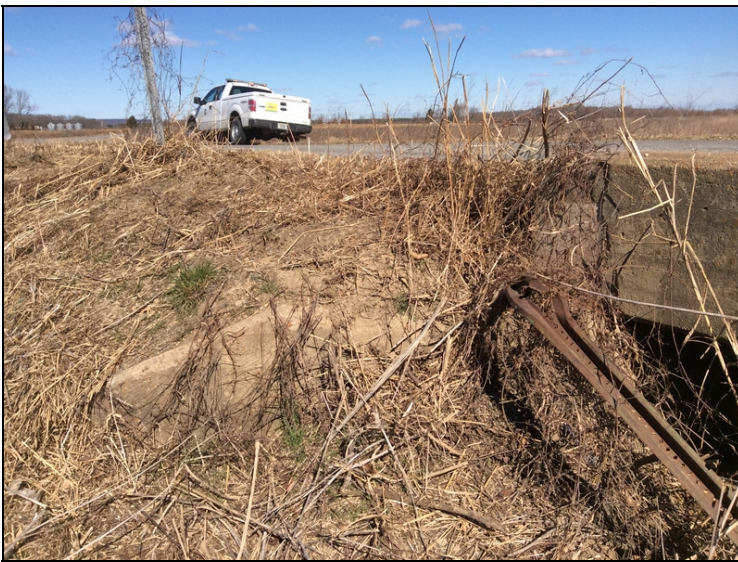
Typical cracks & spalls to left wing @ Abutment 1 & 2.

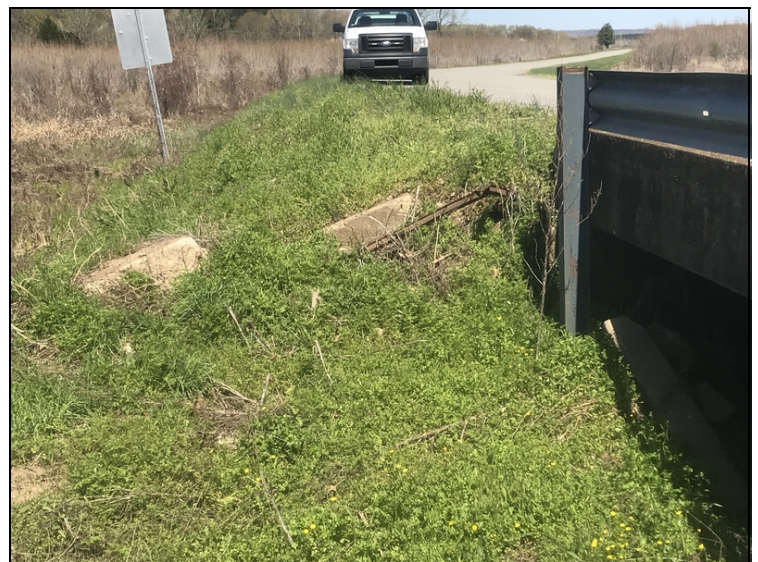
Cracks to Right wing walls at Abutments 1 & 2.
