Bridge Inspection Report

A5020
I 30, WB-13-52.27
over
BLACK CREEK

Structure Number: A5020

IDENTIFICATION		INSPECTIONS	
(1) STATE CODE	056 - Arkansas	(90) INSPECTION DATE	02/23/2017
(8) STRUCTURE NUMBER	A5020	(91) DESIGNATED INSPECTION FREQUENCY	24

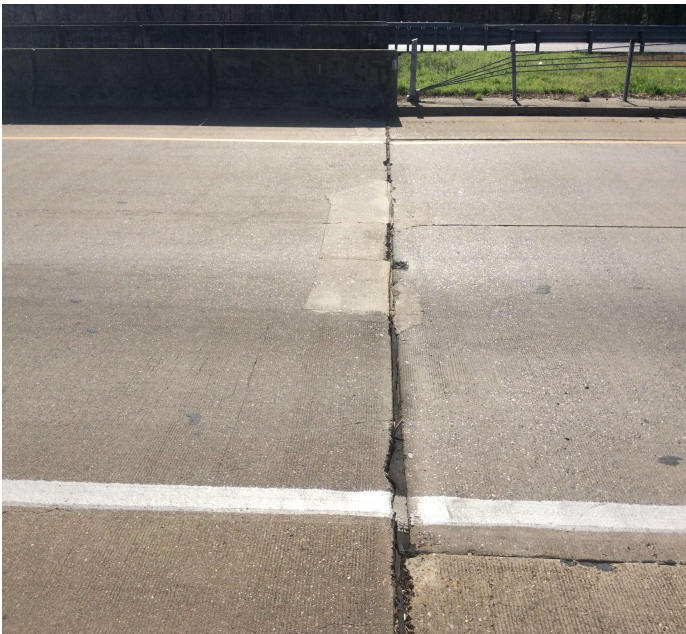
JOINTS AT BENTS 1 AND 8 JOINTS NEEDS
TO BE FILLED. COULD CAUSE EROSION UNDER
APPROACH SLAB.

PHOTO 1 Description Bent 1 Joint bad

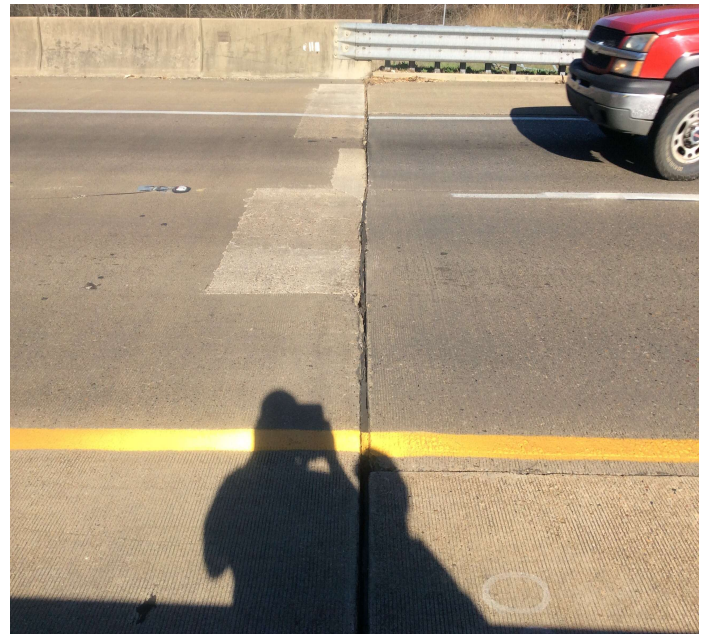
PHOTO 2 Description End of bridge joint..

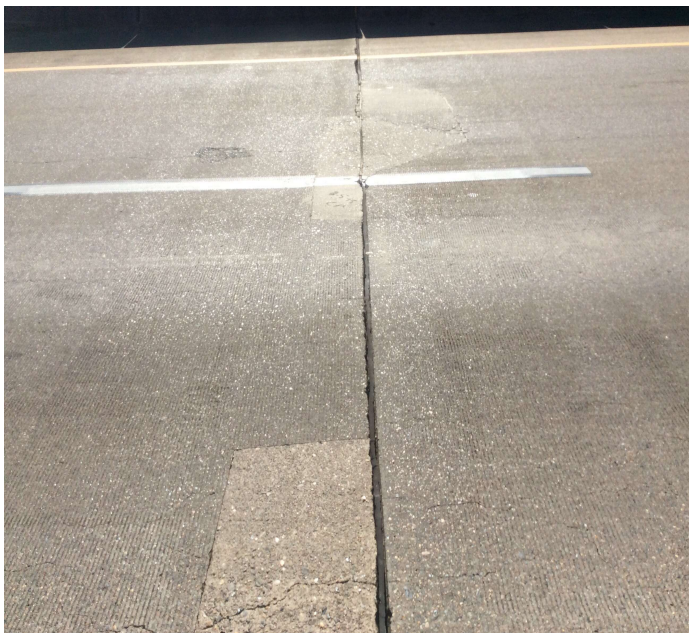
PHOTO 3 Description Joint bad ...

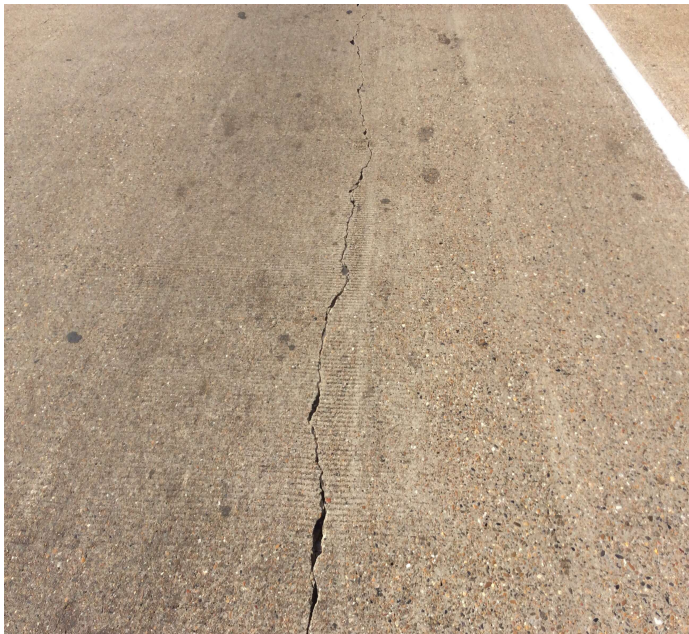
CONCRETE DECK CRACKS IN ALL SPANS
LARGE SEALABLE DECK CRACKS IN 2" THIN
CONCRETE OVERLAY.

PHOTO 1 Description Span 2 crack

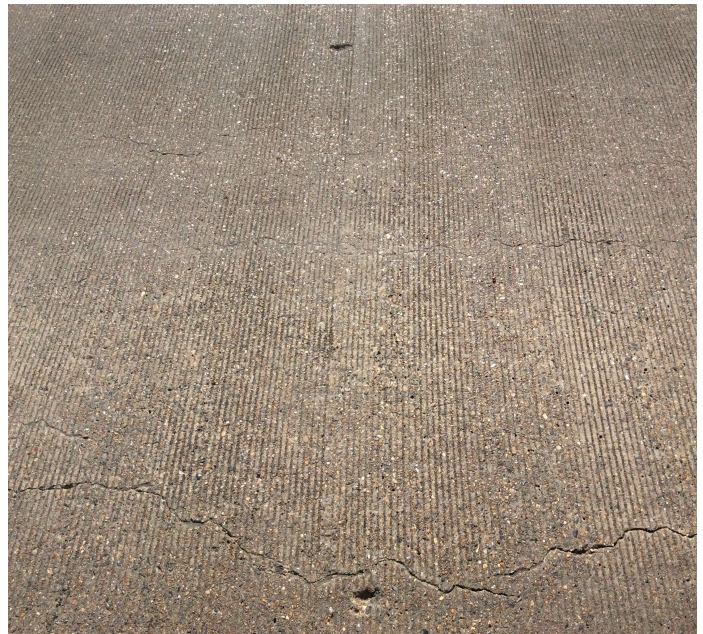
PHOTO 2 Description Sealable deck cracks...

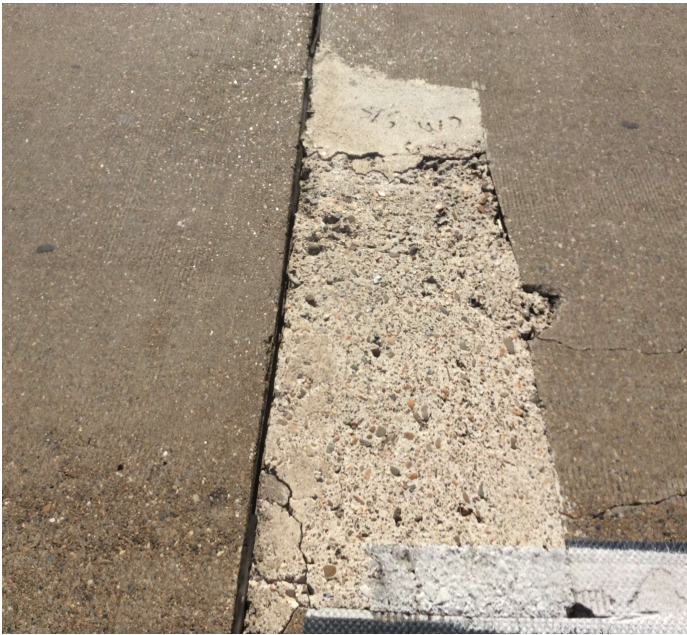
CONCRETE DECK AT BT. # 1 OLD PATCH IS
BRAKING UP.

PHOTO 1 Description Patch area span 1
